Analysis of the technical condition of the inner façades of the Donjon at the Kłodzko Fortress

Abstract: The article presents an analysis of the technical condition of the interior façades of the Donjon in the Kłodzko Fortress. The aim of the study is to understand the processes leading to the deterioration of the architectural heritage. The Kłodzko Fortress, located in Lower Silesia, is one of the most important and largest fortifications in Poland, with a rich history dating back to the Middle Ages. Modern structures date mainly from the 17th and 18th centuries. The article focuses on the analysis of the technical condition of the internal façades of the donjon, which are exposed to various degradation factors such as weather conditions, human activity, and time. The studies were carried out in 2016 and 2023. They aimed to determine the current condition of the donjon's internal façades and the causes of the observed deterioration. The two surveys made it possible to assess differences in damage and the speed of degradation processes and their impact on the current state of the façades.

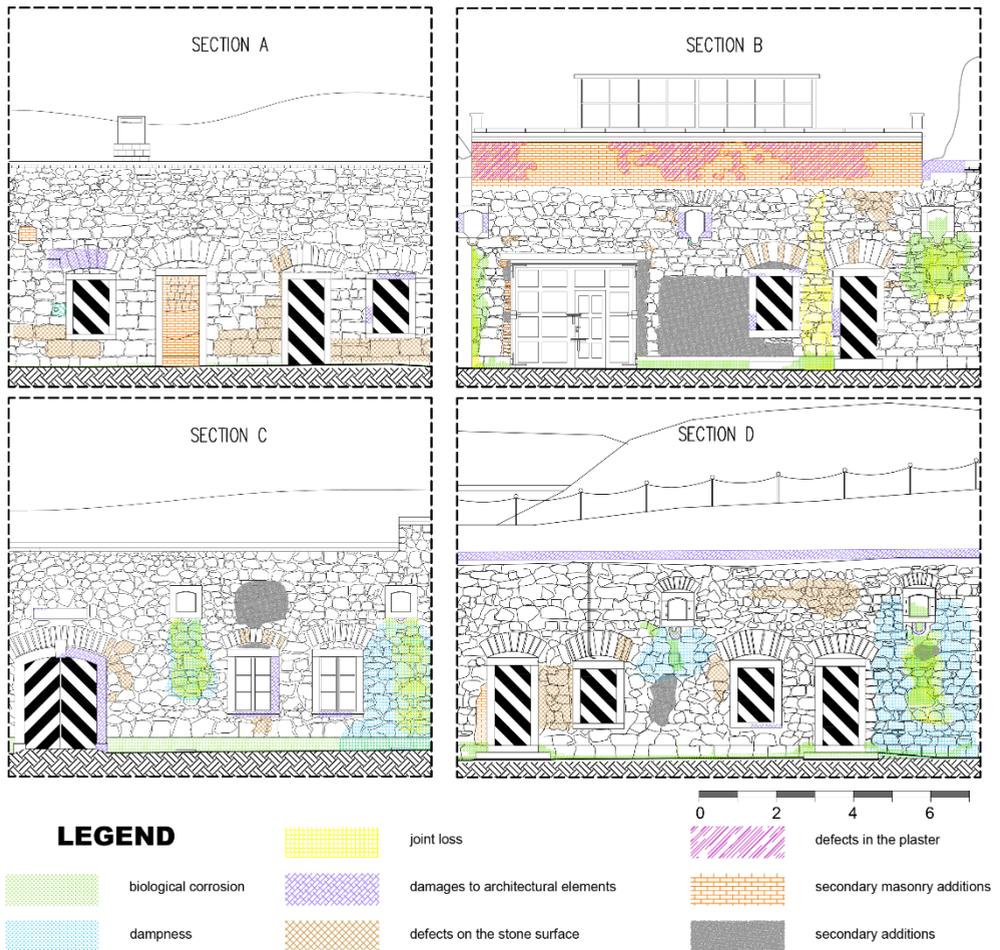
Fig. 3. Damage analysis of selected sections of the Donjon façade. *Source:* own study

The technical condition of the masonry varies, changing in relation to its exposure to sunlight. In places where the sun shines much longer on the façade (Fig. 3 Section A), the technical condition can be described as good (Figs. 16-17, Figs. 20-21). Where there is less light, the technical condition of the masonry is usually sufficient. On the inner façades of the Donjon, there is localised washout of the joints and biological corrosion resulting from a poorly functioning rainwater drainage system. There is also damage to the crown cornice, through which water from the earthen embankment moves causing dampness to the interior of the masonry and façade surfaces (Fig. 3 Section D, Figs. 4-5). The gargoyles are damaged in several places, rendering them unfit for purpose (Fig. 3 Section B, Figs. 4-5, Figs. 10-11). There is also surface crystallisation of salt, causing localised efflorescence and staining.

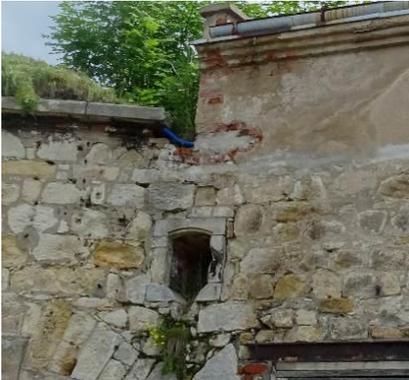
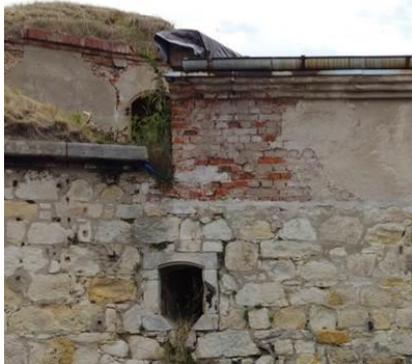
Damage is particularly visible on architectural elements that protrude from the face of the wall, i.e., window and door bands, gargoyles, and cornices (Figs. 4-5, Figs. 12-14, Figs. 18-19).

Fig. 4., Fig. 5. Progressive deterioration of the plaster and masonry of the clay brick superstructure. Damage to the upper layers of the stone façade due to salt and frost damage in areas of increased moisture. Deterioration of historic limestone masonry joints

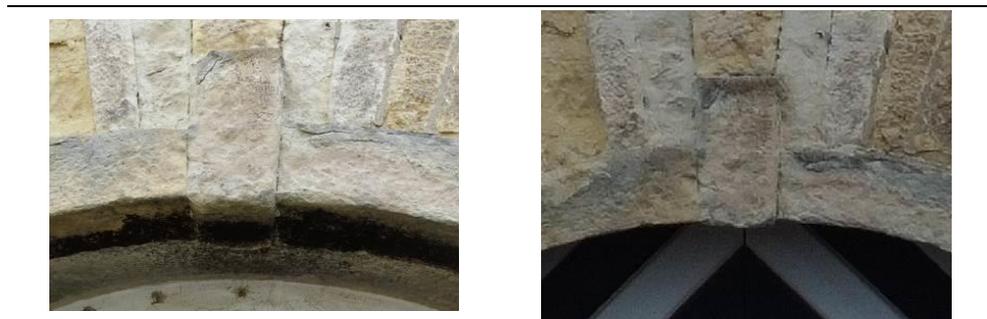
Above the window and door openings are arched lintels made of stone. Their technical condition is mostly assessed as good (Figs. 20-21). No obvious cracks or cavities are visible. Only locally, powdering of the stone surface and losses in historic joints were found (Figs. 6-7). Near the stone bands of the door and window openings, damage to the face of the masonry is present: losses in the pointing, salt corrosion of the mortar, damage to the face of the stone blocks (Figs. 14-15).

Fig. 6., Fig. 7. Surface damage to the stone blocks of the lintel of the casemate gate. Visible powdering of the stone surface, loss of historic joints

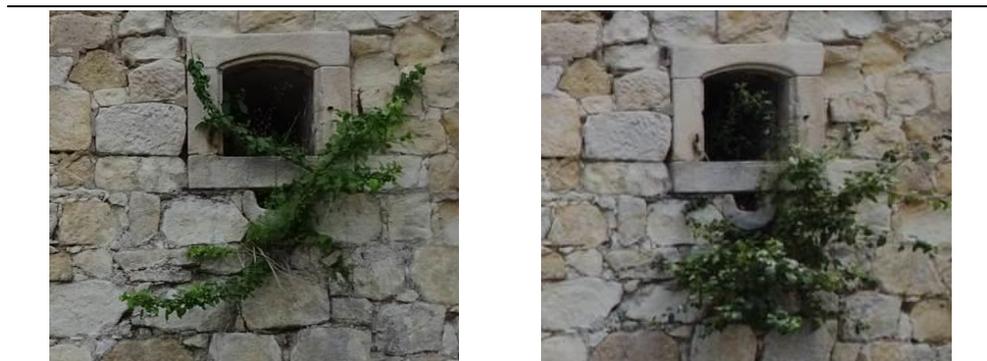
Fig. 8., Fig. 9. Proliferation of perennial rooted vegetation in the wall void below the damaged stone gargoyle. Deterioration of the joints around the gargoyle due to poor drainage of rainwater. Water runs directly down the face of the masonry

The next steps should include addressing all the stone gargoyles. Currently, most of the water flowing down the drainage channels penetrates the brickwork, causing considerable damage to the facing brickwork immediately below the buttresses. In most cases, the stone elements of the buttresses need to be replaced.

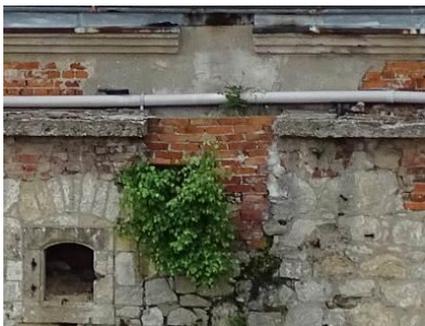
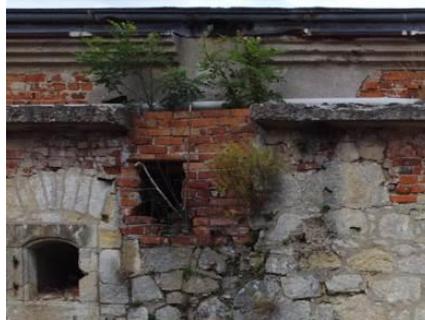
Fig. 10., Fig. 11. Further growth of weeds and young shrubs after removal of mature shrubs. Root systems of perennial vegetation cause degradation deep within the wall

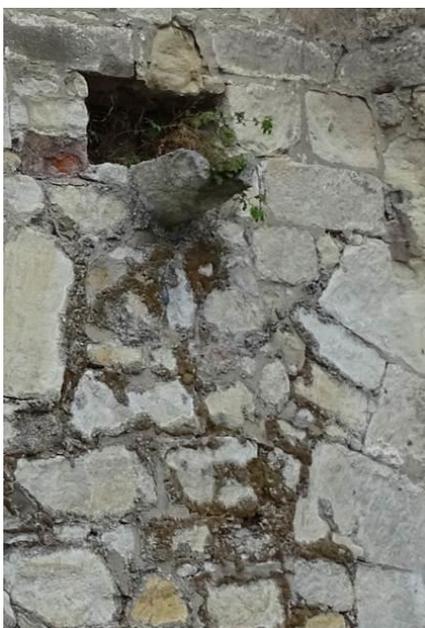
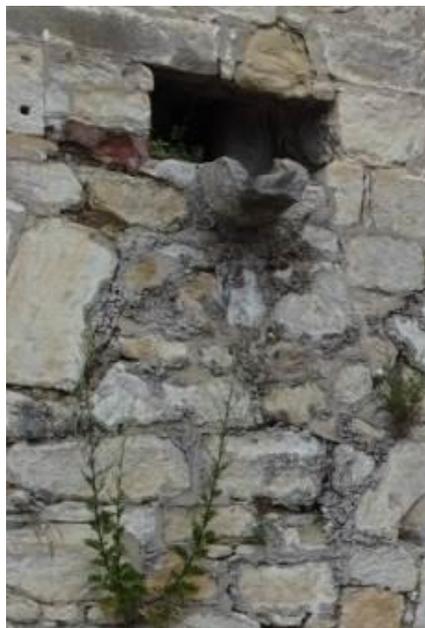
Fig. 12., Fig. 13. Biological corrosion of the limestone joints of the masonry face. The growth of moss and algae causes micro-damage to the mortar, creating a substrate on which annual and perennial vegetation can grow. This development intensifies the degradation processes

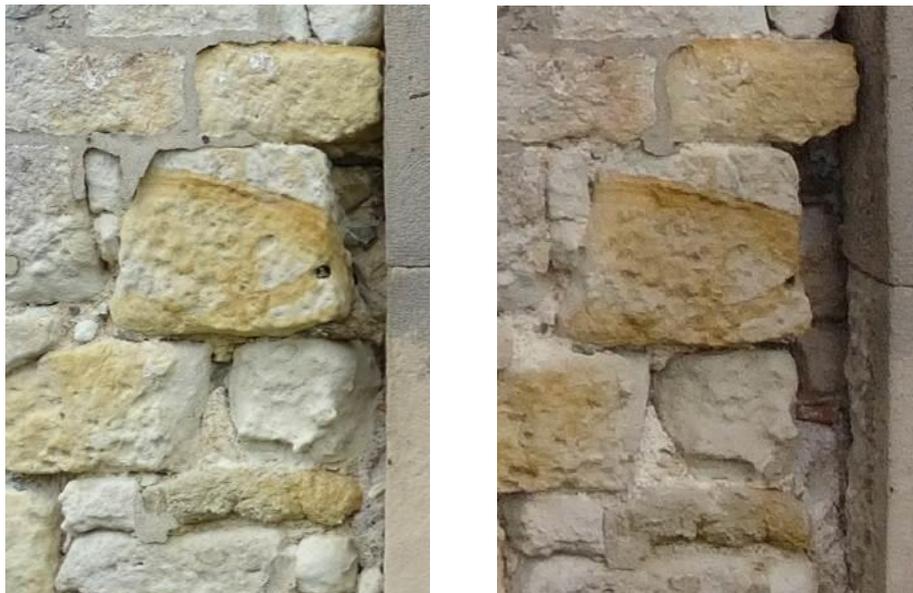
Fig. 14., Fig. 15. Changes in the condition of the masonry face due to salt and frost damage. Over a number of years, there has been increasing damage to the surface of the masonry and significant deterioration of the historic and secondary pointing of the masonry

In areas where there has been significant damage to the facing layers, work will need to be carried out to fill joints, replace or repair stone blocks, and clean sections of the façade of dirt and organisms that cause biological corrosion.

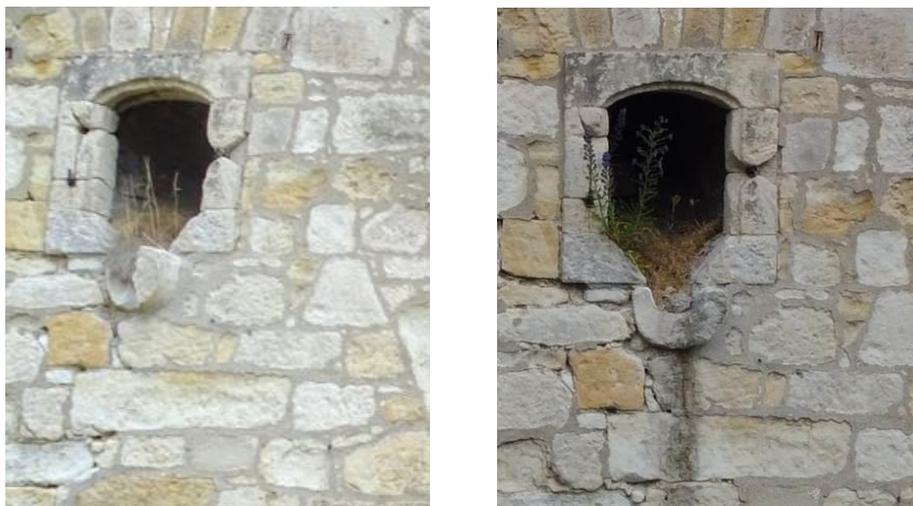
Fig. 16., Fig. 17. Vegetation growth inside the gargyle. Inadequate drainage of rainwater results in streaking on the face of the wall. Damage to the stone face and joints from moisture, salt and frost corrosion is an additional problem

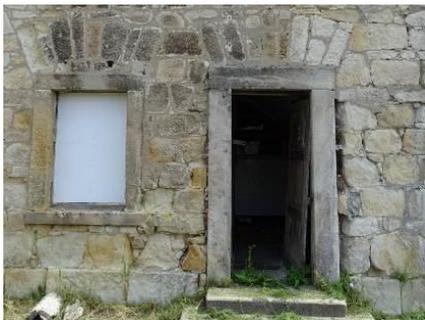
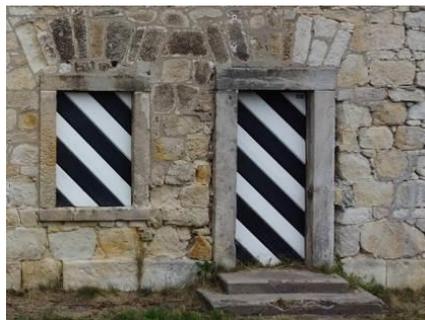
Fig. 18., Fig. 19. Replacement of the completely damaged entrance door and the panel in the window opening with new ones. Changes that significantly improve the aesthetics of the Donjon's façade

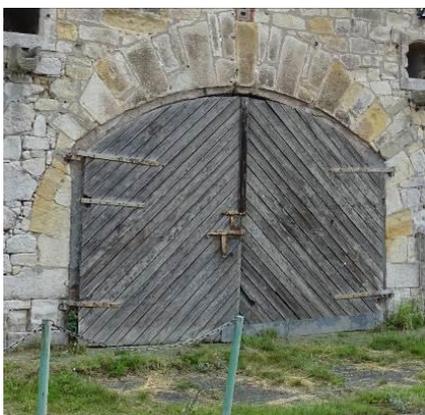
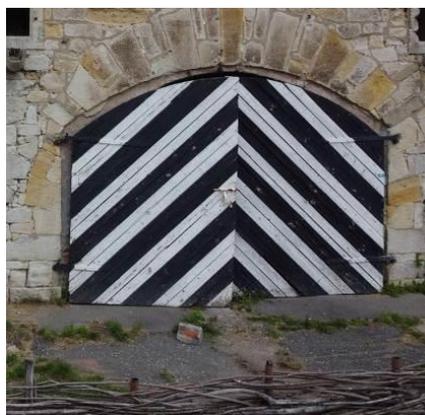
Fig. 20., Fig. 21. Renovation of the gate leading to the casemate, repainted in the original style. Removal of the metal chain-link fence and its replacement with a low wooden fence

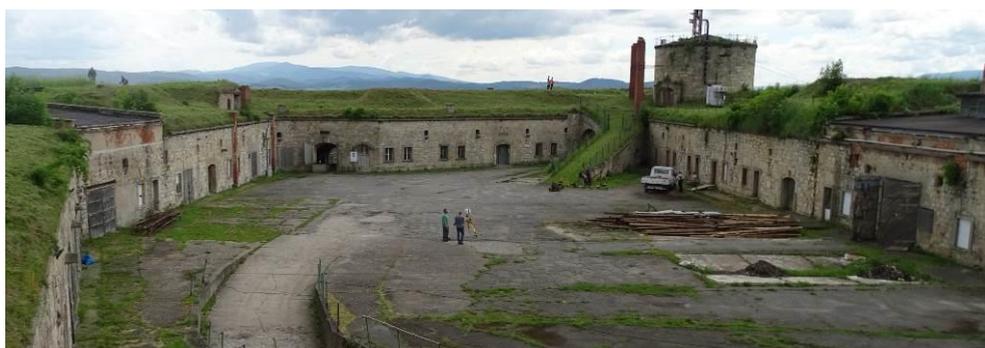
Fig. 22. Donjon's visual state for 2016. Source: authors

The stone plinth is largely in a poor state of repair. Along almost the entire inner perimeter of the Donjon, there is a high level of dampness in the area of the plinth. This is caused by leaks in the band and the condition of the masonry, particularly in the lower part, and is detrimental to the growth of living organisms (Fig. 3 Section C, Figs. 18-19). In addition, the poorly profiled slope of the courtyard surface contributes to the elevated moisture levels in the lower parts of the Donjon façade (Figs. 22-23).
