The wooden roof structures of Żuławy Region arcaded houses of type III - research, current state and analysis

Tomasz Zybala

*The Department of Structural Mechanics; Faculty of Civil and Environmental Engineering;
Gdańsk University of Technology;
tomasz.zybala@pg.edu.pl; ORCID: 0000-0001-9186-4960*

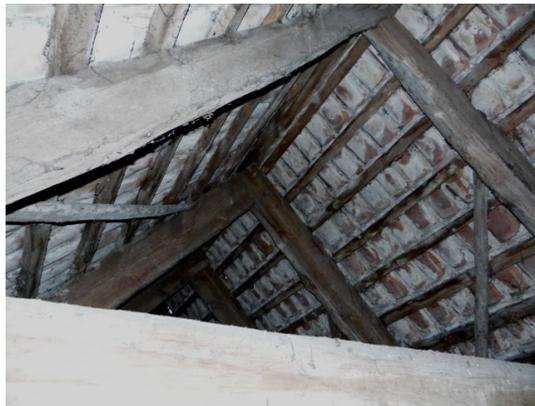
The connection of rafters in the ridge is made with lap joints (Fig.7), the connection of the collar beam with the rafter with simple lap joints, for which two dowels are used (Fig. 8). The roof slope inclination angle is 45° (Fig. 9)¹². The number of trusses above the main body of the house is 15, the span of the roof is 12.40m and the spacing of trusses is 1.25m. The condition of the structure is acceptable¹³. As a result of leakage of the roof covering, numerous dampness and damages are visible in the roof structure. Gravitational ventilation of the attic is not disturbed; there is constant air circulation.

Fig. 7. Bystrze– the view on the ridge. (author's own photography)

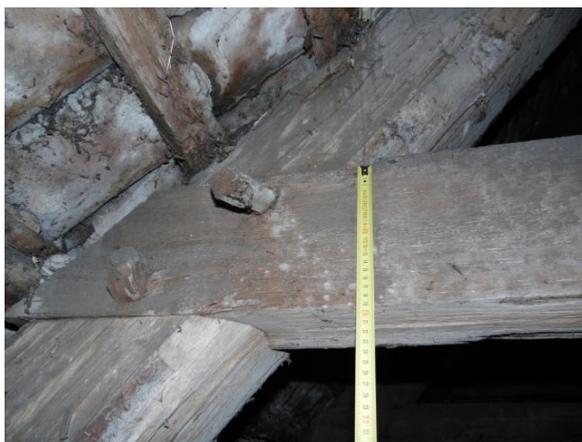
Fig. 8. Bystrze – connection of a collar beam with a rafter. (author's own photography)

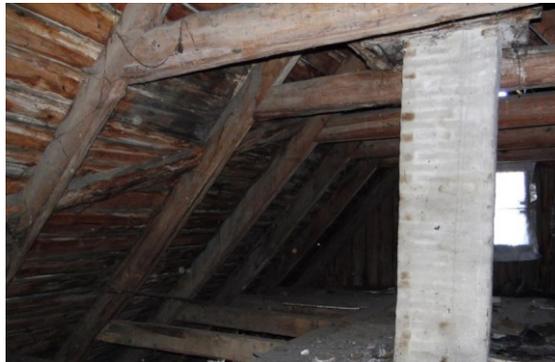
Fig. 10. Marynowy – the view on the rafter framing with two collar beams (author's own photography)

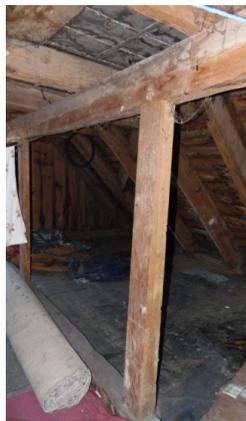
Fig. 11. Marynowy– the posts supporting a collar beam (author's own photography)

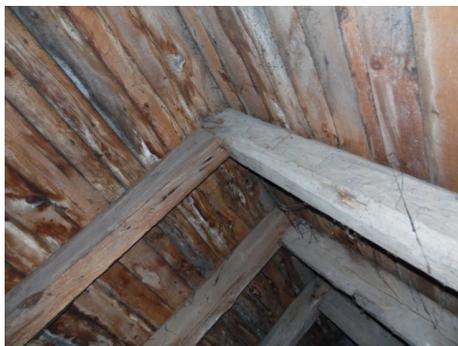
beam there are 5cm thick plates. The structure is in good condition. The roofing is sealed. The components of the rafter framing are well preserved and despite their age, they do not show any major damage. Some elements of the rafter framing show carpentry markings, one may see the symbol IIII on a collar beam (Fig. 14). Gravitational ventilation of the attic is not disturbed, there is constant air circulation.

Fig. 13. Nowa Kościelnica – connection of the rafter (author's own photography)

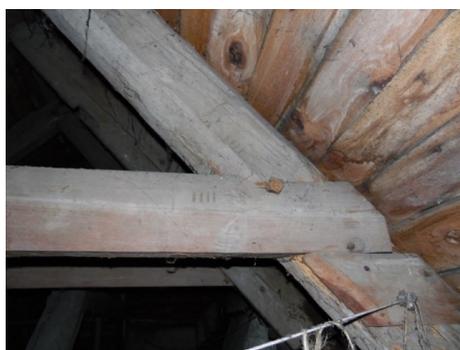
Fig. 14. Nowa Kościelnica – connection of the rafter with the collar beam (author's own photo.)

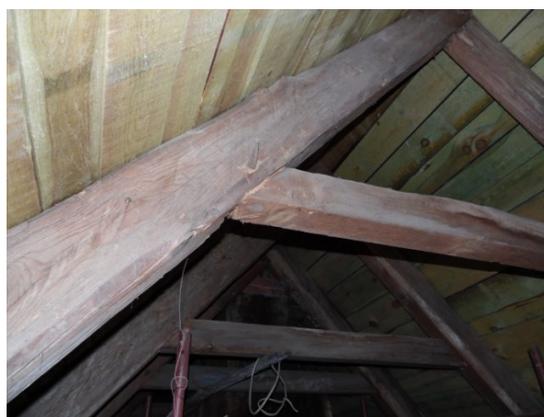
Fig. 16. Rybina – roof structure (author’s own photography)

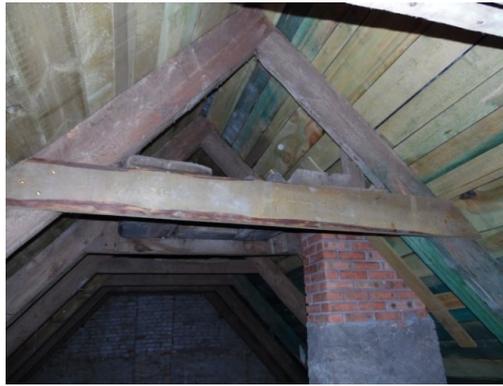
Fig. 17. Rybina – a new collar beam in the structure (author's own photography)
