Evaluation of lime plaster on masonry walls in historical buildings prior to renovation

Abstract: This study analysed a quantitative assessment of the adhesion of lime plasters to the substrate in a historic neo-Gothic building. The diagnostics of the plasters were conducted to preserve their large surface area due to their historical value. The use of modern non-destructive and destructive methods allowed for a significant reduction in the work required to remove the historic plaster. It was noted that only the correlation of non-destructive and destructive methods can enable an accurate determination of the necessary repair work on historic plasters. Challenges in diagnosing plasters in historic buildings are also discussed.

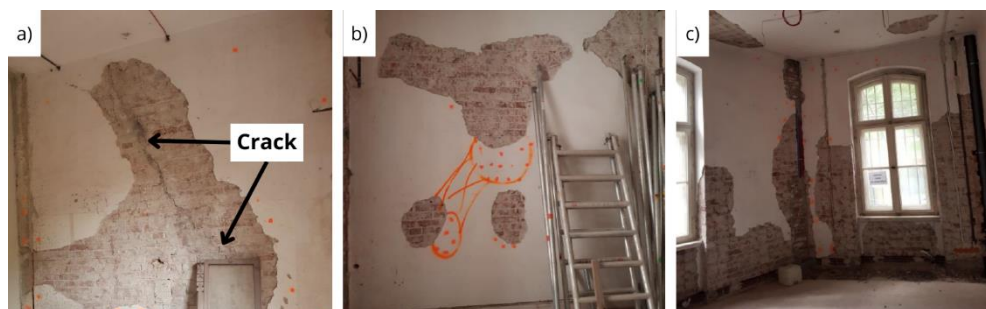
Fig. 1. Views of damage and defects in plasters: a) caused by a crack in the wall b, c) caused by delamination

The plaster in question does not cover the entire walls in the rooms, as it has been removed in some areas by scraping (Fig. 1). The surfaces without plaster form irregular shapes, varying in size depending on the reason for their removal. However, the conservation and repair work required a comprehensive assessment of the plaster's condition (both qualitative and quantitative), and its historic value necessitated minimising the extent of removal.

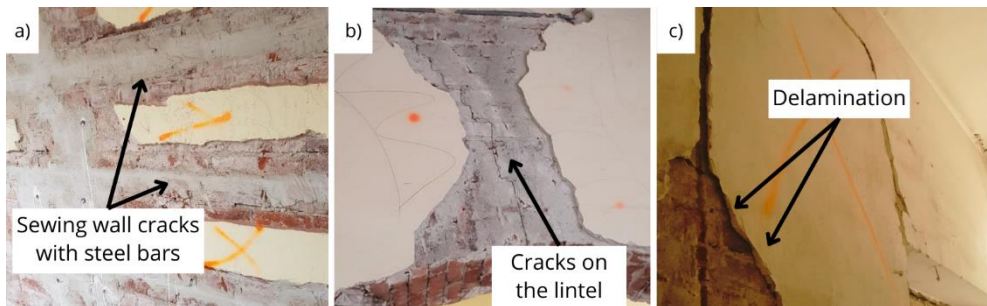
Fig. 2. Examples of defects in plasters: a) caused by the repair of a crack in the wall, b) caused by structural cracks, c) delamination

When repairing cracked walls (where the crack was more than 3 mm wide), a large area of plaster was removed to "stitch" the wall using steel rods placed in the horizontal joints of the masonry. Ensuring the proper anchorage length of these bars required removing significant lengths of narrow plaster strips to create a strip system (Fig. 2). It was also observed that, as a result of the repair work, the adhesion of some sections of plaster deteriorated, leading to a greater extent of plaster removal. The surface of the original plaster, significantly weakened by numerous irregular and random areas of chipping, was assessed by the supervisor overseeing the repair work as difficult to maintain. This led to an additional increase in the area to be chipped to ensure a permanent bond between the original and new plaster. There were also numerous instances of damage to the original plaster caused by the removal of old electrical and sanitary installation equipment. Additionally, many bruises and spot damage to the plaster were observed.

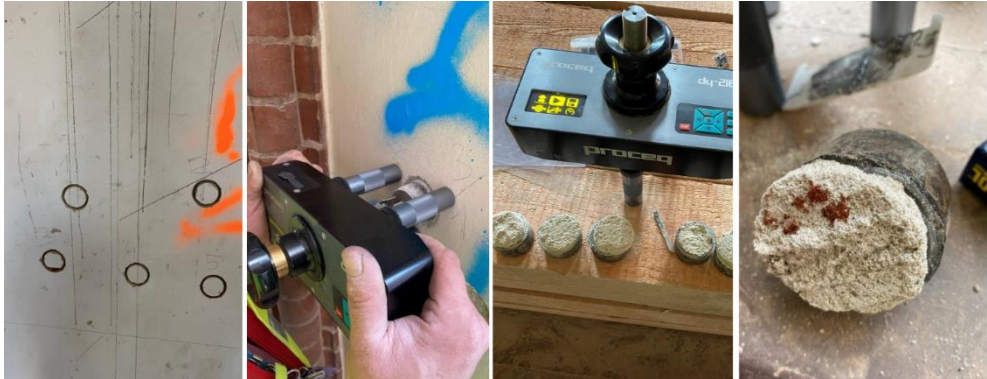
Analysing these results, it can be observed that the plaster at the test sites exhibited varying properties. The average thickness of the plaster ranged from 11 to 20.2 mm, while the average pull-off strength ranged from 0.04 to 0.11 MPa. All the tested plasters met the requirements of the PN-58/B-10100 standard [8]. [Figure 3](#) presents example images from the

pull-off strength tests. The causes of reduced plaster adhesion are typically linked to poor workmanship, external factors (e.g. war damage, partial destruction of the building, settling of the structure), or weather conditions [1-5]. Nevertheless, plasters generally show relatively good adhesion to the substrate, though the main issue tends to be aesthetic defects (cracks, scratches), which often lead to the decision to repair them [6-7].

Fig. 3. Examples of photos from pull-off testing of plasters

A convoluted design situation and an inaccurate diagnosis of the historic lime plaster led to the identification of an excessively large area for removal. Considering the historic value of the tested plasters, by re-verifying their condition using both non-destructive and destructive methods, it was possible to significantly reduce the extent of the plaster to be removed. It was recommended to replenish local plaster defects and carry out local repairs. A combination of several diagnostic methods was advised to thoroughly assess the condition of the plasterwork, as using the rinsing method alone does not provide sufficient information to determine whether or not to remove historic plaster. Due to the aesthetic and historical value of lime plaster in historic buildings, a combination of the qualitative rinsing method with the quantitative pull-off method is considered the most appropriate approach. This combination allows the identification of areas requiring further plaster diagnostics through rinsing in the first step, without performing semi-destructive tests such as pull-off testing. In areas where troweling indicates questionable quality, a quantitative pull-off test should be conducted to assess the plaster's adhesion to the substrate and compare it with standard requirements. It is also recommended that, in the case of historic plaster, the number of test samples should be increased (compared to standard requirements), due to the significant variation in the plaster's properties. While the location of the measuring device did not appear to affect the test results, it should be noted that ceiling plaster adhesion is generally lower than that of wall plaster. It is advised to limit the extent of plaster to be repaired based on diagnostic results, particularly using non-destructive methods.
