Restoration of load-bearing structures in a multi-storey residential building after a fire caused by military operations

Abstract: This article presents the visual and instrumental investigations, along with the necessary engineering and technical decisions, for restoring load-bearing structures of multi-storey residential buildings damaged by fire due to war. It is economically advisable to replace and strengthen 20% of the emergency floor slabs and 16% of the load-bearing walls to allow residents to return to their homes as soon as possible. The temperature during the fire was determined using specific samples of damaged materials, building structures, and equipment, which allowed for a more accurate assessment of the damage to brick walls and prefabricated reinforced concrete floor slabs. The possibility of further use of the building was also determined based on a survey and necessary measurements of its structures, including the determination of physical and mechanical characteristics (crack width, flexures, concrete strength, brick grade, and mortar grade). The prefabricated reinforced concrete round hollow floor slabs had delaminated along the ribs between the hollows, show

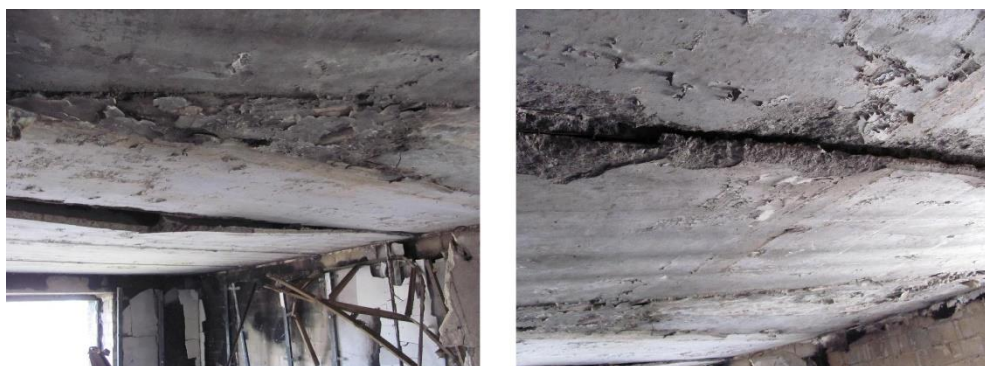
In some apartments, the reinforced concrete lintels and parts of the round hollow floor slabs were covered with soot. Additionally, there was a lagging of the reinforcement from the concrete in the floor slabs, concrete spalling, and sagging of individual round hollow slabs in areas where the fire load was concentrated (Fig. 3). The concrete exhibited a reddish hue. Moreover, the prefabricated reinforced concrete round hollow floor slabs were delaminated along the ribs between the hollows and had sagged. Other observed damage included the falling of gypsum plasterboard finishes, peeling of plaster, changes in the brick surface colour, and soot deposits on the walls.

Fig. 3. The damage to the prefabricated reinforced concrete round hollow floor slabs

It is worth noting that the working reinforcement of prefabricated reinforced concrete round hollow floor slabs was heated to 300-800°C (assuming a concrete cover of at least 15 mm in diameter) under fire conditions lasting up to three hours. Such a temperature regime significantly impairs the physical and mechanical properties of the reinforcement and its adhesion to the concrete. A pale grey shade of the concrete and the absence of soot suggest a combustion temperature above 900°C, as soot burns off completely at this temperature.

The prefabricated reinforced concrete round hollow floor slabs delaminated along the ribs between the hollows and sagged (Fig. 3). In the sand-lime brick masonry, there was complete flaking of plaster and discolouration of bricks to a depth of more than 100 mm and 120 mm (Fig. 4). As a result, the outer walls lost up to 120 mm of their cross-sectional thickness, and the inner walls along axes 'B' and 'B/2' were reduced to 240 mm in thickness (120 mm on each side, respectively).

To restore the prefabricated reinforced concrete round hollow floor slabs damaged by the fire, it was decided to replace them with a monolithic floor on metal beams using I-beam No. 22, spaced 1200 mm apart. A reinforcing mesh with working reinforcement of $\varnothing 8$ mm A400C and distribution reinforcement of $\varnothing 6$ mm A240 with a pitch of 200 mm was then laid on the lower flanges. The concrete used had a strength grade of C20/25, and the thickness of the monolithic reinforced concrete floor slabs was 90 mm. The slab was poured 15 mm below the lower edge of the I-beam to ensure fire resistance. Extruded polystyrene was laid on the slab to bring the floor level in line with the preserved existing prefabricated floor. Afterward, a finishing screed with a thickness of 40 mm was laid on top of the newly constructed floor structure. The floor structure was then placed on this finishing screed (Fig. 5).

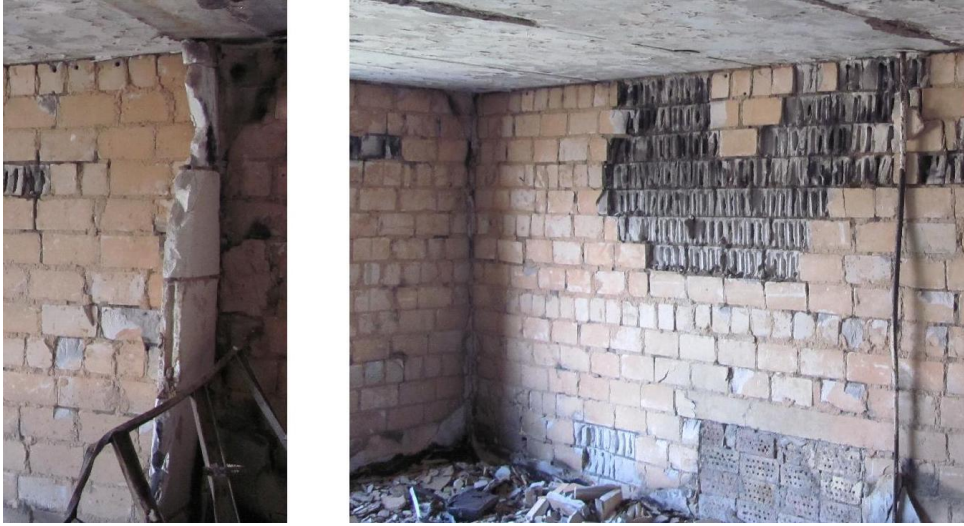
The impact of the fire load on individual apartments was extremely severe. On the third floor, all the apartments were completely destroyed by the fire. In these apartments, the gypsum plasterboard partitions collapsed entirely (Fig. 4).

Fig. 4. The damage to the brick walls and gypsum plasterboard partitions

Damaged load-bearing walls made of sand-lime bricks were restored by installing a jacket made of reinforced shotcrete. Before installing this jacket, the walls were cleaned of plaster remnants, delaminated bricks, and soot. Then, reinforcing meshes with cell sizes of 250 x 250 mm were installed over the entire storey height. Vertical reinforcement rods with a diameter of $\varnothing 10$ mm and horizontal reinforcement rods with a diameter of $\varnothing 8$ mm were used, both made from A400C class reinforcement. These meshes were placed on both sides of the wall and connected with reinforcing clamps made of A240 class reinforcement, with a diameter of $\varnothing 8$ mm and spaced 500 x 500 mm apart. The clamps were installed in pre-drilled holes in the masonry. After this, shotcrete was applied, with a strength of M250 (C20/25). The thickness of the jacket was 40 mm, ensuring the complete filling of any lost masonry volume (Fig. 6).

Damaged gypsum plasterboard partitions with a thickness of 100 mm were replaced by partitions made of aerated concrete blocks. These blocks were reinforced with wire (diameter 4 mm) every three rows (900 mm). Slots with prefabricated reinforced concrete lintels, where the depth of concrete destruction due to fire load reached the reinforcement, were strengthened by installing lintels made of steel equal-sided or unequal-sided angles,
