# State of preservation of the Red Barracks of the Owcza Góra Fort

**Maciej Trochonowicz**

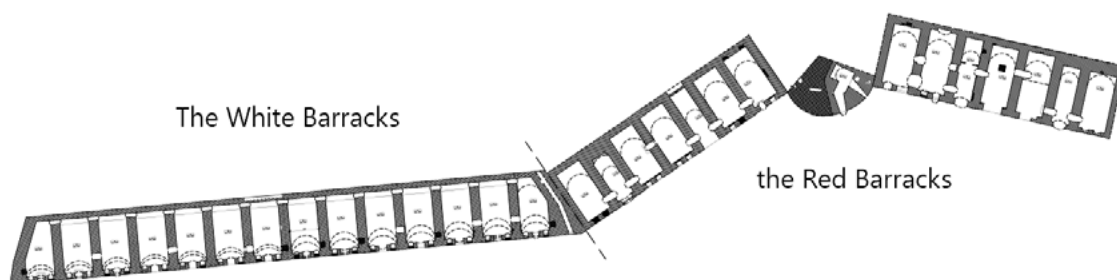
**Fig. 1.** Barracks plan of the Owcza Góra Fort

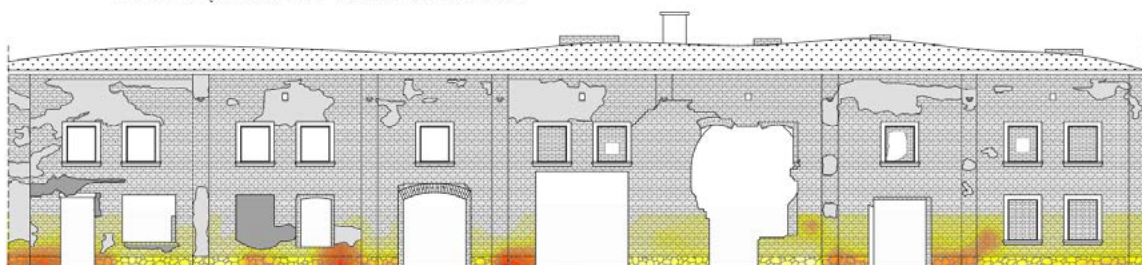
**Fig. 10.** Moisture map of the front elevation of the Red Barracks – southern part.

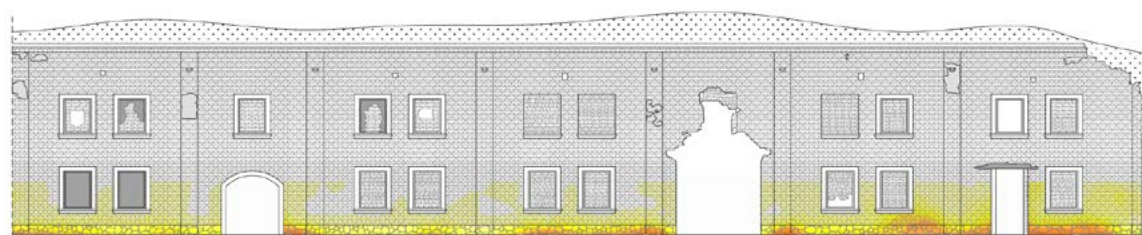
**Fig. 11.** Moisture map of the front elevation of the Red Barracks – northern part.

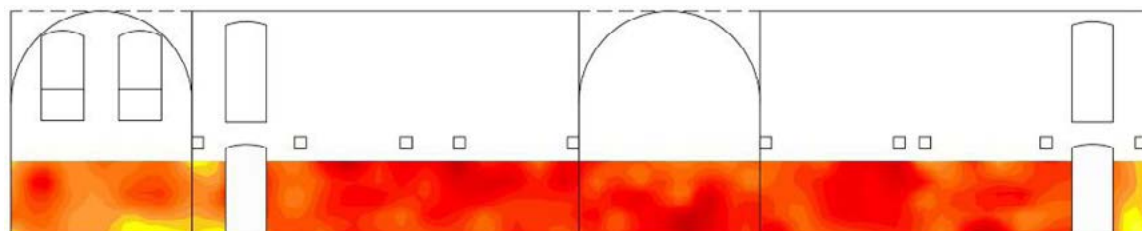
**Fig. 12.** Map of interior moisture – development of the 020 room

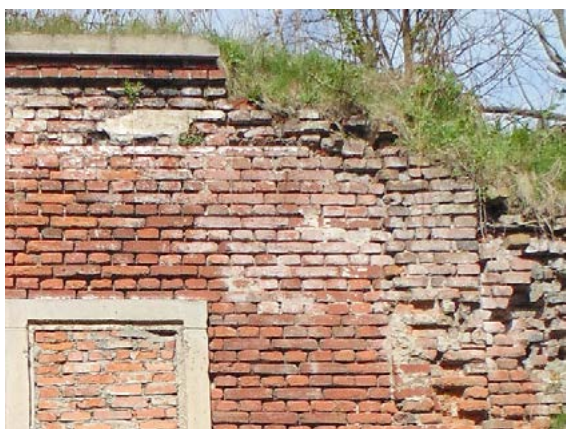
**Fig. 13.** The northern part of the Red Barracks. Significant damage to the corner of the front wall. Numerous cavities and shortages of bricks. Lack of joints.

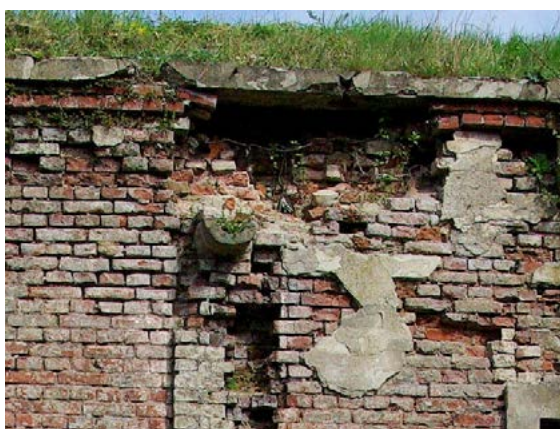
**Fig. 14.** The southern part of the Red Barracks. Extensive losses of bricks and stone cornice. Visible biological corrosion of a drainpipe and chemical corrosion of bricks.

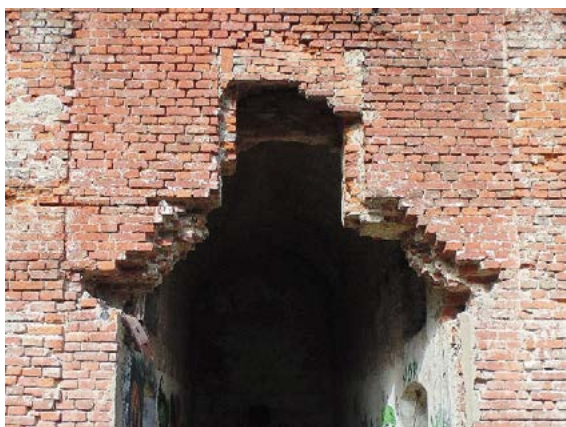
**Fig. 15.** The northern part of the Red Barracks. Significant shortages and cavities in the wall.

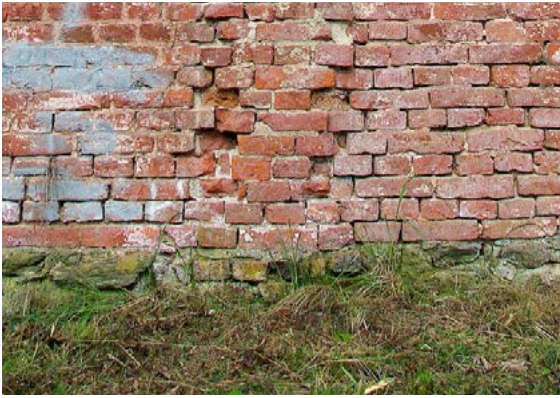
**Fig. 17.** The northern part of the Red Barracks. Biological corrosion of the plinth in the form of mosses and lichens. Chemical corrosion of bricks.

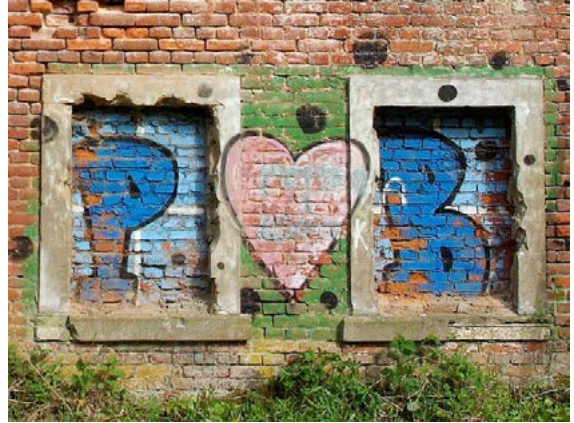
**Fig. 18.** The northern part of the Red Barracks. Mechanical damage to stone bands. Vandalism in the form of graffiti.

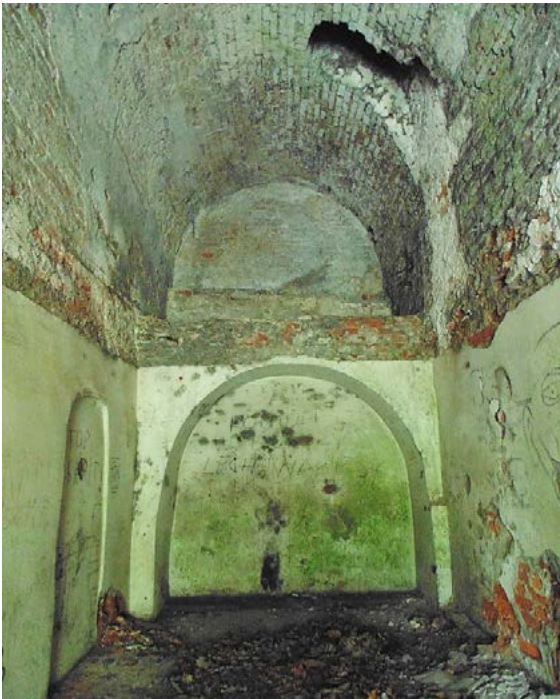
**Fig. 19.** Room No. 16. High degradation degree is visible. Numerous defects and cavities in the surface of walls and vaults. Strong biological corrosion and high moisture content in the back wall.

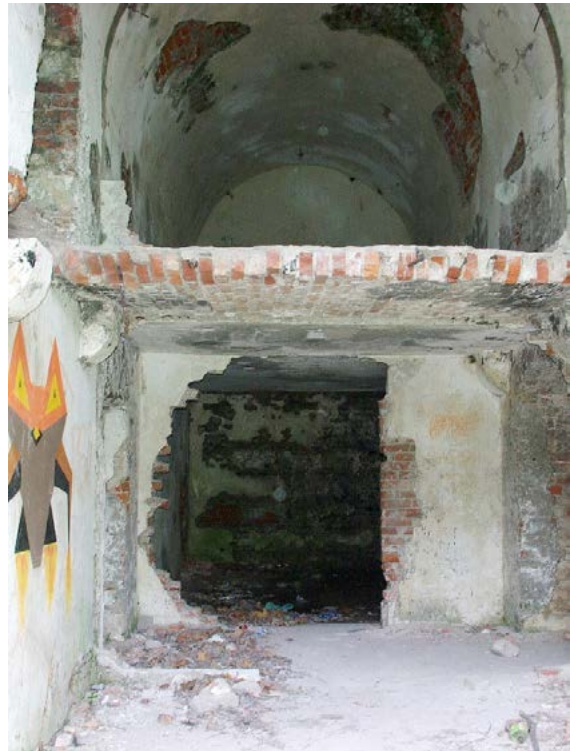
**Fig. 20.** Rooms No. 25 and 26. View of the entire room. Numerous loosening of plaster and cavities in bricks.

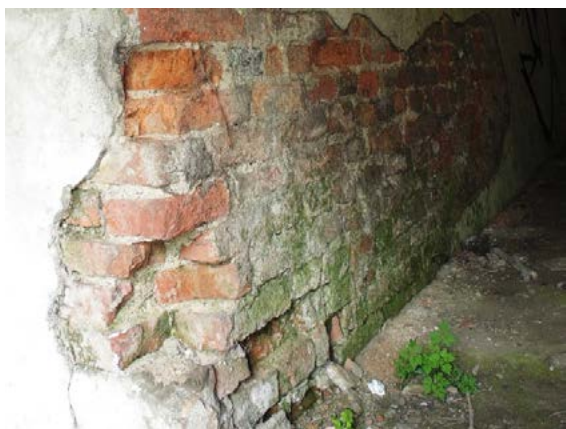
**Fig. 21.** Room No. 16. Losses of bricks in the structural wall and visible biological corrosion.

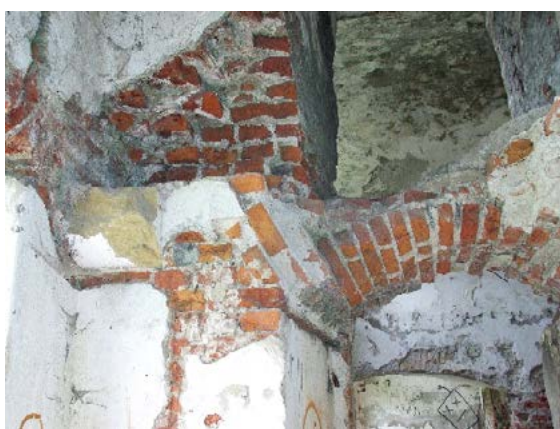
**Fig. 22.** Rooms No. 25 and 26. Extensive cavities and damage to bricks on the wall and door lintel.

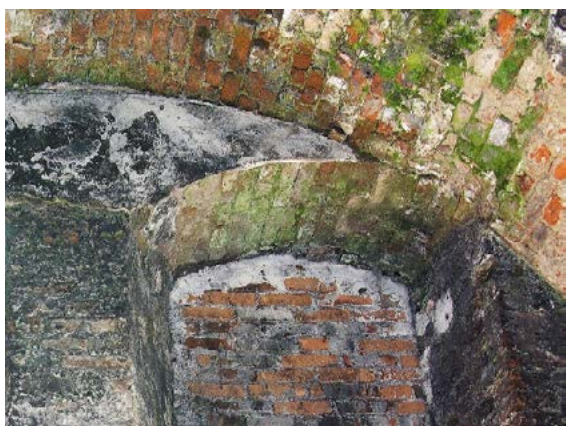
**Fig. 23.** Room No. 27. Mosses, lichens and salt efflorescence on the window lintel and vault.

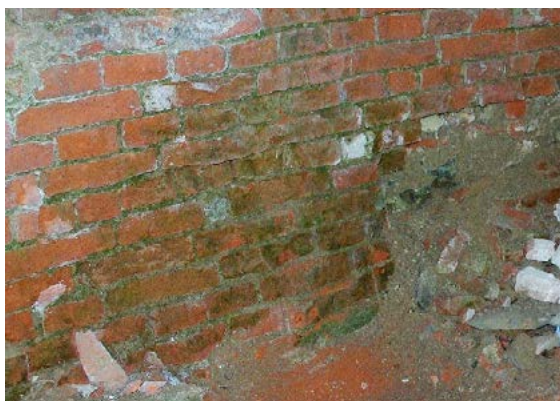
**Fig. 24.** Room No. 28. Deconsolidation of the top layer of bricks caused by chemical corrosion. Biological corrosion in the form of mosses and lichens.

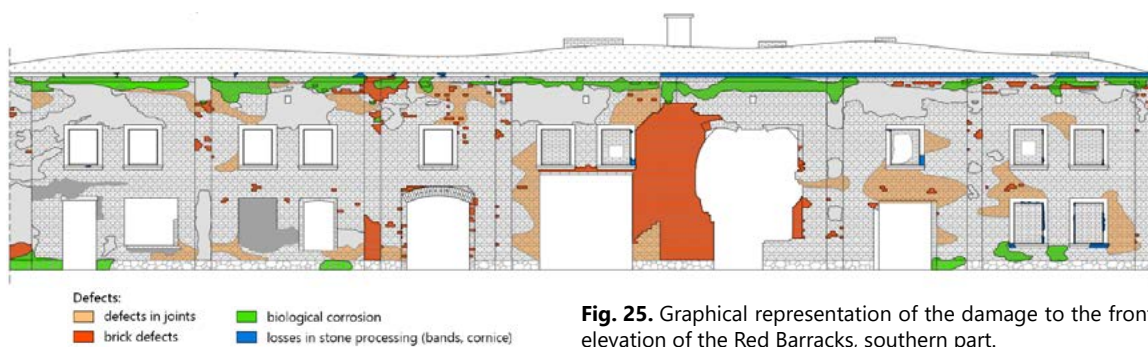
**Fig. 25.** Graphical representation of the damage to the front elevation of the Red Barracks, southern part.

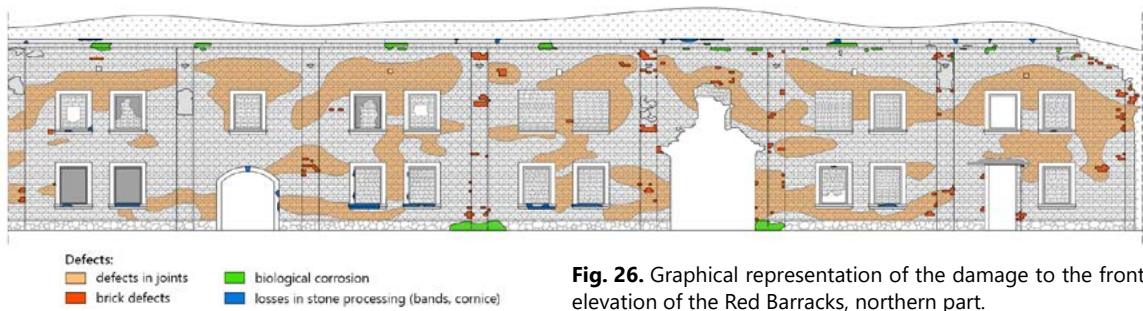
**Fig. 26.** Graphical representation of the damage to the front elevation of the Red Barracks, northern part.
