# Comparative method with the use of laser scanning as a starting point for the assessment of the state of preservation of the face of the walls in the Kłodzko Fortress

**Abstract:** This article presents architectural studies of the state of preservation of the face of the wall of the Kłodzko Fortress on the basis of the surveying works performed since 2016. These works include measurement of the entire fortress with the use of laser scanning. The analysis was carried out on the face of the wall, gradually degrading due to external factors and incorrect protection of the masonry. For detailed analysis, clouds of points from the period of 2 years (2017–2018) were used, taking into account the discussed northern part of the wall of the Great Tenaille (Wielkie Kleszcze). The paper explains the importance of the surveying process for the conservation works aiming at protection of the historical tissue from further degradation.

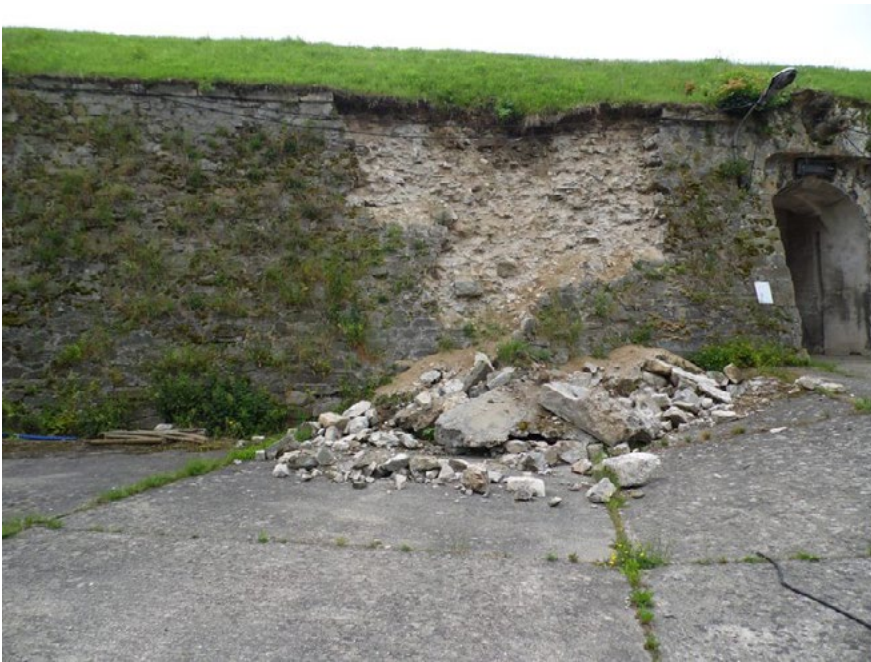
The façade of the Great Tenaille (Wielkie Kleszcze), subjected to comparative analysis, located in the northern part of the Kłodzko Fortress, was surveyed with the use of a laser scanner. The scanning includes annual measurements from 2016. Measurements from 2017 and 2018, during which the face of the wall significantly subsided, were analysed. The authors of this study draw attention to the critical condition of the wall: in the central part of the façade, a significant sliding of the face of the wall was visible (Fig. 3). Point but deep rock losses have been observed. A significant part of the façade was overgrown with invasive greenery: grass, moss, and bushes. On the  $\frac{1}{4}$  of the façade, the face of the wall was visibly bulging. There was noticeable lack of cornice on the length of 7.5 m, and the condition of the cornices was alarming. The face of the wall is assessed as being in bad technical condition, i.e. the structure was in critical condition, with the urgent need for reinforcement, renovation or replacement; it constitutes a direct threat to the health and life of people in the building or its vicinity. Immediate intervention is required regarding safety works based on conservation guidelines. The reason for the collapse of the face of the wall was probably poor protection of the defect that had occurred

**Fig. 3.** Photograph showing the wall face (2018) – authors' own photograph

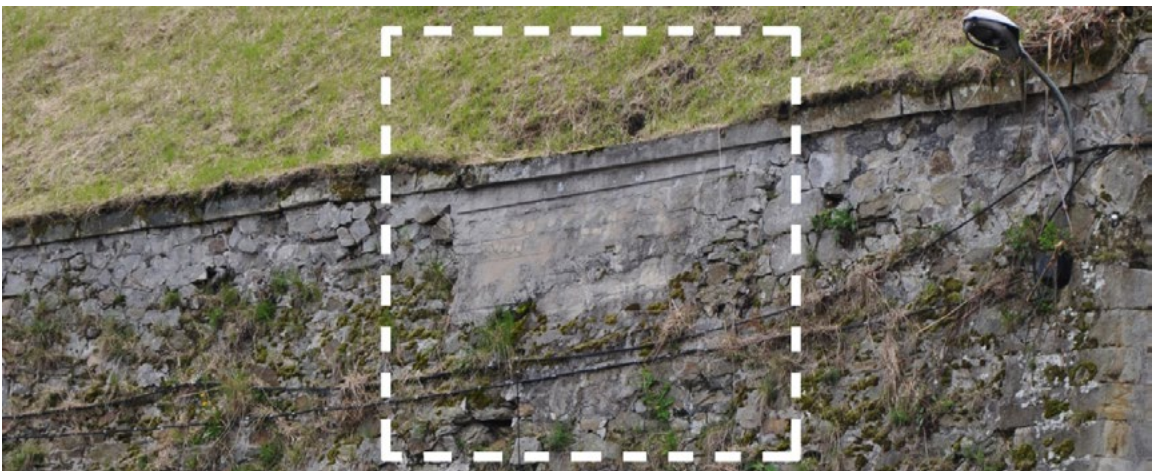
earlier. The authors conclude that the reinforcement in the form of a concrete layer (Fig. 4) was not properly anchored to the original brickwork layer, which resulted in further corrosion of the brickwork material and, as a consequence, the significant part of the brickwork slipped. After comparing the measurement carried out in 2017 (Fig. 5.) with the measurement carried out in 2018 (Fig. 6.), a secondary reinforcement is visible in the place of the loss in the masonry, which resulted in separation from the original masonry material and, as a result, sliding of both the supplementary material and the further part of the original masonry element. After generating a cloud of points from the *Leica Cyclone* program showing a horizontal cross-section at the point where the layer of masonry slipped, the depth of the cavity was determined to be up to 0.5 m (Fig. 7).

**Fig. 4.** Photograph showing secondary concrete filling of the face of the wall (2017) – authors' own photograph

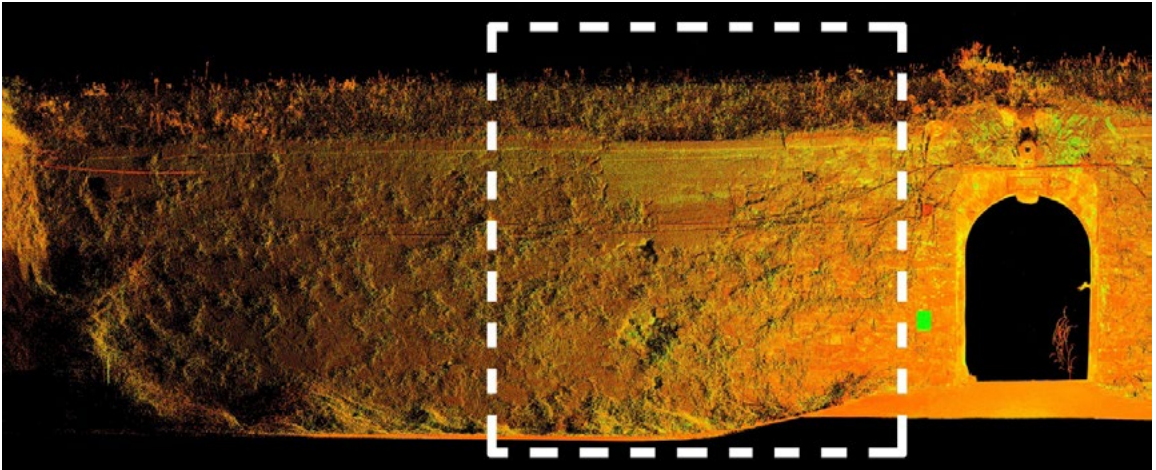
**Fig. 5.** Scan of the face of the wall with a marked place of the slide (2017) – authors' own elaboration

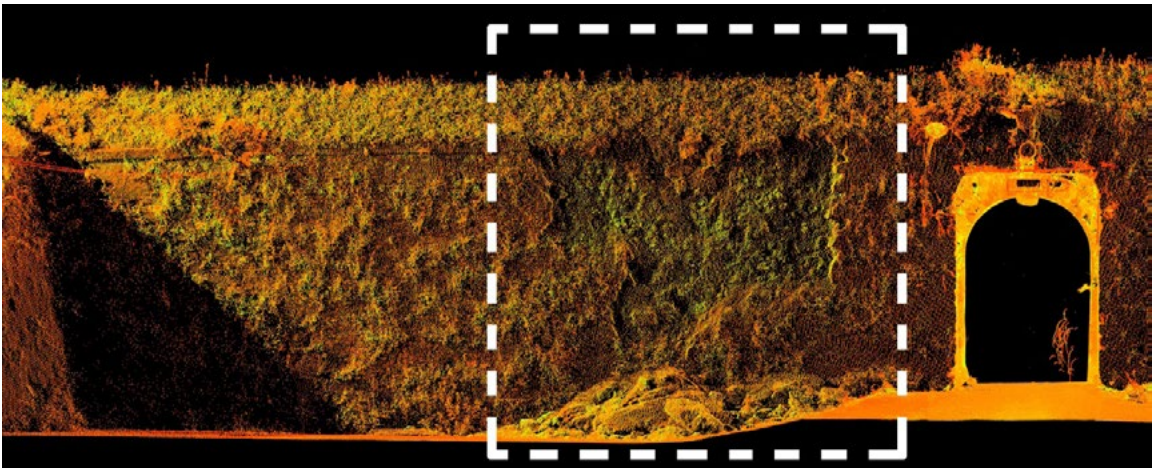
**Fig. 6.** Scan of the face of the wall with a marked place of the slide (2018) – authors' own elaboration

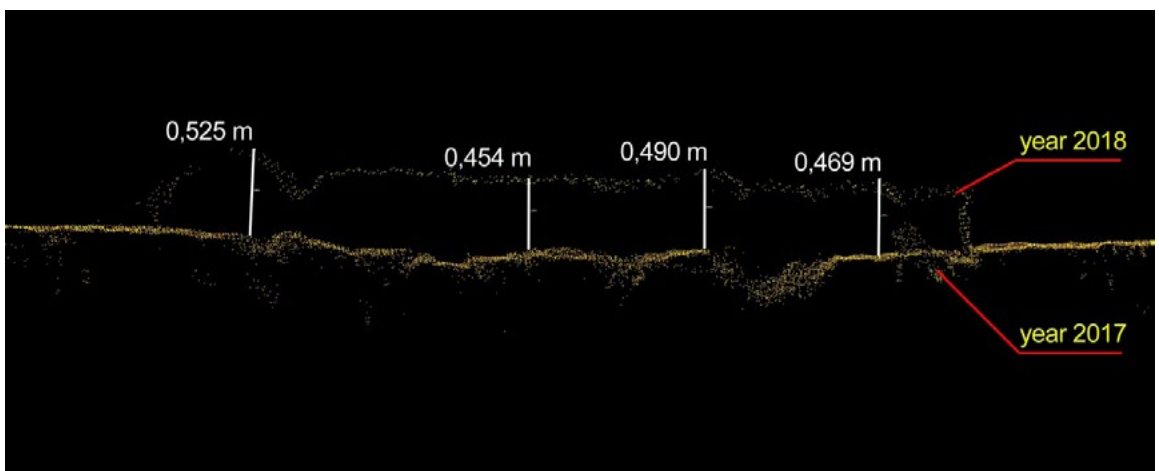
**Fig. 7.** Plan of walls from 2017 (before the wall slided) and 2018 (after the wall slided) – authors' own elaboration

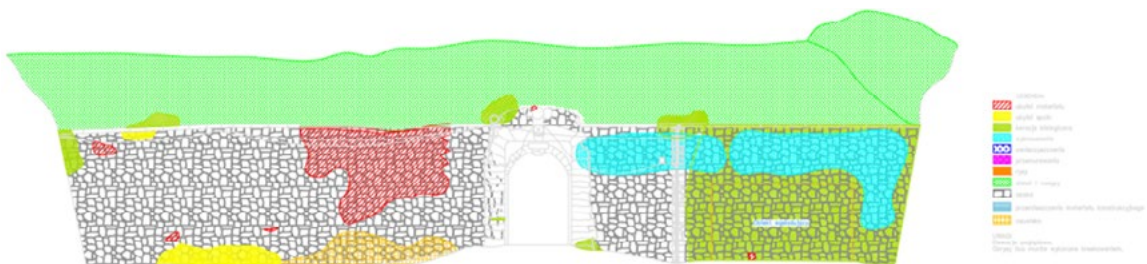
**Fig. 8.** Graphic survey – source: Archives of the Department of Conservation of Built Heritage, Faculty of Civil Engineering and Architecture, Lublin University of Technology

During the research work, a graphic survey of the northern face of the Great Tenaille wall was made in 2018 (Fig. 8). In the drawing presented below, the face of the wall is marked with numerous loss of material, welds, biological corrosion, demolition, contamination, greenery, displacement of construction material and landslides. The condition of the wall was then assessed as critical. Thanks to this study it is possible to make a detailed estimate of repairs necessary to stop the process of degradation.

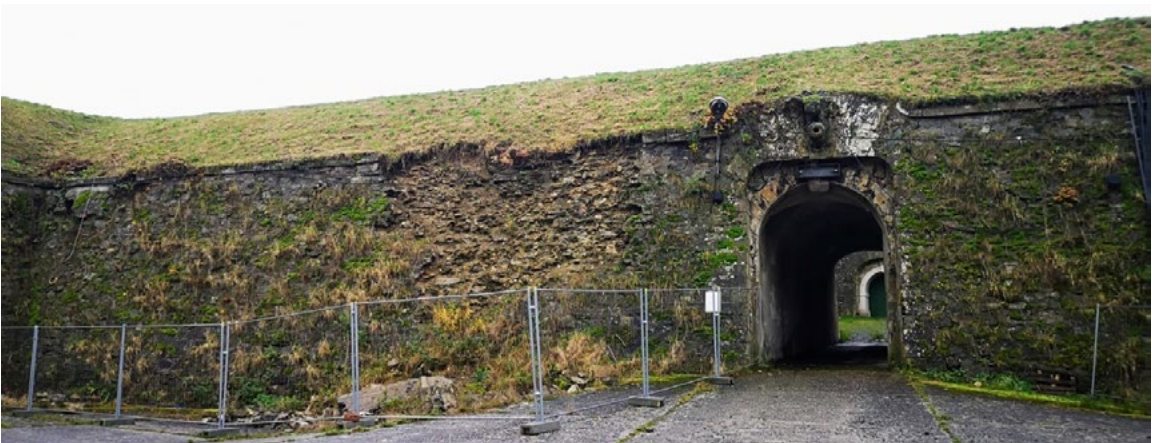
Currently, we can observe progressive degradation of the wall, further slipping of layers of stone and cornices, as well as continuous growth of invasive greenery and numerous lichens and moss (Fig. 9).

**Fig. 9.** Photograph showing further degradation of the wall (2020) – authors' own photograph

In order to prevent further corrosion and to repair the existing condition of the analysed part of the wall, it is necessary to take strict conservation measures. It is essential to:

- clean the wall from degrading greenery,
- complete the welds,
- replenish the cavities,
- in the case of minor cavities, protect the existing condition,
- complete the wall structure on the basis of technical expertise,
- supplement or reinforce the wall structure on the basis of technical expertise.
