Return of the Authentic Artistic Decor of the Assembly Hall of the Main Building of the Lviv Polytechnic University

Abstract: The publication highlights the results of pre-project, design and work studies on the conservation of the interior of the Assembly Hall of Lviv Polytechnic University. The assembly hall is located in the main building of the university. The building was erected in 1874–1877 according to the project of the architect Julian Zaharievich. The hall received its finished artistic design and decor in 1884 after the painting works designed by the architect Ivan Dolynskyi and the installation in the frieze of 11 artistic canvases made at the Kraków Academy of Arts under the direction of Jan Matejko. Paintings are the main decoration of the hall and using artistic allegorical images reveals the development of humanity and the role of technical and spiritual progress in this process. The paintings were preserved in good condition, but the interior of the hall itself was thoroughly changed in the 20th century. The restoration works were carried out on the interior of the hall from 2015 to 2021 to return it to its original appearance. The restoration work was divided in

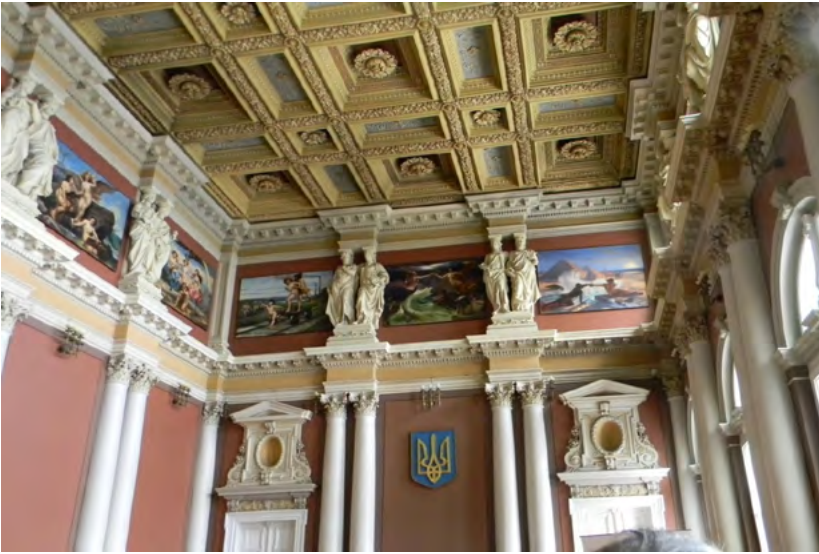
The most significant changes to the artistic decoration of the Aula occurred during the interwar period. Perhaps due to the change in the heating system, a sharp alteration in the microclimatic conditions of the room occurred, leading to the appearance of numerous microcracks in the painted surface of the walls and decorative elements. Rather than painstaking repairs, the decision was made to simply paint over the walls, columns, and cornices with oil paint (Fig. 3). Later, such layers of paint were applied to the walls and decorative elements two more times. Under these new layers, the original artistic design by Yu. Zaharievych, with its specific polychrome decoration of the interior, was hidden for many years (Fig. 4).

Fig. 3. Interior of the Assembly Hall before restoration. *Photo by M. Bevz, 2015*

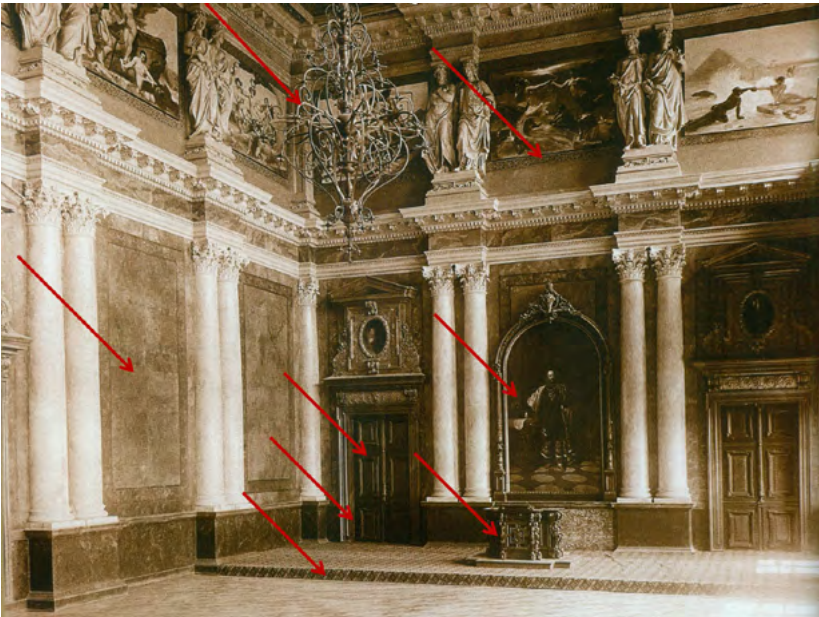
Fig. 4. Indication of losses in decoration and finishing elements of the Assembly Hall, using images from a 1909 photograph [Bobalo, Yu., editor, (2014)]

- Three layers of new paint on the marbleizing painting of the walls and on the sculptural and architectural décor.
- The decorative frames around the paintings by J. Matejko have been painted over.
- The gas chandelier has been lost.
- The floor and the rector's podium have been changed.
- The portrait of the founder and the artistic decoration of the artwork have been lost.
- The color scheme of the woodwork – doors and windows – has been changed.
- The curtain closing mechanisms on the windows have been lost.
- The air heating control mechanism has been lost.
- The rector's pulpit has been lost.

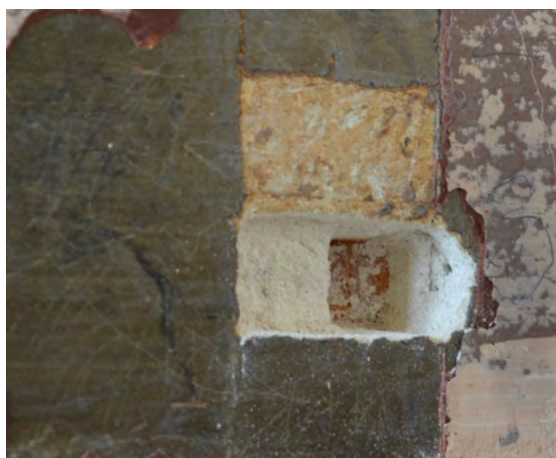
Additionally, the exploration revealed numerous damages to the authentic surface and the unstable state of the plaster in certain areas with different types of destruction. As a result of this stage of work, a description of the techniques used for the wall paintings was made, the goal was established, and the concept of appropriate restoration measures was approved.

Fig. 5. Plaster soding. *Photo by M. Bezv*

The stabilization (strengthening) of the limestone layer occurred primarily in two cases: when the plaster detached from the brickwork or when the plaster itself was destroyed. In the first case, the technique of filling voids with a solution of lime or nano-lime using injections was applied. In the second case, a silicon-organic solution was introduced into the plaster, which bound and reinforced the crumbling structure of the plaster.

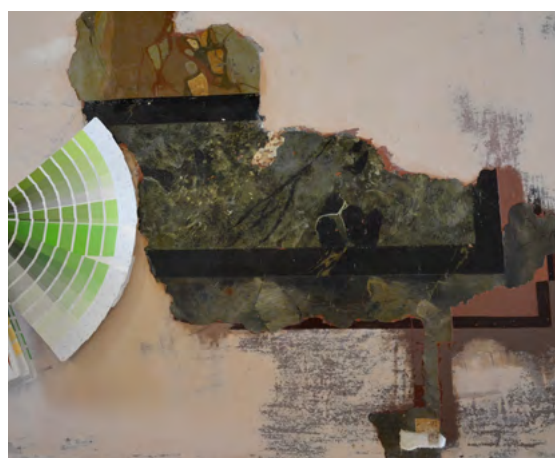
Fig. 6. Soding of paint layers. *Photo by M. Bezv*

- Strong adhesion between the authentic layer and the upper layer of paint;
- Voids, cracks, and general destruction of the plaster;
- Paint delamination;
- Thin, delicate layer of authentic marbleization;
- Zones with poor adhesion between the authentic paint layer and the plaster;
- Multi-level, complex marbleization pattern with layers and additional paintings.

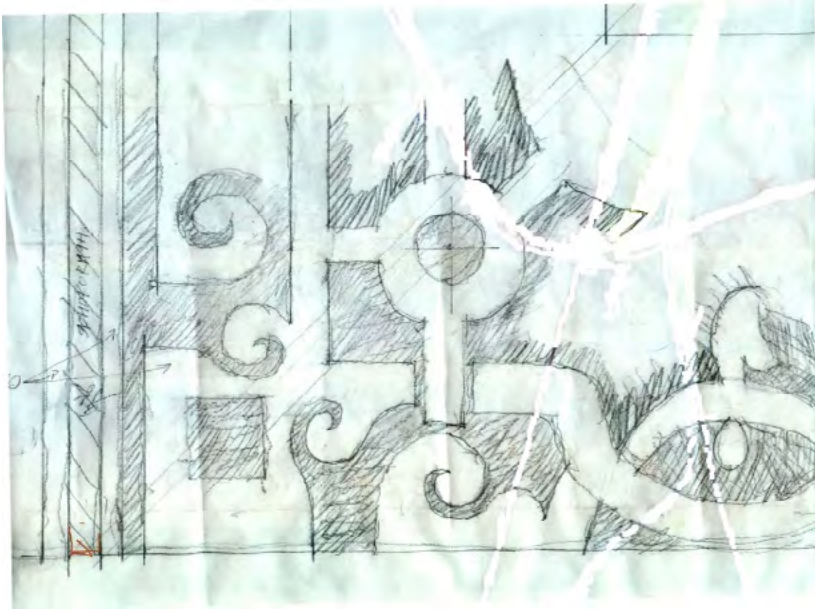
Fig. 7. Detail of the cleaned corner fragment of the ornamental decoration around the paintings by J. Matejko, revealed under the layers. *Drawing by M. Bevz, 2015*

Thanks to the restoration of several authentic fragments, it was possible to remove the exact pattern of the ornament, establish clear boundaries of the composition, and study the author's technique (Fig. 7). Thus, it was discovered that the ornamental composition imitated a carved gilded frame with plant motifs and a profiled bezel, aiming for an illusionary perception of volume when viewed from below. Fragments of the authentic ornament were revealed and restored in the second and eleventh bays, along the entire upper edge of the painting, and a corner fragment on the fourth bay (Fig. 8).

The restoration of the frescoes around the series of paintings "The Triumph of Progress" was highlighted as a separate stage of restoration, as it followed a different algorithm. Considering that most of the cleaning area was in the red zone (1 dm²/hour), to avoid significant loss of the authentic surface during cleaning and to shorten the time frame of the work, it was decided to carry out restoration within the yellow cleaning zones, while the remaining areas would undergo reconstruction of the ornament after removing all layers except the one following the authentic layer.

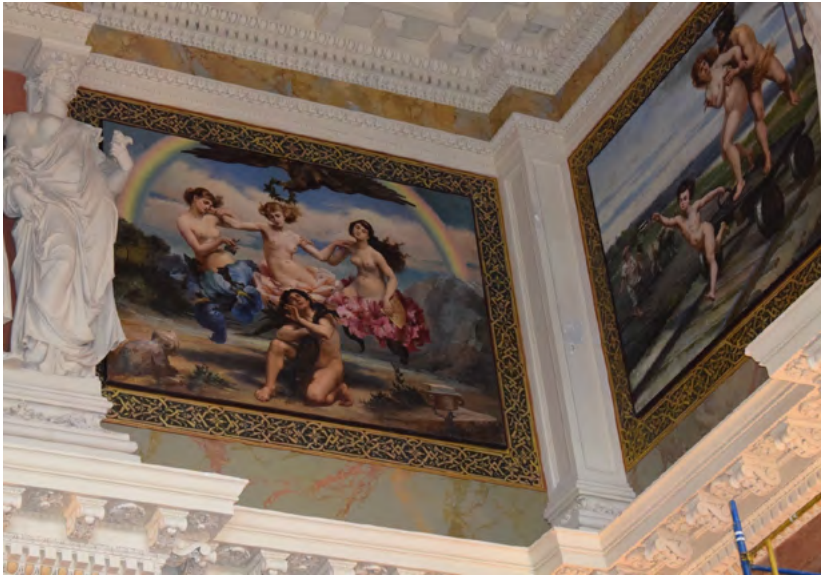
Fig. 8. The frieze of the assembly hall after the restoration of the painted decoration. *Photo by M. Bevz, 2022*
