Saint Nicolas' Church on the Czwartek Hill in view of current research

Saint Nicolas' Church on the Czwartek Hill in view of conservator's examination

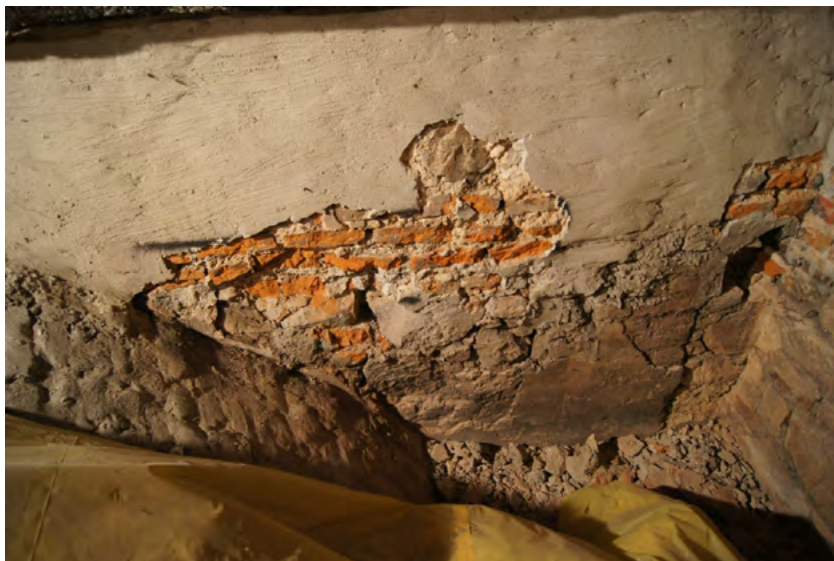
Fig. 1. View of the chancel wall from the attic over the nave with plaster relics visible, to which current vaulting was added

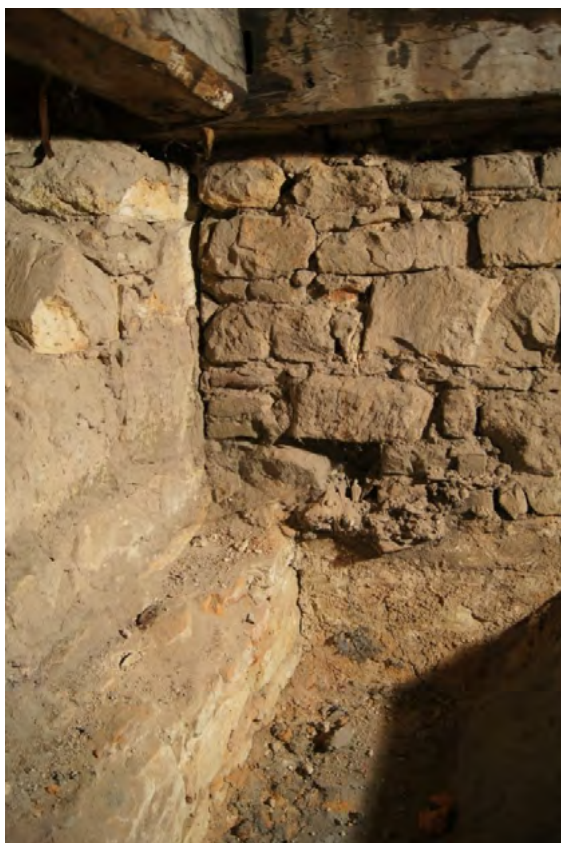
Fig. 2. View of the chancel wall from the level of the attic over the presbytery with the chancel wall visible, added to the southern wall of the presbytery

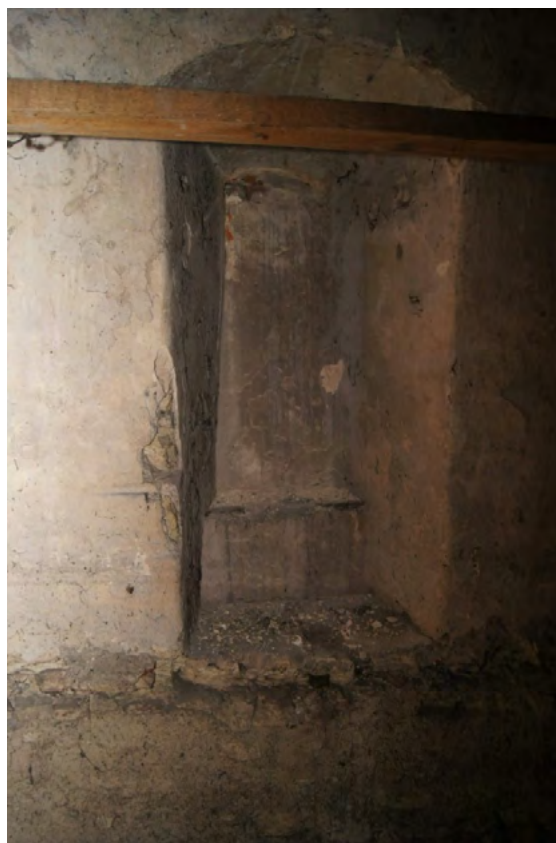
Fig. 3. Northern wall of the presbytery, view from the attic over the sacristy with the opening leading to the presbytery visible

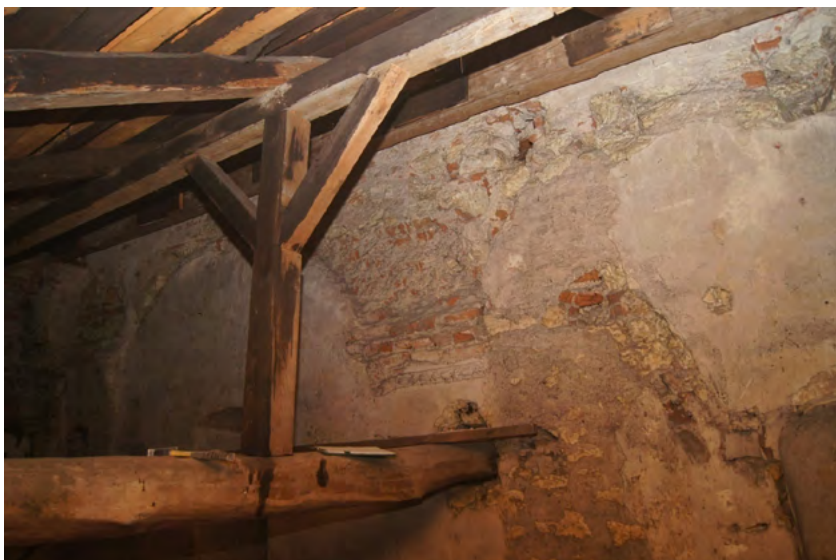
Fig. 4. Northern wall of the presbytery, view from the attic over the sacristy with the negative after two vaulting lunettes visible

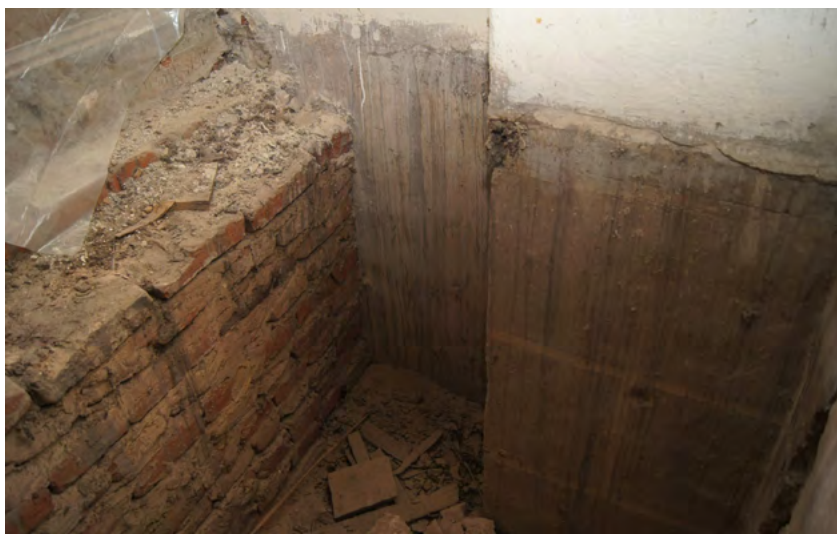
Fig. 5. Discovered paintings of nave walls and pilasters after removing the floor of choir loft arcade

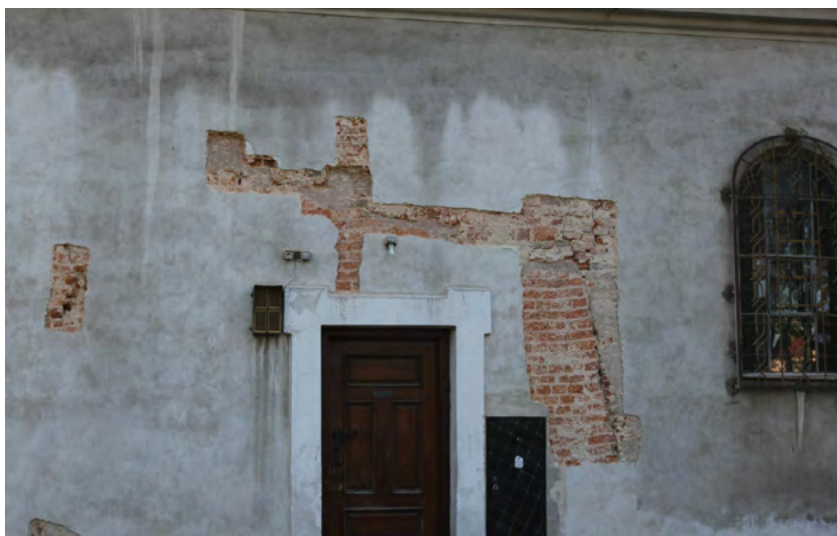
Fig. 6. Uncovered buttress edge of the northern sacristy wall

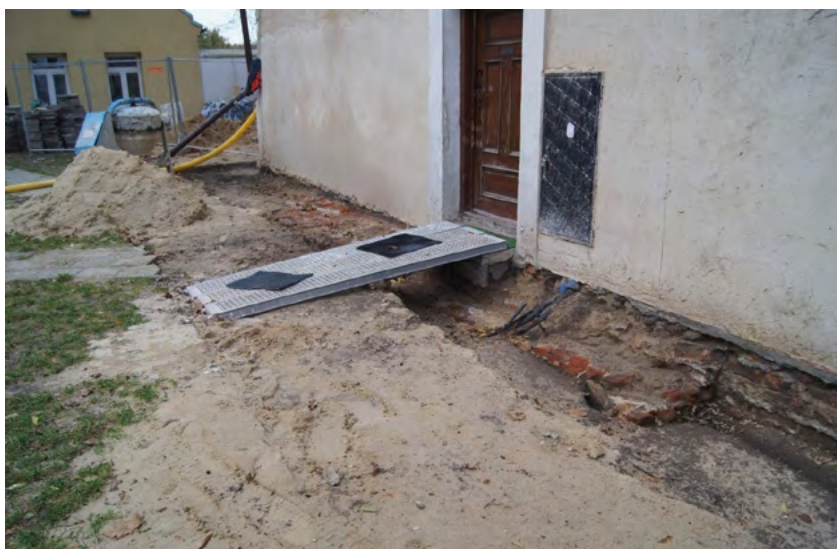
Fig. 7. Wall discovered in the excavation of the northern sacristy wall

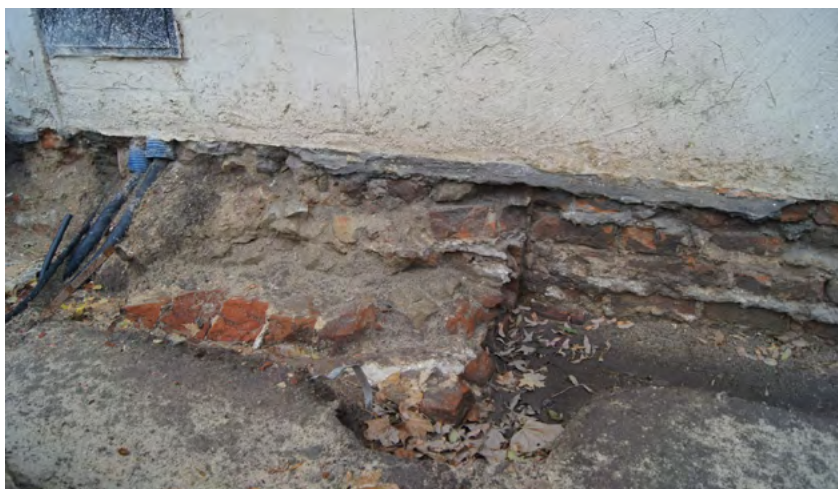
Fig. 8. Wall discovered in the excavation of the northern sacristy wall

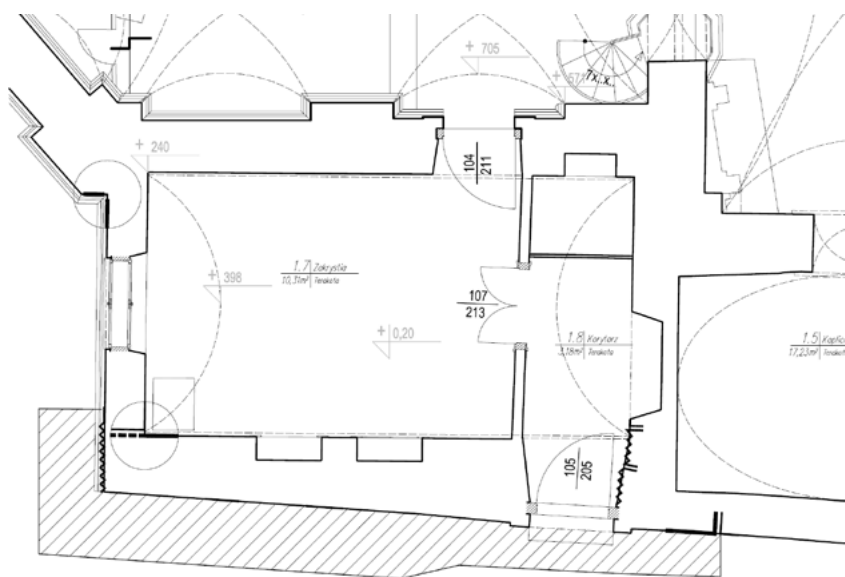
Fig. 9. Plan of the ground floor of the sacristy, brick wall below the land level was marked with hachure

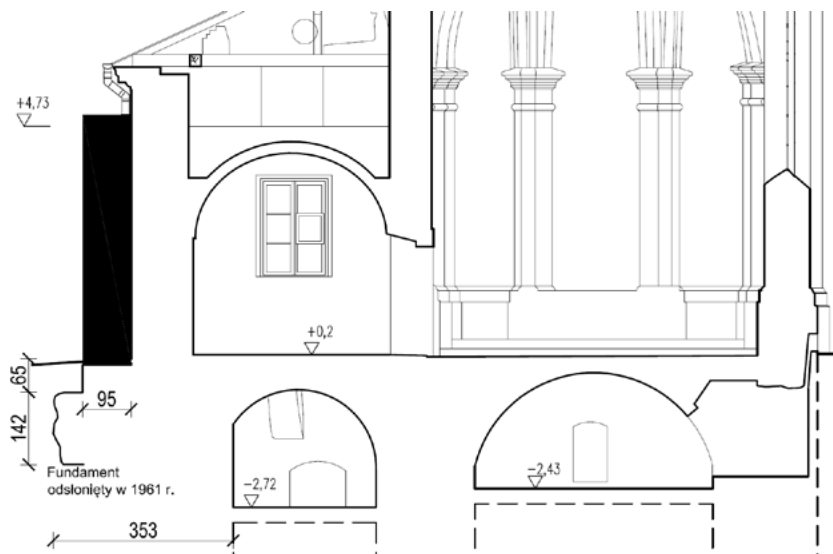
Fig. 10. Cross-section of the presbytery and sacristy (location of the removed sacristy wall was marked in black)

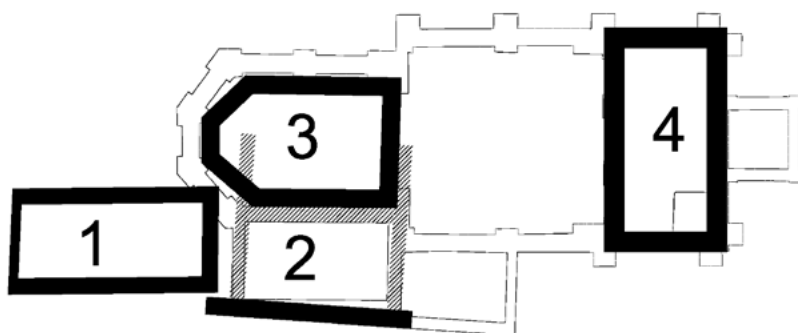
Three objects, which do not match the construction and arrangement of the church building, were specified within the structure of the buildings, together with one specified based on the differences in materials and rapports in the nodes (Fig. 11).

1. The object is situated between the sacristy and the fencing. It extends beyond the outline of the church and it had assuredly formed the basement of the building, which does not exist nowadays (it is possible that its overground part was preserved, used as a fragment of fencing). We know that the basement could not have been made by drilling method, but through large-surface excavation. Additionally, it seems that the current presbytery wall was erected on its corner. It would have been impossible to locate this space/building if church presbytery had been present both from a functional and technical side, and thus it can be assumed that it might have been demolished, for example, during the construction of presbytery walls.

2. The most mysterious part of the church building, which requires much deeper studies. In the 17th and 18th century, an additional residential level had been situated over the sacristy. It has not been established whether the two-level building was located here before the erection of the church in its current form. We know for sure that the wall between the presbytery and sacristy is 76 centimetres thick and it is deprived of pilasters (the presbytery includes pilasters and the core of the wall is 80–90 cm thick). The opening leading to presbytery was preserved on the first level (currently covered by vault resistance), which resembles an embrasure more than a window.⁴ However, the most unusual part of the sacristy is formed by its northern wall, the course of which differs from the outside and from the inside (what is more, the currently dug out wall crowning/offset below the wall is also characterised by a diversified course – Fig.9). We also know that in the middle of the wall thickness, at the basement level, the wall gets stratified, but it was impossible to determine which one was attached to which. The uncovered part below the level of ground was performed simultaneously with the external part of the wall (it was initially 76–96 centimetres thicker). It only remains unknown why the thickness of the wall was reduced so much instead of demolishing it and constructing it again. It can for sure be stated that this procedure was laborious, time-consuming and backbreaking considering the reality of those times.⁵ Before being reduced, the wall was ca. 350 cm thick, and at the ground floor level, its thickness amounted to 220 cm. Solving the problems of thickness this wall, should be made by archaeological excavations, maybe should be possibly to determined their function.

3. Presbytery crypt. The arrangement of the presbytery walls at the level of the basement differs from the one on the ground floor both when it comes to the arrangement itself as well as to its location. Distinct stratification is visible in the southern wall, unveiling the connection of two walls, but it was impossible to specify whether the wall of the current presbytery was added here subsequently or else it had been the opposite course of events. It seems that the walls at the basement level determine the shape of the older church, which was demolished during the construction of the already existing structure, but this assumption would be possible to confirm only after performing at least flooring excavations.

4. Gallery under the choir loft. It seems that here, another object existed within the basement parts, which could have been preserved exclusively under the ground or in some parts of the over-ground section. Unfortunately, in this case, due to the existing buttresses, pilasters and choir loft arcade, which cover the nodes and walls of the object, the only information possible to be achieved will come from archaeological excavations.

Fig. 11. Location of objects on which the church in its current form could have been constructed
