Problems of protection and restoration of historical monuments of L'viv built using Roman cement

Mykola Bevz

Abstract: In article are shown examples allow confirming that Roman cement was widely used in Lviv in the second part of the 19th century while erecting the public and residential buildings. The creating and develop a program on research, preservation and restoration of historical and architectural monuments, on which the architectural and ornamental finishing of facades was carried out with application of Roman cement is proposed.

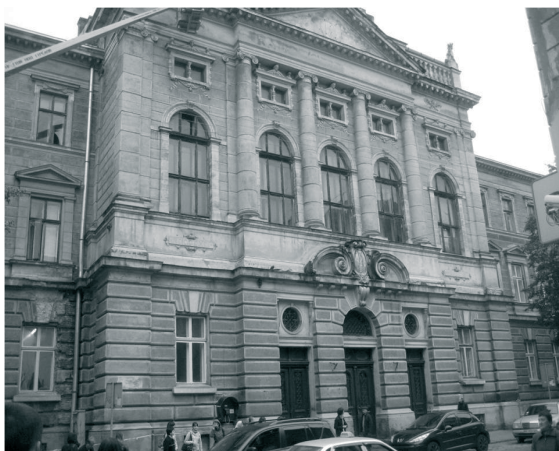
Fig. 3. The elevation of former “Palace of Justice”, built with using Roman cement. The architects: Franz Skowron and Jan Zawieyski, project 1891. Foto M.Bevz, 2011.

Krakow (in particular while building the local schools) [14]. Building of the Regional Court in L'viv once again evidences the fact of architect's inclination towards the technologies with Roman cement. In this regard we would like to note that they are used in a very specific way here. Analysis shows that all plastic and sculptural decorations on façades are made from Roman cement, but besides massive rustication on parterre floor is performed in combination technique – profiled pulled frame of every plank of rustication is made from Roman cement and filled inside with a help of lime plaster, which provides the special “pecked” surface finish (fig. 5).

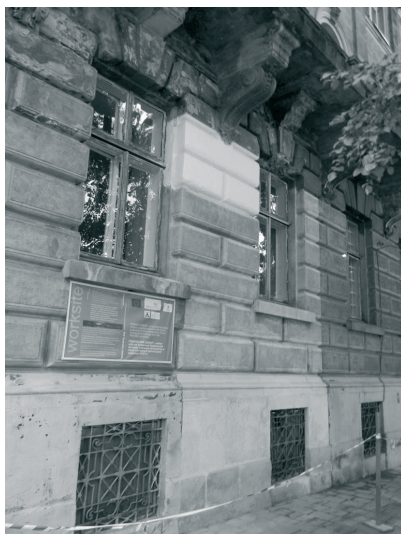
Fig. 4. The fragment of elevation of former “Palace of Justice” after the cleaning, made under promotion prof. J.Weber during the workshop in Lviv as the cooperation between the EU-FP7 project N226898 ROCARE. Aim was to demonstrate the possibility to recover the genuine appearance of the historic elevation by the use of Roman cement as historically authentic and compatible material. Executors were: Atelier Gurtner Wien (Austria) in cooperation with the restoration team of Department of Restoration of architectural Complexes of L'viv Polytechnic. August, 2011.
