The history of renovation design of the front facade of the Main Post Office Building in Lublin

Elżbieta Pytlarz

*Faculty of Architecture, Town and Space Planning, Lublin University of Technology,
e-mail: e.pytlarz@pollub.pl*

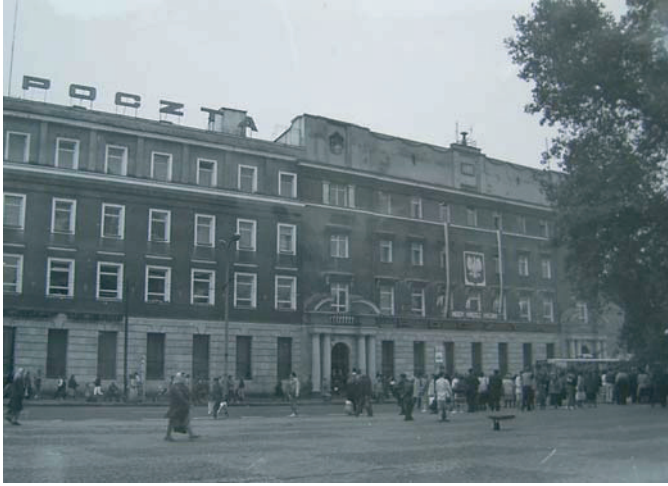
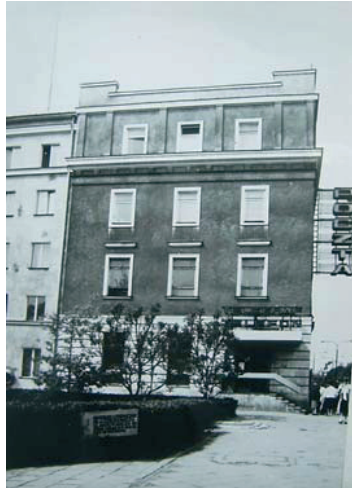
Photo 1. View of the Main Post Office Building after the repairs held in the 70 – ties.

The oldest part, which was rebuilt and which had storeys added in 1921-24 according to Bohdan Kelles – Krauze's design (Kurządkowska [7]), has endured in its unchanged form up till now. Since 1924 the building has been restored several times. In 1938 its roughcast was renovated and its plinth course was covered up with clinker (APL [1]). In 1950 the outer walls of the building were renovated and in the period of 1953 – 1958 the part of so called "the new post office building" was added, which was the eastern wing of telegraph after J. Ogórkiewicz's design (Kurządkowska [7]). In the 70 – ties of the 19 th century the structure was extended

from the side of the back yard and at the same time the complete refurbishment of the main building (Pastuszak [10]) took place [Photo 1].

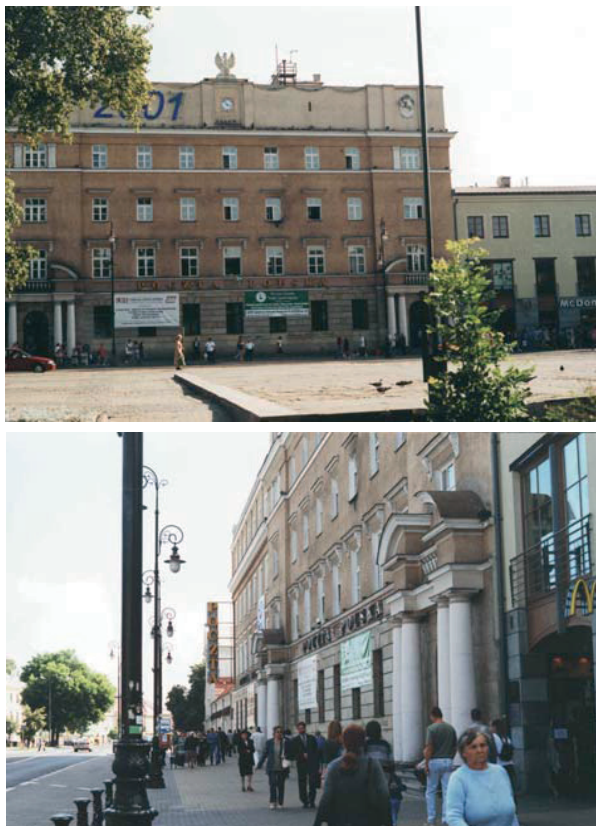
Photo 2. View of the Main Post Office Building, 2001.

and structural renovation design for the Main Post Office Building facade. During initial negotiations with the Client, the design assignment formulated as “refurbishment design” was changed into a “renovation design”, although the name used in the tender documents had to be maintained in the working plans. All the cooperating representatives of the Post Office shared our opinion that the structure should not only be renovated but also embellished [Photo 2].

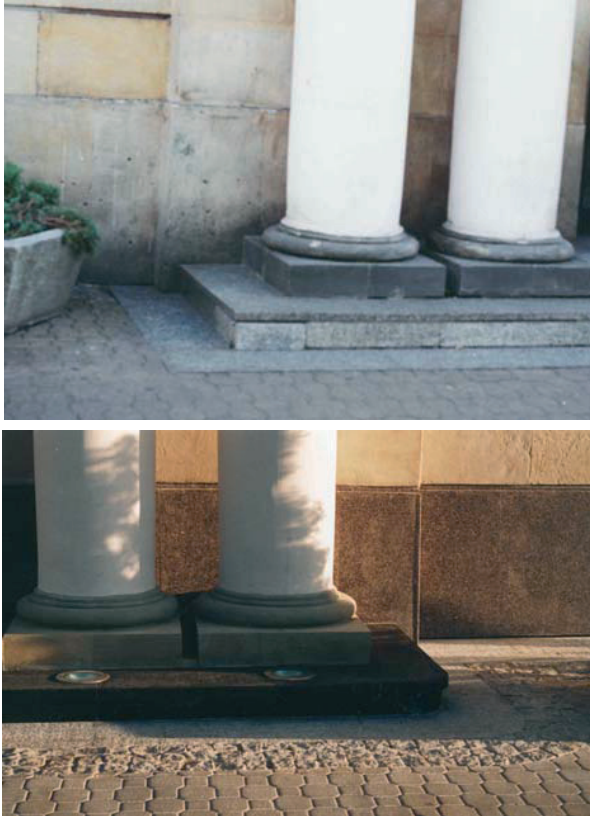
Photo 3. View of the pavement at the main entrance before and after renovation.

ing pavement through a belt of granite stones. According to the first idea of the building's illumination, floodlights lighting up the front wall of the building from the floor level were to be fixed among the granite plates on the ground. The idea of illumination was changed but the granite belt was built which, in my opinion, softens the vicinity of the building's plinth ground course made of precious stone and the pavement made of yellow concrete stones [Photo 3].

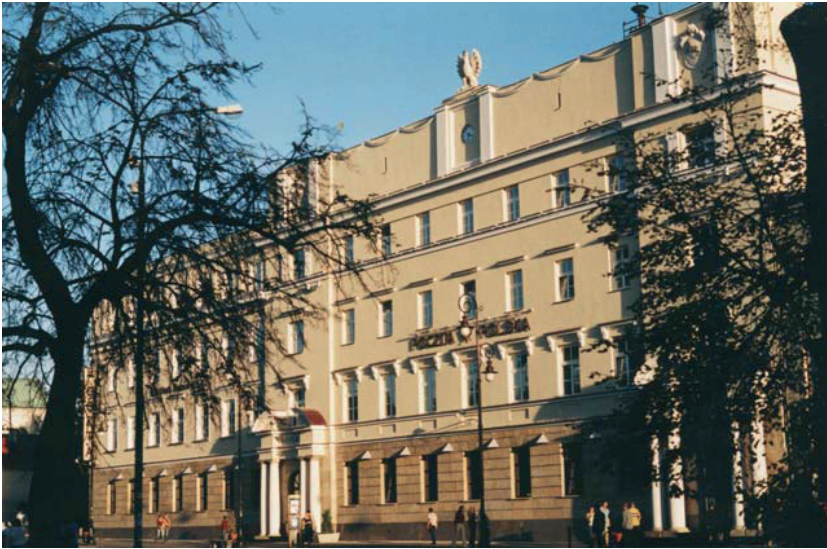
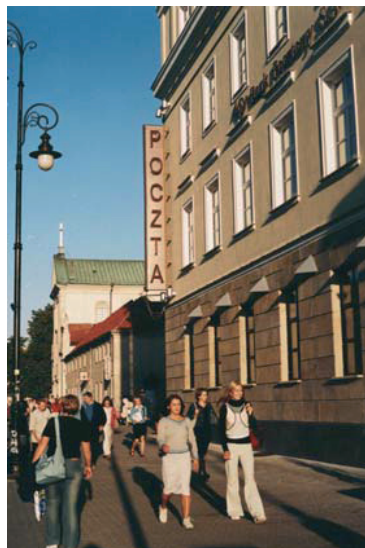
Photo 4. View of the Post Office Building after renovation, 2000.

study the technique of facade renovation, and the colours were chosen. The basis for the choice of suitable paints was the opinion that the colour lighter than the sandstone placed on the “tall” plinth course of the building would make it look “lighter” and, not so “overwhelming” as before.

In the design there were suggested plain mineral plasters containing trass, which are more resistant to dirt than the existing spotted ones. This decision made the workers put the plasters onto the walls precisely and carefully. During the implementation of the project three shades of paints were tested. What is more, the colour suggested in the previous designs from 1993 (Kręglicki and Lakutowicz [5]) and 1994 (Kręglicki and Lakutowicz [6]) was also used. Having done two trials, the colour used in my design was chosen (Pytlarz [11]) [Photo 4].

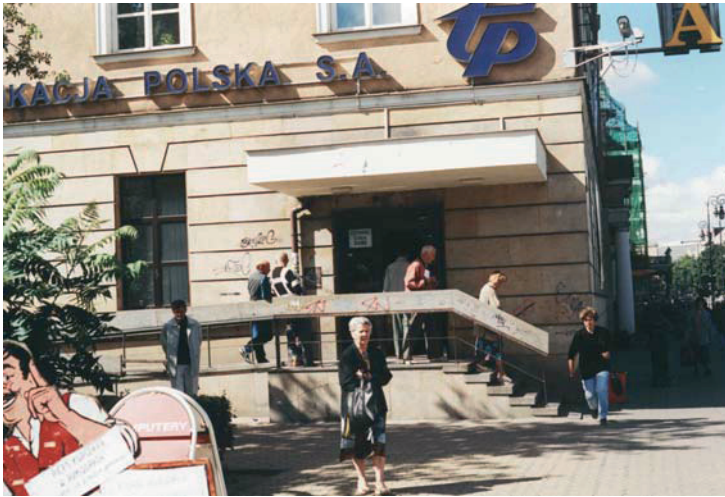
Photo 5. View of the entrance to the building in Czechowicz Square, 2001.

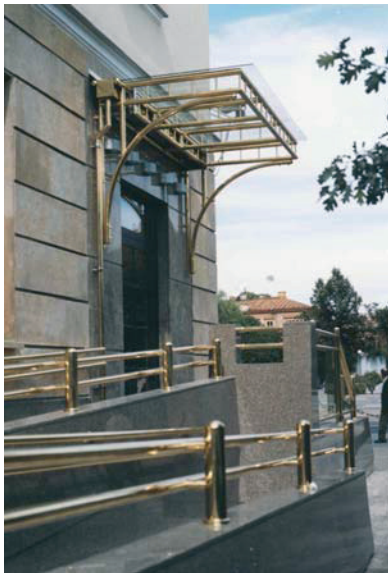
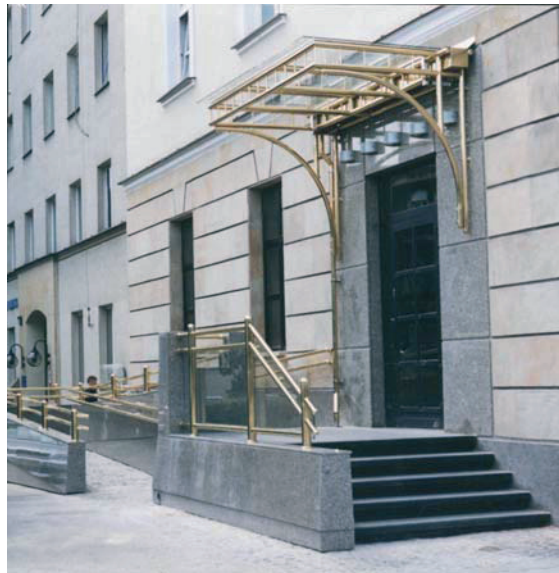
Photo 6. View of the side entrance from J. Czechowicz Square, 2003.

Granite stone for the plinth course and for the trim surrounding the building was also chosen from numerous samples. I must admit that my cooperation with the building company “Mitex”, the Conservator Dariusz Kopciowski and the Investment Supervisors was really very efficient. Subcontractors were searched for in the whole country because in the Lublin district there was no firm which would be able to make according to the design either advertising inscriptions (metal letters spatially formed and then painted with powder) or the vertical inscription as well as the roof over the side entrance designed of brass pipes (Wójtowicz [13]) [Photos 5 and 6]. Brass was not chosen accidentally in the design because the roofs over neighbouring entrance to the Polish Telecommunication Building are made in the same way (steel pipes with an external coat imitating brass).

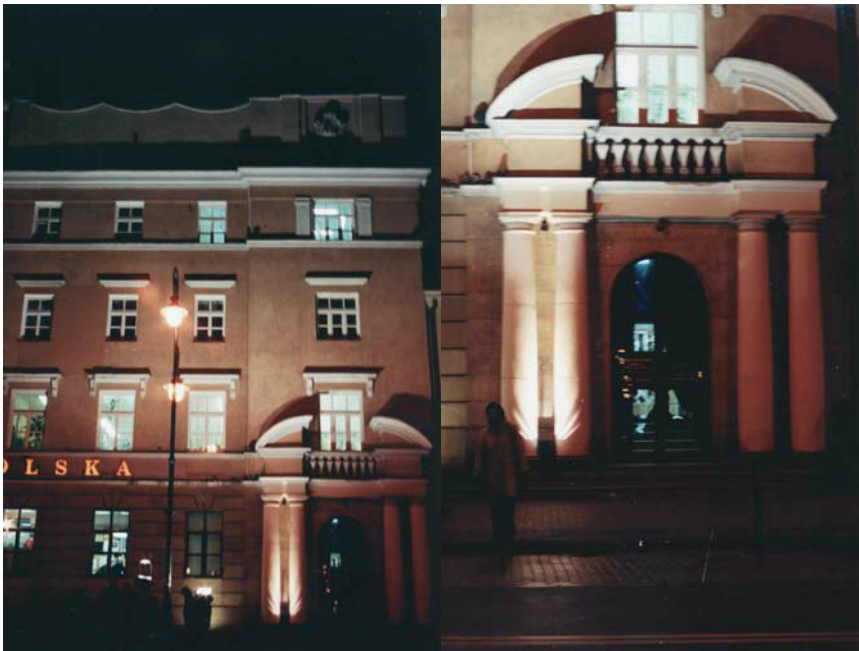
Photo 7. A picture of an illumination test, 2002.

“Uniform” illumination of the Post Office Building facade recommended by the Conservator appeared to be practically impossible to implement. The only solution was to fix floodlights onto street lamps so called “crosiers”. The concept of illumination of this kind was created and tested in cooperation with the company “Thorn” [Photo 7]. The weight of the floodlights with adequate power to illuminate the area of wall surface was so big that it would have been necessary to change the construction of the street lamps. The Bureau of Council Economy did not accept the idea and the design had to be changed.

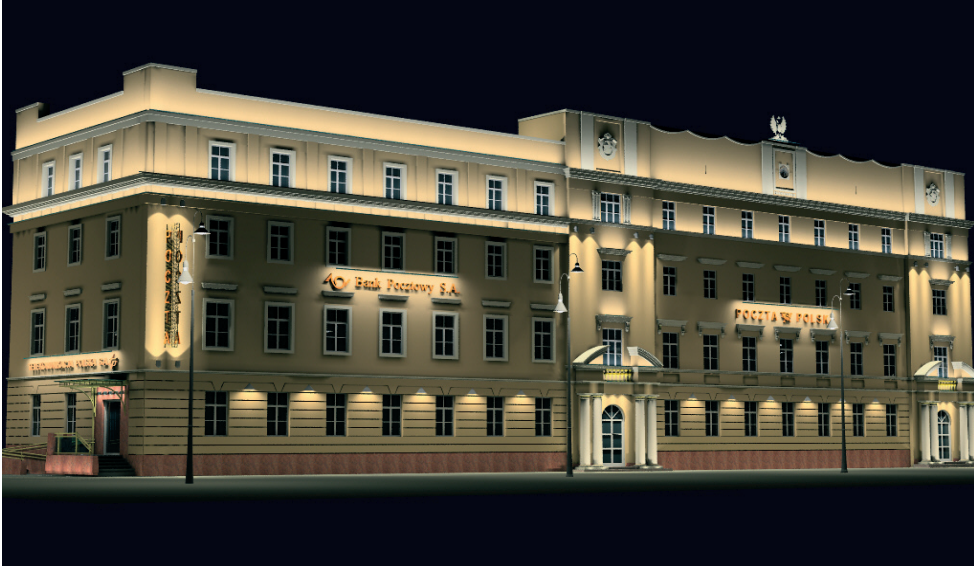
Photo 8. The illumination design of the Main Post Office Building in Lublin – visualization, 2003.

suggested reducing the illumination of advertising inscriptions which, in my opinion, resulted in spoiling the effect of evenly lit building facade. Considering the costs of the designed illumination system linear lamps, which were to illuminate attics and cornices of the Post Office Building had to be changed into connected fluorescent lamps which accentuate the tallest parts of the front facade with cool and strong light too intensively [Photo 8].
