Biological corrosion and vegetation in the aspect of permanent ruin

Abstract: The article presents the mechanisms of biodegradation of structures of historical objects intended for exposure in the form of a permanent ruin, and principles of proceeding in removing undesirable vegetation in these objects. Particular attention was paid to issues related to the diversity of damage caused by living organisms. Rules for the removal of algae, lichens, and fungi as well as the operating procedures for removing unwanted higher plants are presented.

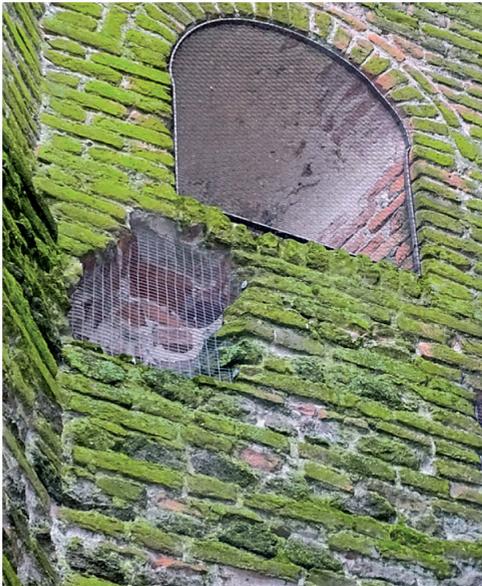
Fig. 1. Algae colonies on a moist ceramic brick wall

Algae, bryophytes, and mold fungi have quite high requirements for the moisture of the ground, which is why they grow over the basement strip of the walls and shady places. The largest concentrations of these organisms are observed on the walls from the north. Their habitat is usually natural stones and brick, but they also occur on joints and plasters. Initially,

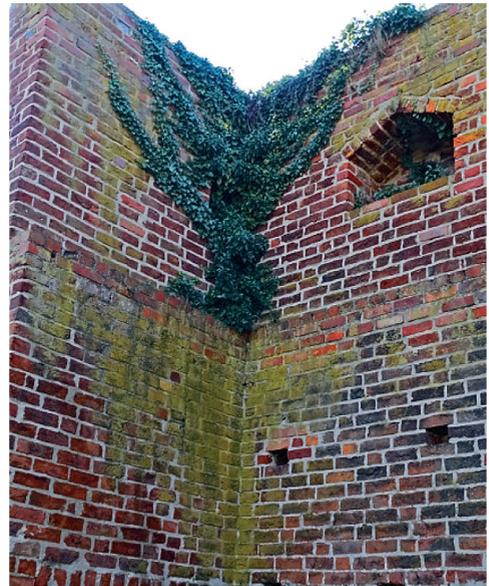
Fig. 2. The development of algae and lichen in the corner of the wall directly under the ivy, which is growing the wall and the crown

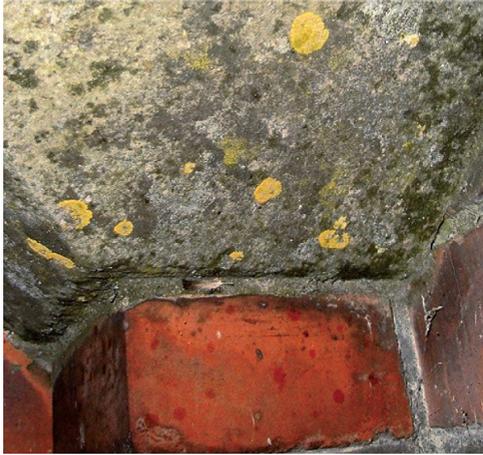
Fig. 3. A fragment of the plastered ceiling overgrown with lichens

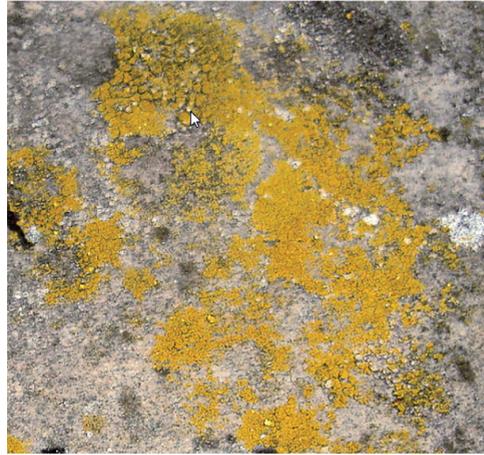
Fig. 4. Colonies of lichens on the historical plaster of the external wall of the object

Lichens have much lower requirements for a substrate moisture. They are quite resistant to low and high temperatures. Thanks to the possibility of absorbing moisture from the air, they are independent of the ground conditions. They grow stones, bricks, joints, and plasters. Their colors vary widely from bright ones to black. Due to the color of fruiting bodies, they are often treated as a dirt.

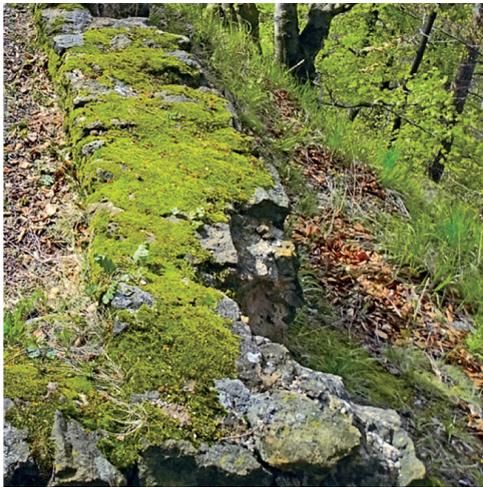
Fig. 5. Mosses growing on the low crown of the north wall of the ruin

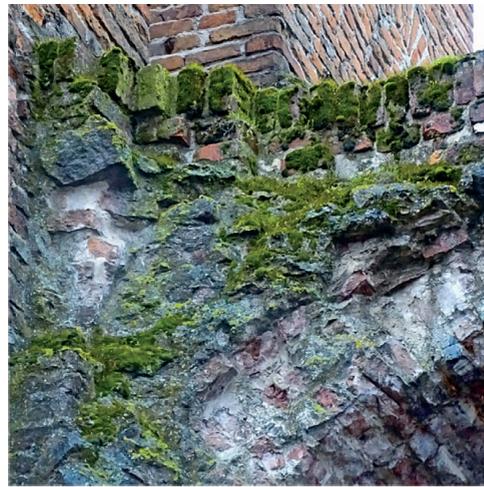
Fig. 6. Moss and algae, which overgrow the crown and the face of the wall

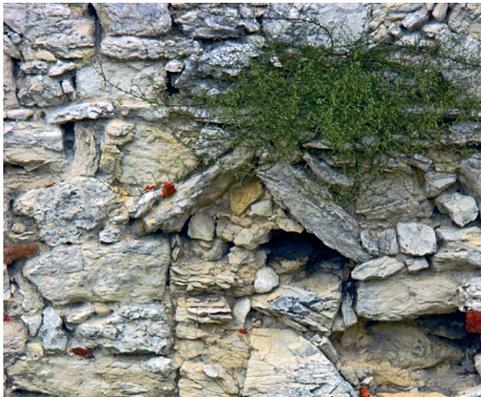
Fig. 7. Photograph of a heavily sunlit southern facade. The development of vegetation in the wall crevices

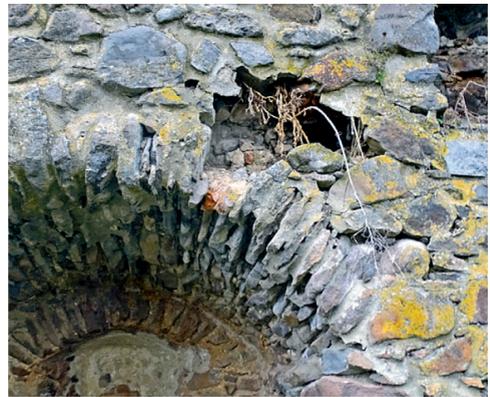
Fig. 8. Damage to the face of the wall associated with the growth of the root system of low vegetation

Another consequence of the development of low vegetation is damage at the interface between the weld and masonry related to the development of the root system. The expanding roots cause damage to weak /mostly lime or clay/ joints, which can lead to further damage to the face layers /individual detachments of small stones or entire fragments.

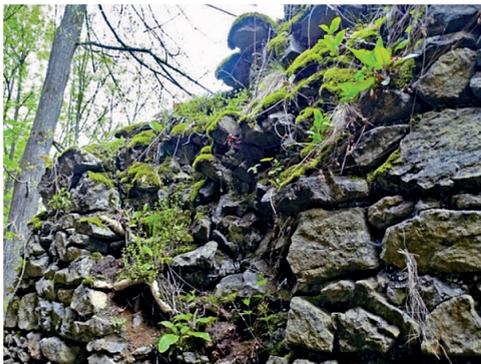
Fig. 9. The crown and the face of the curtain wall planted with a single and perennial vegetation

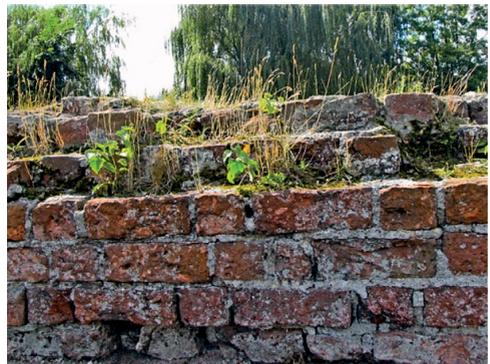
Fig. 10. The expansion of low plants and mosses on the crown of the ceramic brick wall. In the foreground young shrubs are visible

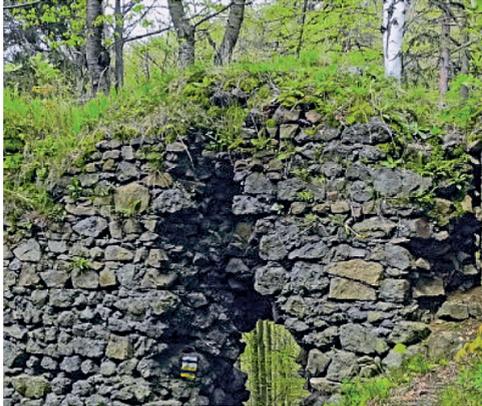
Fig. 11. The low crown of the wall completely overgrown with greenery. The tight layer of humus and greenery prevents evaporation of the moisture retained in the wall

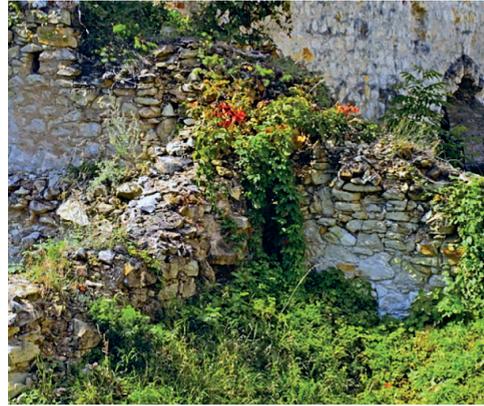
Fig. 12. A wall relic covered with vegetation. A large amount of green causes the illegibility of the ruin

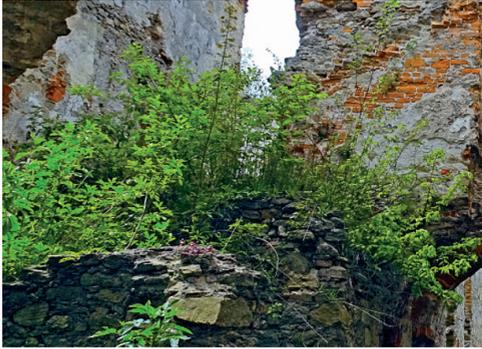
Fig. 13. A fragment of the vault intensely overgrown with shrubs

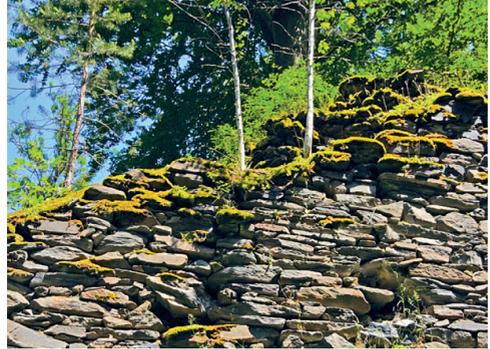
Fig. 14. Stone wall with young birches on the crown

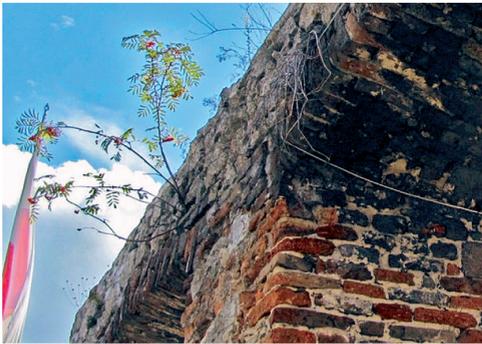
Fig. 15. The rowan rooted in the gap between the wall of the crown and the lintel

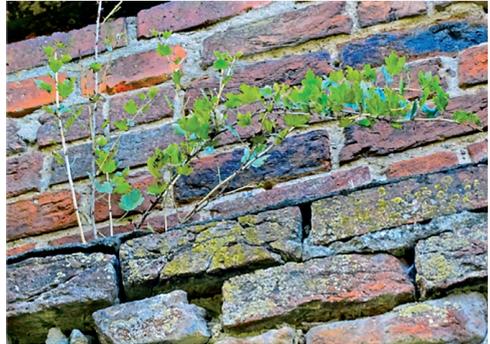
Fig. 16. A shrub with a root system overgrowing a ceramic brick wall

Trees and shrubs also affect the ruin mechanically. The growing roots fill the walls' gaps and cause the emergence of new cracks and surface spalling of stone and brick. Large root systems overwhelming the walls over time can lead to large surface loosening and significant damage to the construction of the entire wall.

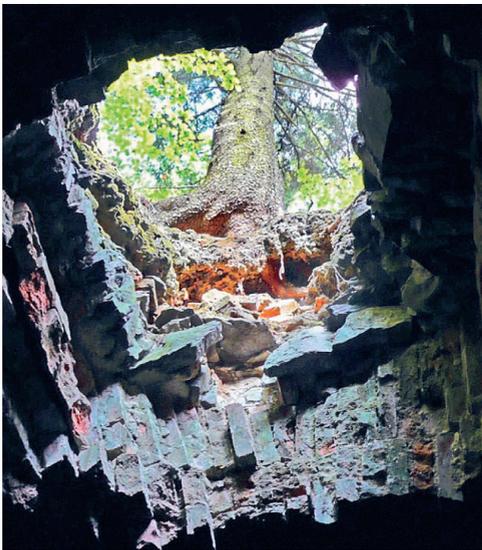
Fig. 17. Vault made of ceramic brick damaged by roots

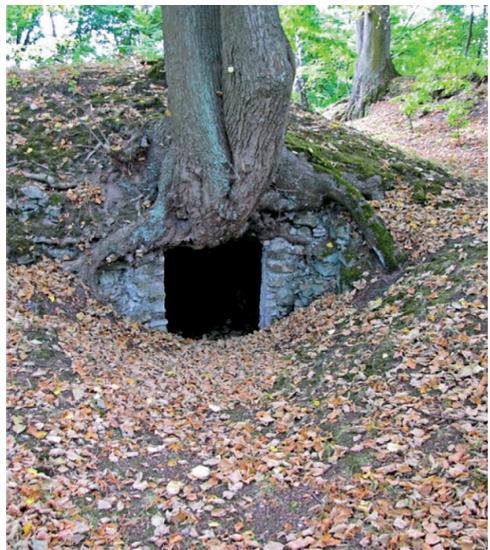
Fig. 18. A huge tree and its root system, which overgrown a stone vault
