## Methods of protection and the state of preservation of the wall topping of Gothic brick castles

**Abstract:** This article is an analysis of methods of securing historic walls in objects in the form of so-called permanent ruins. The research group consists of the brick Gothic castles of Mazovia in Ciechanów, Czernsk, Liw and Sochaczew. Based on the analysis of documentation and our research, the effectiveness of the solutions applied in 4 different technological variants was evaluated. The state of preservation of the introduced solutions after several years of work was also assessed. The entire study was summarised in a table and conclusions were drawn.

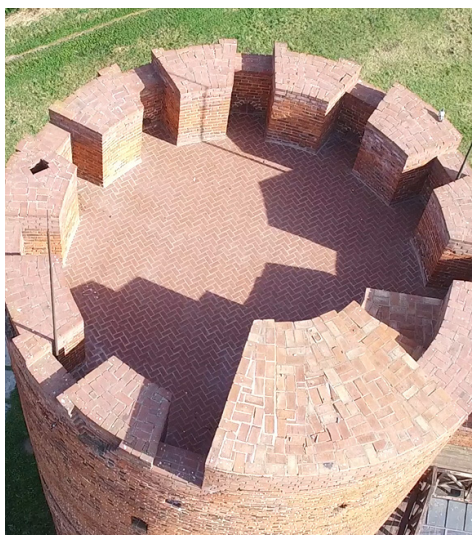
Fig. 5. The wall topping of tower is in good technical condition. Locally visible damage to the top layer of bricks. Defects in pointing, damage to bricks. *Source:* author, 2019

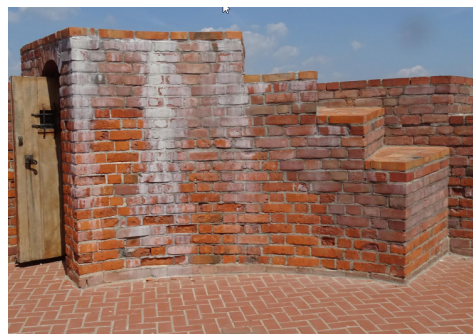
Fig. 6. Tower wall topping. Severe salt corrosion of the brick face of the tower terrace exit. Salt corrosion damaged brick faces. Carbonate streaks on the surface of the masonry. *Source:* author, 2019

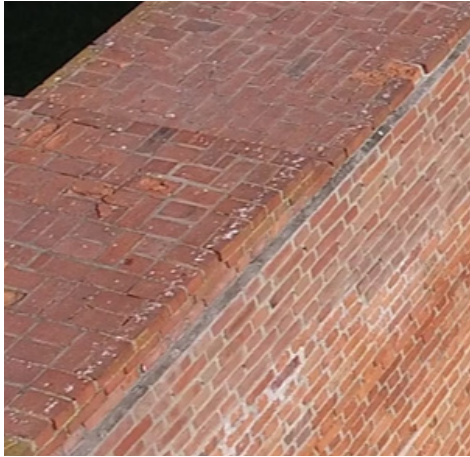
Fig. 7. The wall topping. Localised damage to the surface of the upper layer of bricks. The wall topping contaminated with bird droppings, spotty lichen growth. *Source*: author, 2019

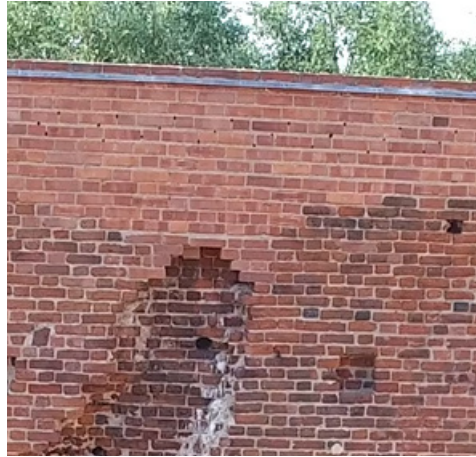
Fig. 8. The wall topping. The wall topping of the wall on the courtyard side. The junction of the historic wall and the over-brickwork. Brick used and pointing to ensure the layers are distinguishable. Sheet metal dripline draining rainwater. *Source*: author, 2019

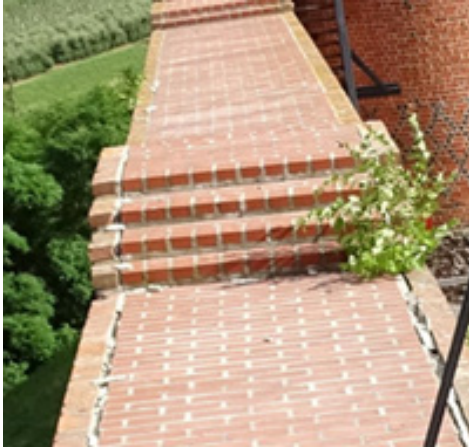
Fig. 9. East wall, view from the tower. Detaching of the face layers of the wall. In areas of damage, water enters the wall. *Source:* author, 2019

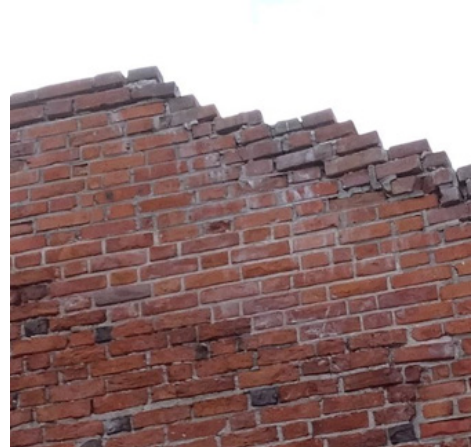
Fig. 10. North wall on the courtyard side. Damage to contemporary brick topping. Damage to pointing, salt deposits. *Source:* author, 2019

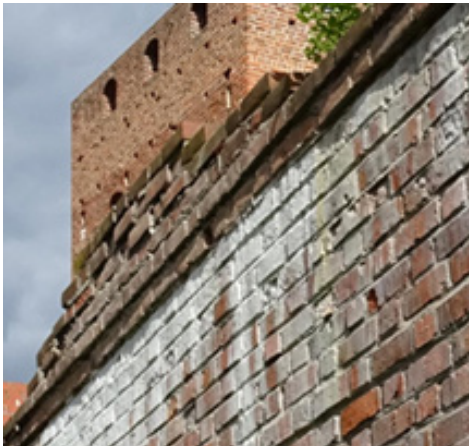
Fig. 11. The north wall from the exterior. Degradation of the surface layers of the modern superstructure. Intense carbonate efflorescence on the face of masonry. *Source:* author, 2019

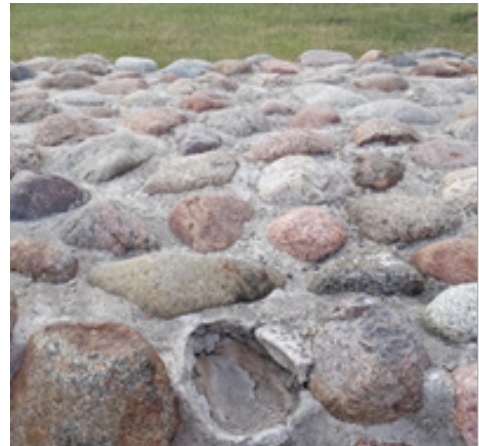
Fig. 12. South wall. Localised damage to wall topping repointed with fieldstone. *Source:* author, 2019

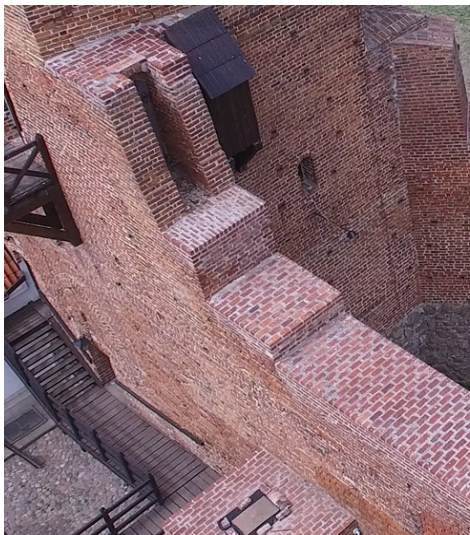
Fig. 13. The wall topping of north-west wall. Localised mortar staining of face, careless pointing of bricks. *Source:* author, 2019

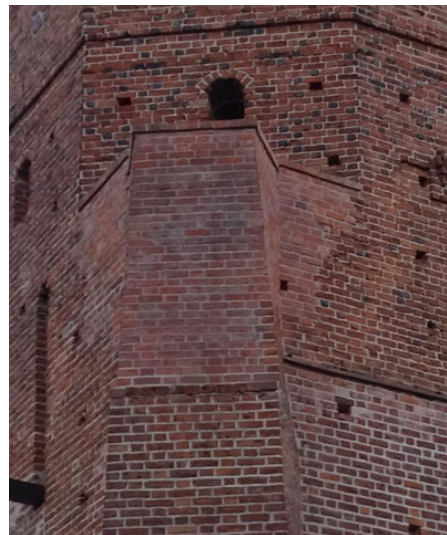
Fig. 14. Tower, view of south-west elevation. The repointed wall topping of the tower buttresses. The brickwork and pointing used ensures that the layers are distinguishable. *Source:* author, 2019

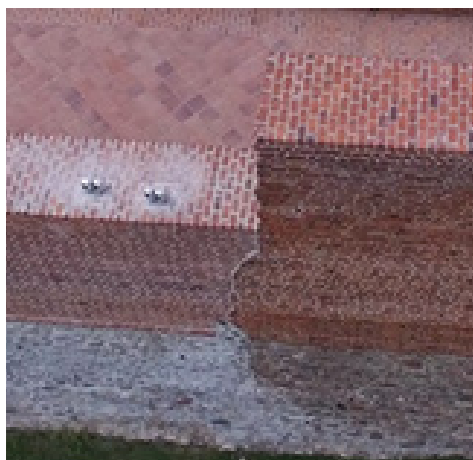
Fig. 15. The wall topping of north-east wall. Unaesthetic pointing, localised carbonate deposits on surface of bricks. *Source:* author, 2019

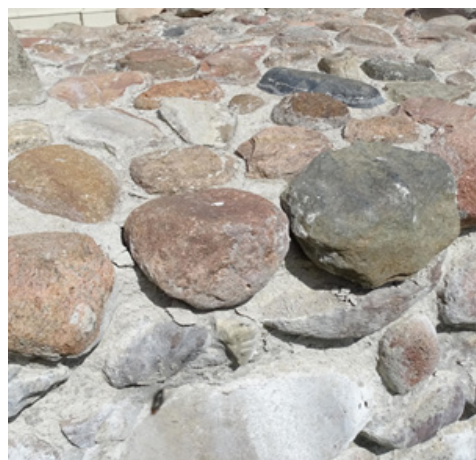
Fig. 16. South-east wall. Damage to joints, detachment of individual tones of face and top layers. *Source:* author, 2019

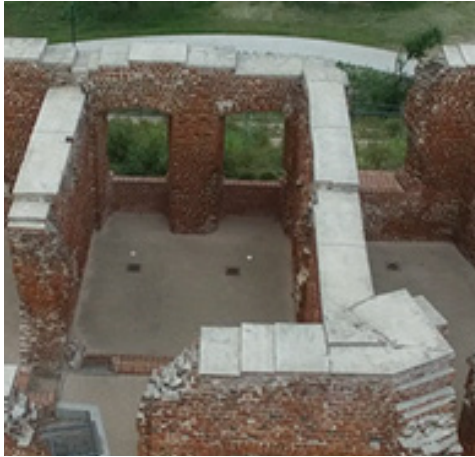
Fig. 17. The wall topping of tower in good technical condition. Locally visible damage to the top layer of bricks. Defects in pointing, damage to bricks. Source: author, 2019

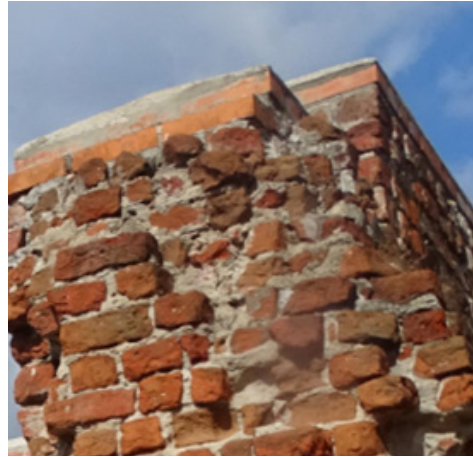
Fig. 18. Tower wall topping. Strong salt corrosion of the face of the brickwork of the tower terrace exit. Salt corrosion damaged brick faces. Carbonate streaks on the surface of the masonry. Source: author, 2019

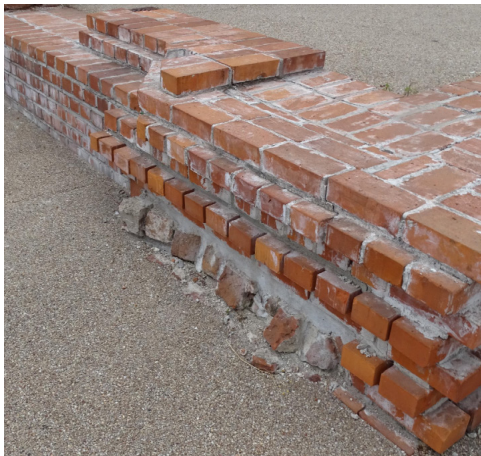
Fig. 19. The wall topping. Localised damage to the surface of the upper layer of bricks. The wall topping contaminated with bird droppings, spotty lichen growth. Source: author, 2019

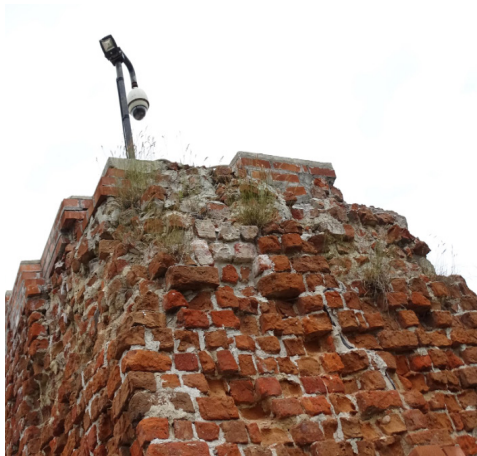
Fig. 20. The wall topping. Topping of the wall on the courtyard side. The junction of the historic wall and the over-brickwork. Brick used and pointing to ensure the layers are distinguishable. Sheet metal dripline draining rainwater. Source: author, 2019
