## **Protection of Ten-Eyed Bridge in Diyarbakır**

**Abstract:** Mesopotamia, which is one of the strategical regions of the Middle East, has hosted numerous communities and civilizations since the ancient times of human history. This situation made the region considerably prosperous in terms of historical and cultural heritage. Ten-Eyed Bridge, that is one of the most important historical and cultural symbols of Diyarbakır, having lasted till today, became an example of this prosperous heritage. However, various interventions and deteriorations have occurred in the construction within long time due to the impact of human and nature. Because of the considerable temperature difference arising due to continental climate of the region as well as damages like the change of conditions of use, amortizations in bearing constructional components in contact with water have emerged. In this study, with the purpose of ensuring further future existence of Ten-Eyed Bridge, adopted methods for structural and physical deteriorations and protection works were examined.

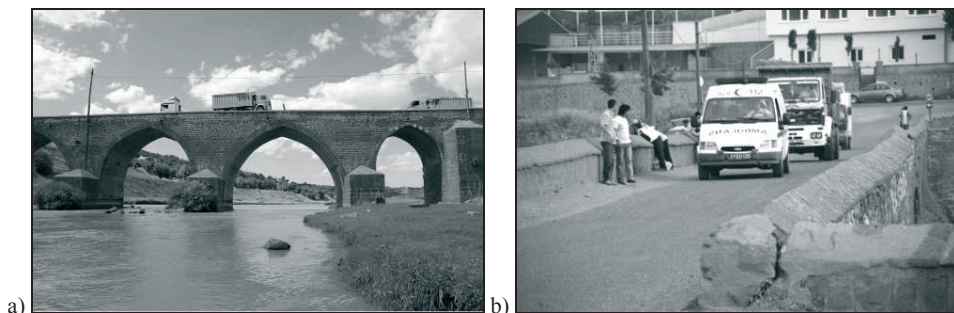
Fig. 4. Examples of moving loads before restoration a) side view b) longitudinal view

The first step towards the beginning of restoration works is the pedestrianization of the bridge. Afterwards, it was aimed that the bridge wasn't exposed to heavy live loads like car, truck, an alternative bridge was built and the restoration was completed in such a way that the existing bridge will be open only for touristic visits. Thus, deformations on the bridge that heavy live loads caused were prevented, Fig. 4.

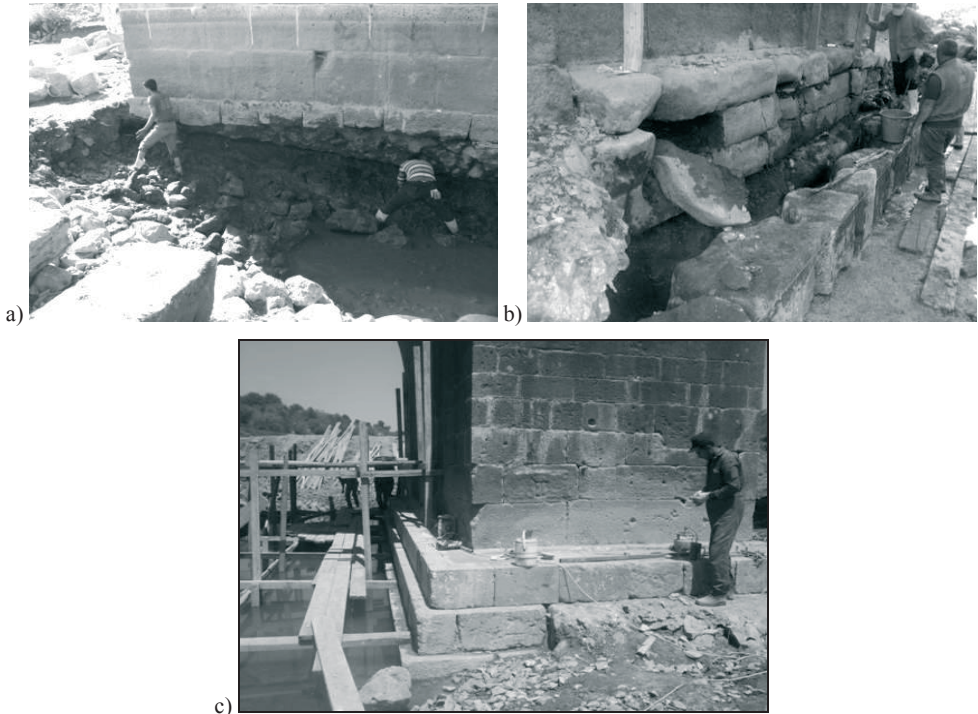
Fig. 5. Conservation works a) discharges on the grounds b-c) splits, cracks and breakages

On the ground where abutments are settled, non linear flow of river water causes their undulation, whirlpool and irregularity of water bed. This resulted a big scours on abutments, the bridge foundation was confronted with serious conveying problem.

Due to these scours, serious discharges occurred on the grounds of abutments, Fig.5.a. Besides, splits, cracks and partly breakages occurred on the lower arrays of abutments because of direct abrasion of water and the decrease and increase of its flow, Fig. 5.b. This issue reached to serious texture losses with the breakage of existing linking clips in some abutments. During restoration, first of all, grounds and its ambient were purified from loam and foreign elements. It was reinforced by basalt prepared in original size by means of staggering with a specific height. As in present, these stones are connected each other with iron clips. Clips settled in slotted hollows on each two stones with lead enabled both that stones resisted against water by interconnecting and the basic carrying system of structure strengthened. In this way, strengthening work was performed in abutment and flood splitters that both ground and scours caused, the complementation of texture and surface on abutments are carried out, Fig. 5.c.

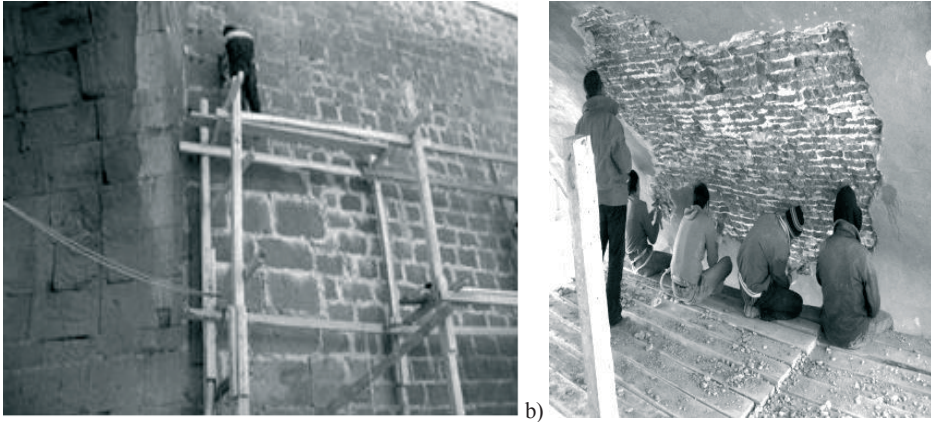
Fig. 5. The cleaning process a) joints, by being scraped b) cleaning of plasters

Arch and spandrel stones that had structural deteriorations were removed by being numbered; the sound ones were used again during reconstruction. Instead of decaying, melting and disconnecting stones, the complementation was carried out by being used the same type of stones. Cement based joints seen in spandrel and arches were cleaned by being scraped without detriment to the original texture with the help of small item chisels and wire brushing, Fig. 6.a. Plasters on the original brick surface inner side of arches were cleaned by pen plaster, original brick texture and brick barrel vault coverings braided on original square order were revealed, Fig. 6.b. Plaster parts between brick and joint were cleaned without detriment to the material by means of compressed air and fine-lead metal pen and with injection air, dusts on the surface were taken.

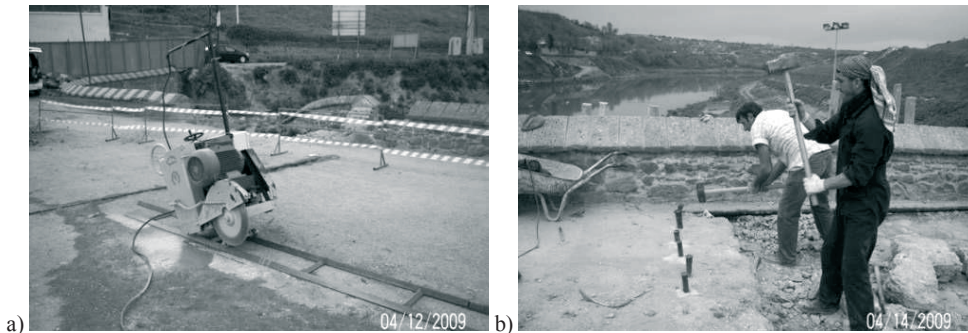
Fig. 6. a-b) revelling of concrete layer

The reveling of non original concrete layer, Fig. 6, is a highly important step in terms of both esthetics and authenticity and engineering in the meaning of unnecessary distributed load. In fact, 39 cm thickness concrete layer, Fig. 7, creates a distributed load with about 0.96 ton/m<sup>2</sup> size on this historical bridge which has 172 m length and whose width varies from 10m to 6m. On the other hand, with the removal of concrete layer, the emergence of original flooring becomes quite happy and good issue in terms of the health of restoration, Fig. 8 - 10.
