Degradation processes and the methods of securing wall crests

Maciej Trochonowicz, Bogusław Szmygin

Abstract: The protection of historical ruins requires solution of doctrinal and technical problems. Technical problems concern above all preservation of walls, which are exposed to the influence of atmospheric factors. The problem that needs to be solved in any historic ruin is securing of wall crests. Form of protection of the wall crests depends on many factors, mainly technical features of the wall and architectural and conservatory vision. The following article presents three aspects important for protection of wall crests. Firstly, analysis of features of the wall as a structure, secondly the characteristics of destructive agents, thirdly forms of protection of wall crests. In the summary of the following article, advantages and disadvantages of each method of preservation of the wall crests were presented.

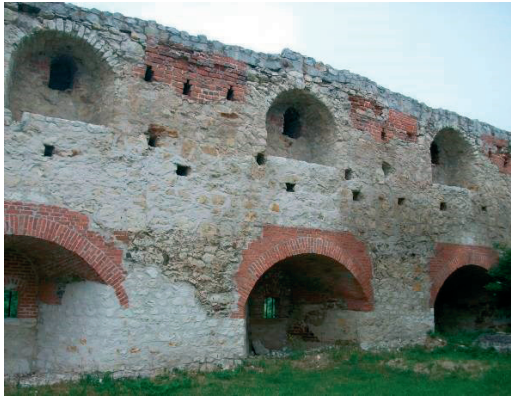
Fig. 4. A massive defensive wall. (The castle of Janowiec on the Vistula River)

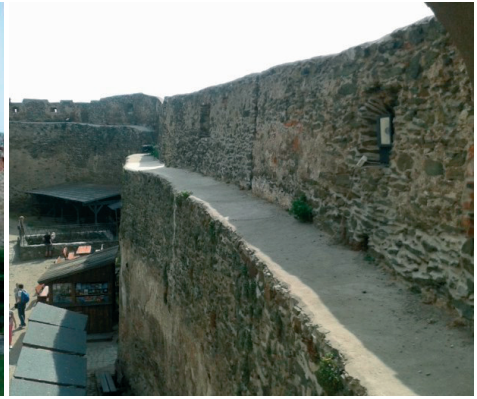
Fig. 5. A massive defensive wall with a high parapet. (The Castle of Bolków)

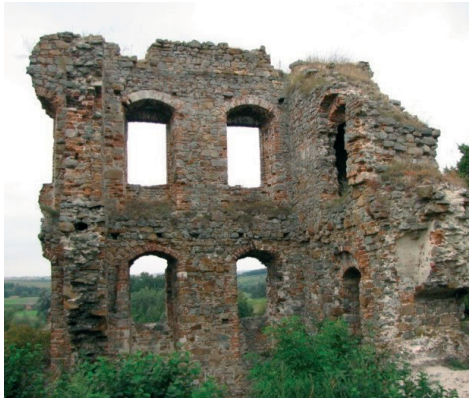
Fig. 6. The wall of the primarily volumetric object. (The castle of Międzygórze)

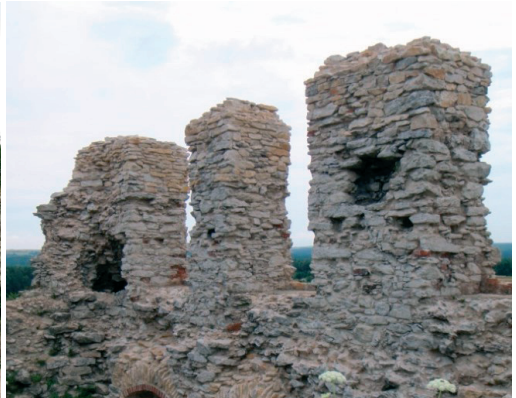
Fig. 7. The wall of the primarily volumetric object. (The castle in Czorsztyn)

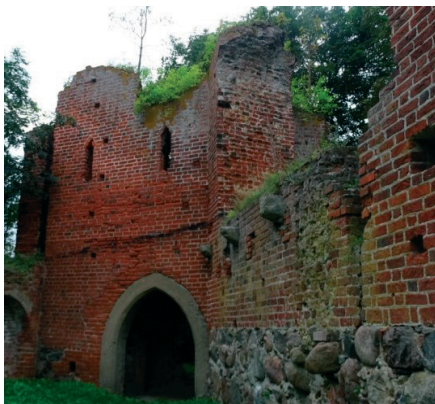
Fig. 8. The Wall of the primarily volumetric object. (The Castle of Pokrzywno)

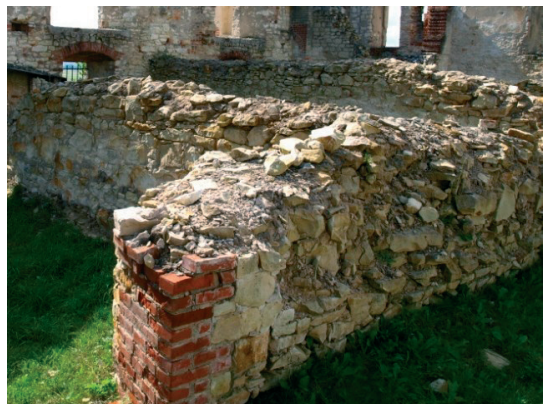
Fig. 9. The Wall of the primarily volumetric object preserved as a relic. (The castle of Janowiec on the Vistula River)

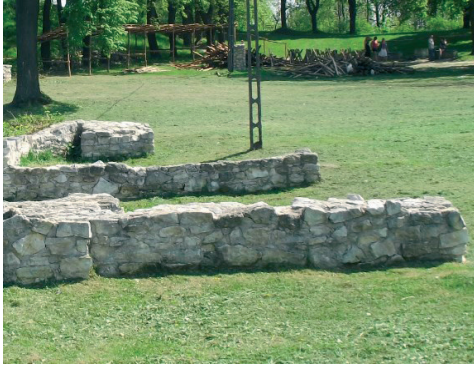
Fig. 10. The Wall preserved as a relic.
(The castle in Iłża)

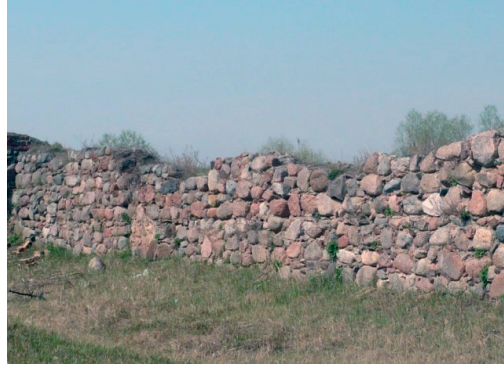
Fig. 11. The relics of the castle intermural space.
(The castle in Bobrowniki)

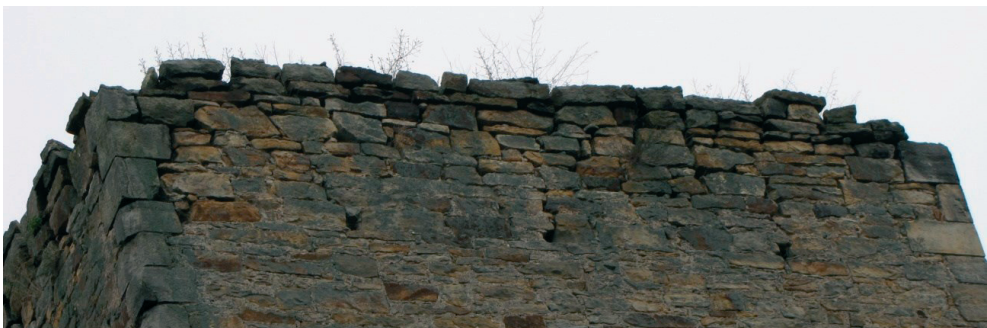
Fig. 12. Degradation of the crest of a stone wall constructed of a really durable material caused by the effect of rainfall and snowfall.

The predominant part of the degradation processes is strictly related and to a great extent dependent upon excessive humidity. Intensification of the phenomena connected with salt corrosion, frost and biological corrosion results from the increase of the amount of water in the area of the wall crest. Thus it is water that influences most – directly and indirectly – the processes of degradation of brick, stone and mortar. The process is caused, first of all, by the rain water that appears on the surface of the crest when it is raining and then proceeds inside the wall. The rain water soaks through the wall and during the first stage causes dissolution of the binding agents of mortar, damage of the media and then, their complete destruction. As a consequence, the carrying capacity of the parts of the wall devoid of mortar become lower. In case of low walls there is an additional problem of ground-water that may be drawn upwards by the capillary mechanism and the result of the process is a similar degradation as in the case of rainwater.

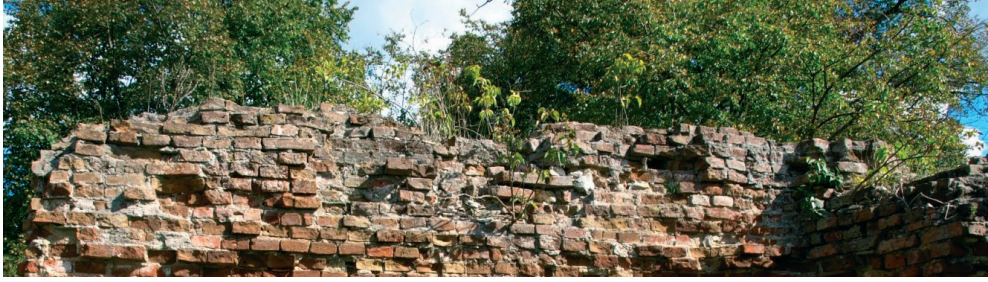
Fig. 13. Degradation of the crest of a ceramic brick wall caused by the effect of rainfall and snowfall

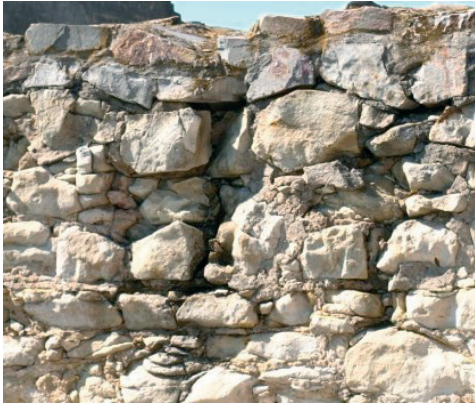
Fig. 14. Degradation of the crest of a stone wall constructed of a low durability material caused by the effect of rainfall and snowfall

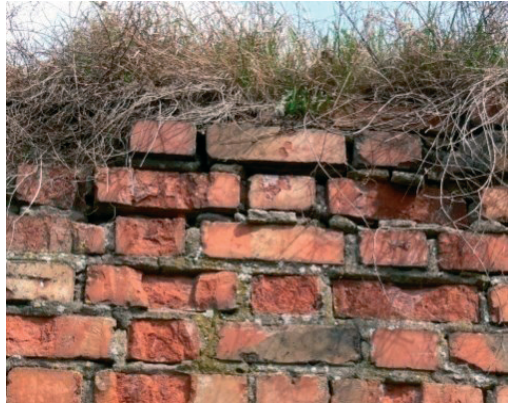
Fig. 15. Degradation of the wall mortar with a good preservation of the wall material.

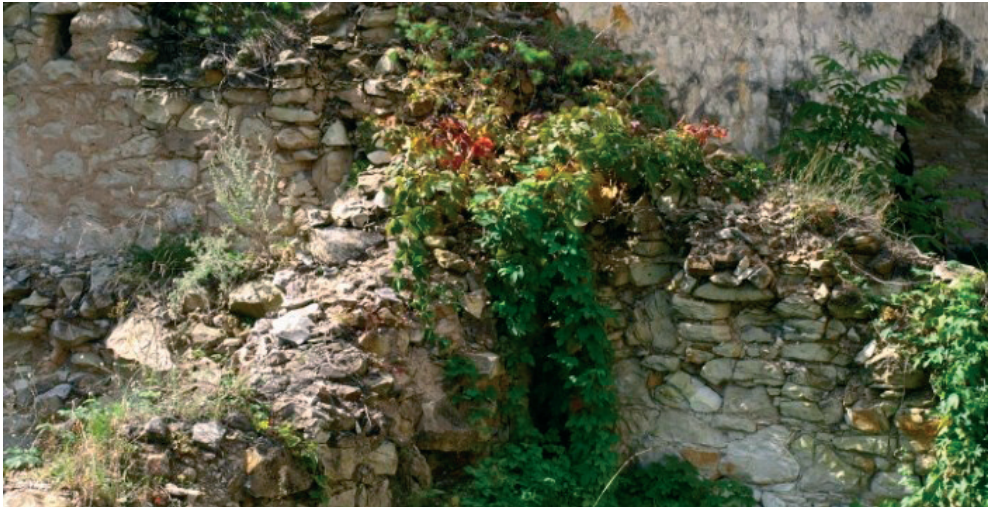
Fig. 16. A significant amount of annuals and perennials causing the degradation of the crown and the loss of legibility of the wall outline (contour).

Biological corrosion, also called biodeterioration is understood, in construction, as varied forms of destruction of the elements of a building caused by the activity of living organisms i.e. biological pests. They are mainly green plants, dry rots, mildew fungi, insects, algae, lichens and bacteria. Like in the case of salt the condition of occurrence of most of the above –mentioned organisms is humidity and its increased level is responsible for the intensification of the corrosion processes. The appearance of even a minimal portion of humus in the wall cracks and on top of the crest results in the growth of green plants. At the beginning the dominant plants are mostly small annuals or biennials and grasses. Their growth is particularly intense at the points of greater humidity. Decay processes cause the appearance of humus acids in the wall as well as the increase of the amount of nitrates. Later on, along with the growth of the humus layer (decay of plants, blowing in soil), there are more perennials, bushes and trees. The results of growth of higher plants are similar as in the case of lower plants, additionally there is the danger of the roots growing into the walls. The developing root system (usually growing into the mortar junctions) causes the stratification of the wall leading to a serious degradation.

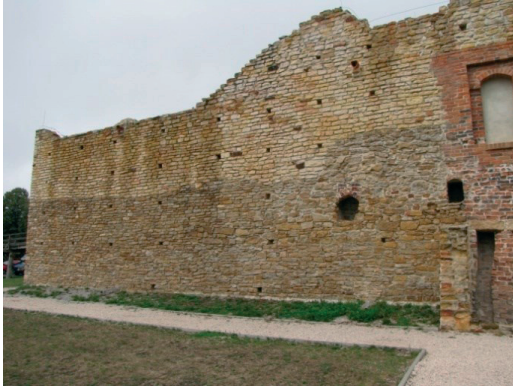
Fig. 17. Reconstruction of substantial fragments of the wall with the material compatible with the historical one. (The castle of Inowłódz)

Certainly the most efficient solution aimed at the durable securing of the wall crest is the partial reconstruction of the object. Reconstructions may vary in character and they are precisely connected with the concept of architectural works concerning the whole object. Contrary to addition to an existing wall where the height of the new construction of the wall is rather small (several dozen centimeters), in case of reconstruction the new fragment of a wall can even be several meters tall. It is usually the native material that is used in reconstructions, varying only in color, the size of the wall elements or the technology of mortar pointing. In the objects with reconstructed walls one can observe various methods of finishing the new crest. It depends upon the function that is to be performed by the object, or the vision of the design author. It is possible to single out three groups of such reconstructions:

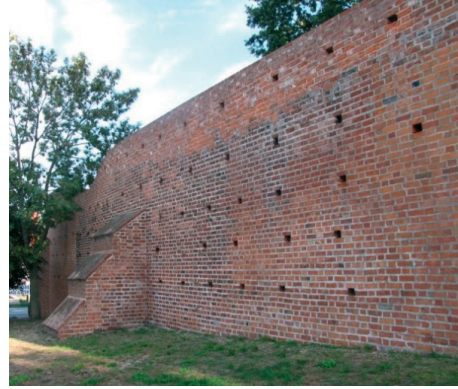
Fig. 18. Reconstruction of substantial fragments of the Wall with the material compatible with the historical one. (The castle of Łęczycza)

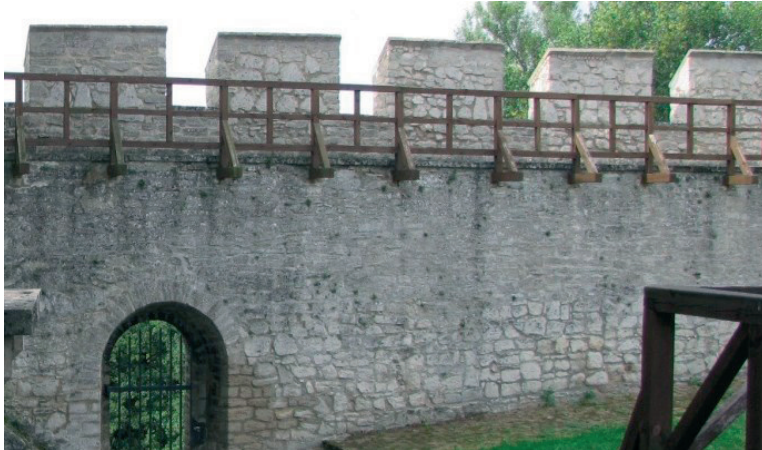
Fig. 19. Reconstruction of substantial fragments of the wall with the material compatible with the historical one)

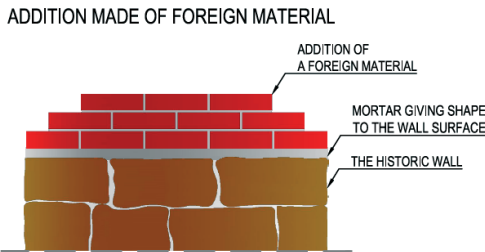
Fig. 20. Addition made of foreign material /A securing layer – addition of a foreign material/ Addition of a foreign material/ Mortar giving shape to the wall surface/ The historic wall

tion is artificial. Undoubtedly an advantage of addition to an existing wall is the possibility of unrestrained shaping of the wall crest which allows to obtain the plasticity compatible with the historical one. Additions are made after the introduction of one more isolation layer, or directly upon the historical material. Certainly a better solution is the use of isolation. It allows supplementary securing of the ancient wall and at the same time as a dividing layer it makes the solution reversible.

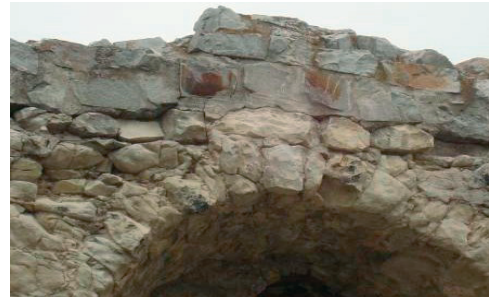
Fig. 21. Addition made of foreign material without the isolation layer. (The castle in Janowiec on the Vistula River)

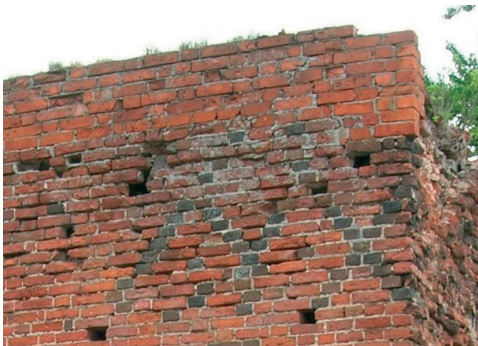
Fig. 22. Addition of the crown made of contemporary brick, on a type of mortar stronger than the original one. (The castle in Bobrowniki)

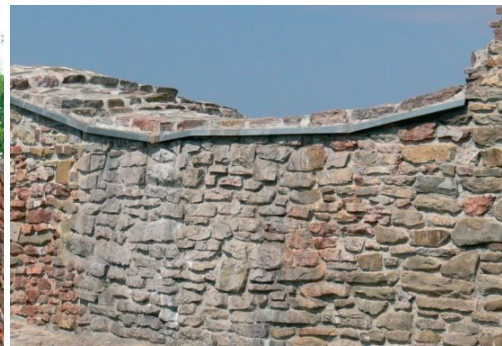
Fig. 23. Addition of the material compatible with the historical one combined with the isolation of sheet metal

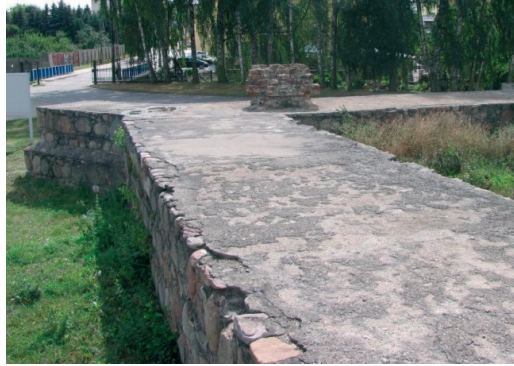
Fig. 25. The crest secured with a layer of cement mortar – without molding. (The castle in Rawa Mazowiecka)

The method consists in making a tight layer of mortars or concretes upon the degraded wall crown. The kind of securing is made directly upon the historical tissue or the isolation material that is assumed to be a dividing layer which allows a simpler removal of the securing layer without the destruction of the historical wall. Plasticity of the material used for securing of the crest allows the shaping of inclinations leading the rainwater flow out of the object or into it. One of the greatest advantages is the possibility of obtaining the form of the wall crest compatible with the line formed by the natural factors. The mortars which form the securing layer should be as tight as possible, so that rainwater should not permeate the securing layer and in case when there is no isolation, infiltrate into the historic layers. In case of low walls this kind of securing may be perceived as not really aesthetic.

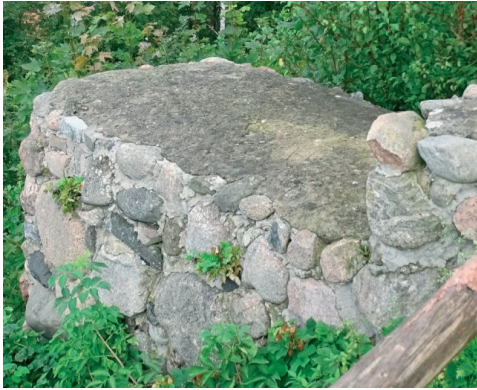
Fig. 26. The crest secured with a layer of cement mortar – with molded inclinations. (The Castle in Kurzętnik)

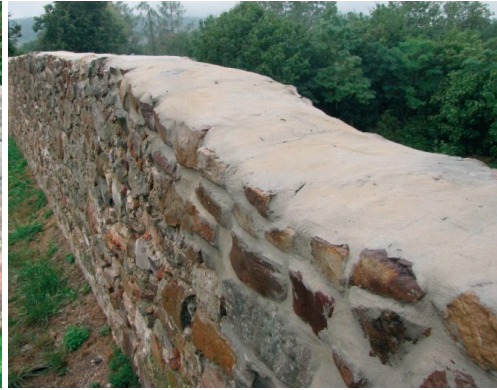
Fig. 27. The crest secured with a mortar layer – with molded inclination. (The castle in Bodzentyn)

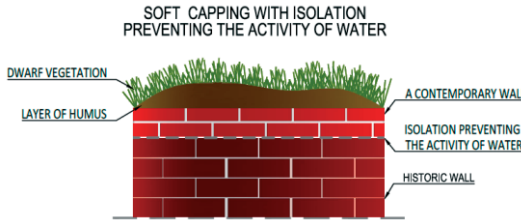
Fig. 28. Soft capping./Soft capping with isolation preventing the activity of water./ Dwarf vegetation/ Layer of humus / A contemporary wall / Isolation preventing the activity of water / Historic wall /

Introduction of a layer of plants upon the wall crest after its previous preparation (with or without isolation, addition to the wall and molding the inclination). The method consists in the intentional covering of the crest with a layer of fertile soil and planting dwarf plants, usually the shallow-rooted grass. This kind of solution is very rarely used because of a whole range of restrictions. The crests secured with soft capping must be supplied with an addition and leveled, which causes the change of the crest plasticity. Vegetation growing on the crest requires some kind of cultivation which makes the access to the crest necessary. Quite a thick layer of humus allowing grass vegetation, creates also a possibility of seeding and growth of undesirable vegetation (perennials, bushes and trees.)

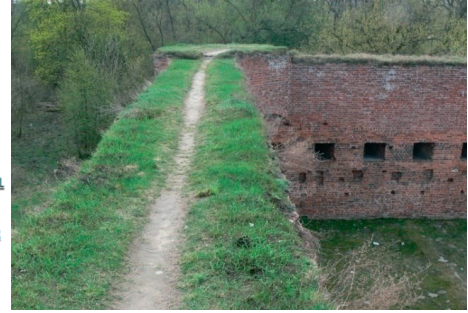
Fig. 29. Soft capping securing the castle wall crest. (The castle of Toruń-Dybbów)

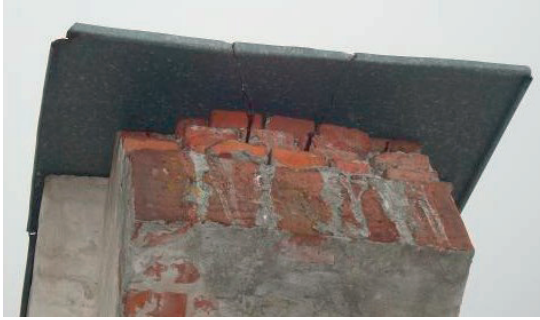
Fig. 32. A steel sheet roofing of the wall crest made directly upon the wall (The castle in Janowiec on the Vistula River)

They are not usually a very aesthetic solution, but a durable and reversible securing of the wall crest against the rainfalls. The types of roofing usually made can be divided into two groups. Most frequently the roofing is made as a temporary one, covering the particularly degraded or threatened with degradation portions of walls as well as permanent constructions over the passages allowing to walk upon the crests. In case of temporary solutions one can observe a certain freedom of choice of the materials used and the construction solutions. A permanent roofing, as to the form and material, may be referring to history or completely modern.

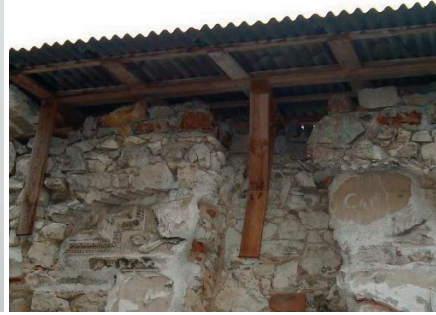
Fig. 33. Securing of the crest and a detail by a wooden construction with corrugated sheet metal (The castle in Janowiec on the Vistula River)

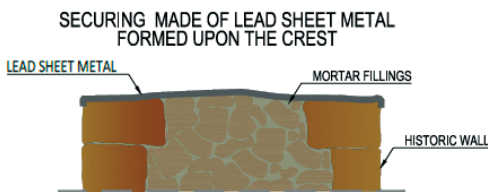
Fig. 34. Making a sweet metal cover on the Wall crest./ Securing made of lead sheet metal formed upon the crest./ Lead sheet metal/ Mortar fillings / Historic wall/

The securing consists in making the cover of soft sheet metal directly upon the top layer of the wall crest without any later addition to the existing wall. At the first stage the crest needs a suitable preparation of the surface, all the holes and caverns must be filled. The surface elements of the crest should be cylindrical in shape. The crest should not be leveled, as it would make the sheet metal fixing more difficult. A metal sheet is put on the prepared crest and then it is hammered so that it could acquire the shape retaining the pattern of the crest. Pulling the metal sheet over the front and hammering it down allows a better connection between the metal and the wall. The method is highly efficient and durable.

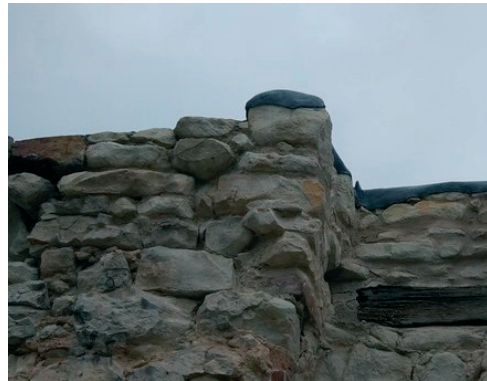
Fig. 35. The crest fragment secured with lead sheet metal. (The castle in Janowiec on the Vistula River)

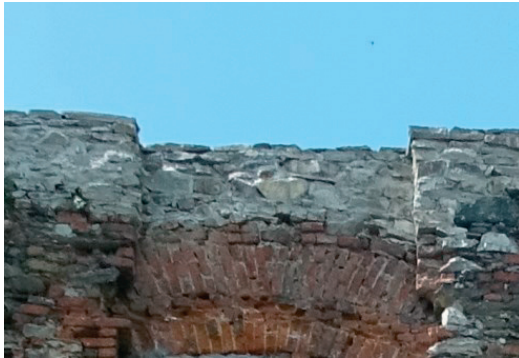
Fig. 36. Securing of the added crest with a cover (The castle in Żąbkowice Śląskie)

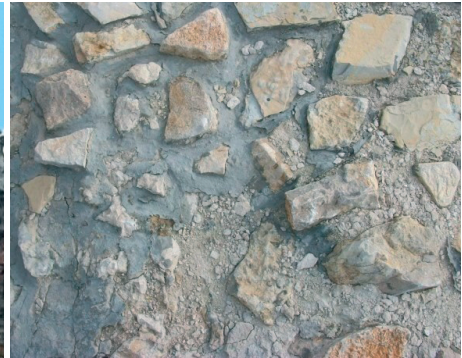
Fig. 37. The degraded chemical cover of the crest.(The castle in Rabsztyn)

The securing devices of this type can make use of hydrophobic or sealing preparations. Along with the dynamic development of construction chemistry at the end of 20th century chemical substances started to be used for surface hydrophobia of stone and brick wall crests. Their proper application requires the fulfillment of a whole range of conditions
