Nativity of the Virgin Mary Kozelshchynskiy Monastery in the Poltava Region: an assessment of architectural heritage and contemporary challenges

Halyna Osychenko¹, Oleksandr Khliupin²

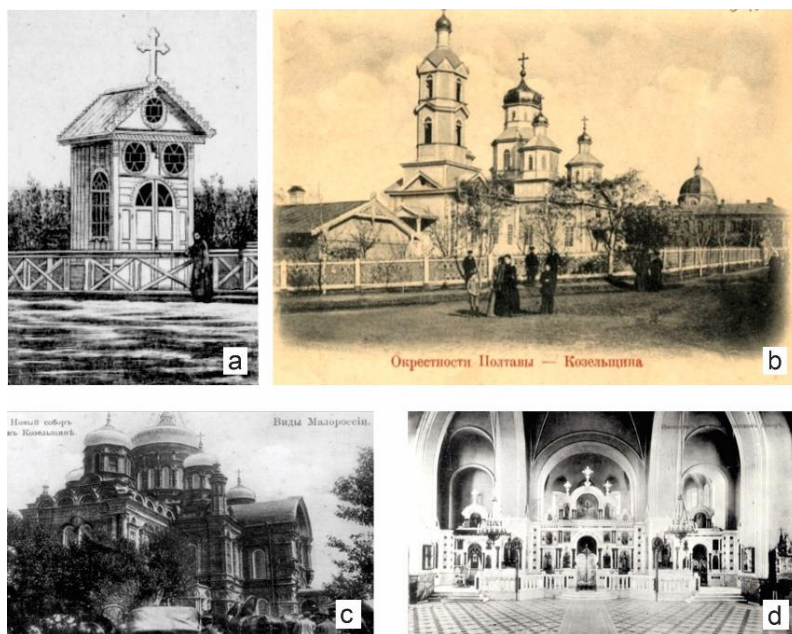
Fig. 2. Monastery buildings: a - chapel housing the icon of the Kozelshchyna Divine Mother, opened in the park of the Kapnist estate in 1881.. *Source:* [52]; b – summer Church of the Nativity of the Virgin Mary, 1882. Photograph from the late 19th century, from the monastery's archive.; c – the New Cathedral built in 1906. Series of postcards "Views of Little Russia", 1906; d – cathedral iconostasis. Photo of the 1910s. *Source:* [41]

The chronology of building construction in the monastery has been established [40,41,45,46,52] and is as follows: a "hospice house" with a school for boys (1887); a house for wealthy residents (1887); an abbot's house with a brick Transfiguration Church attached to the abbess's cell (1891); a windmill, a barn for the mill, and a locomotive shed (1898); the new brick Cathedral of the Nativity of the Virgin (Fig. 2c,d) (1900-1906), replacing the dismantled wooden church; a carpentry workshop (1904); a house for nuns working in the livestock yard (1905); a thrashing barn (1906); a house for female gatekeepers (1907); cells for sisters, an icon shop, and a candle shop (1908); a wooden hospital (1909); a large laundry (1911); and a new parish school for boys (1912).

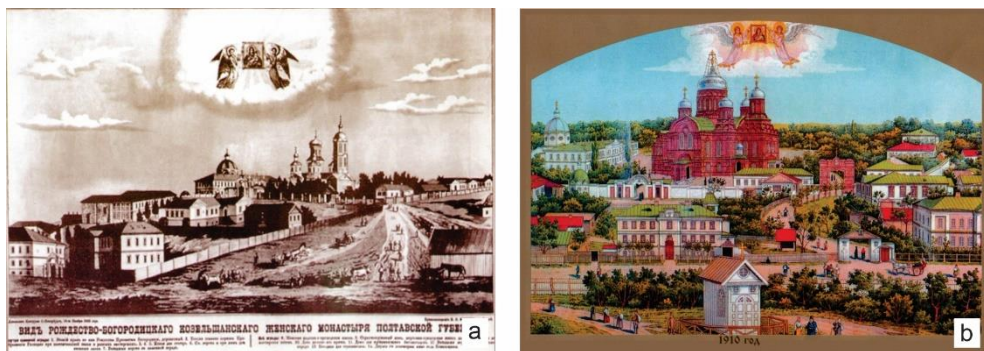
Fig. 3. View of the Nativity of the Virgin Mary Kozelshchyna nunnery, Poltava province. Chromolithography of E.I. Fesenko, Odessa. 1892 (a) and 1910 (b). Source: [41]

A chromolithograph from 1892 represents one of the stages in the formation of the monastery ensemble, while a chromolithograph from 1910 documents the completed composition of the monastery complex, as viewed from the river and the railway station [41] (Fig. 3).

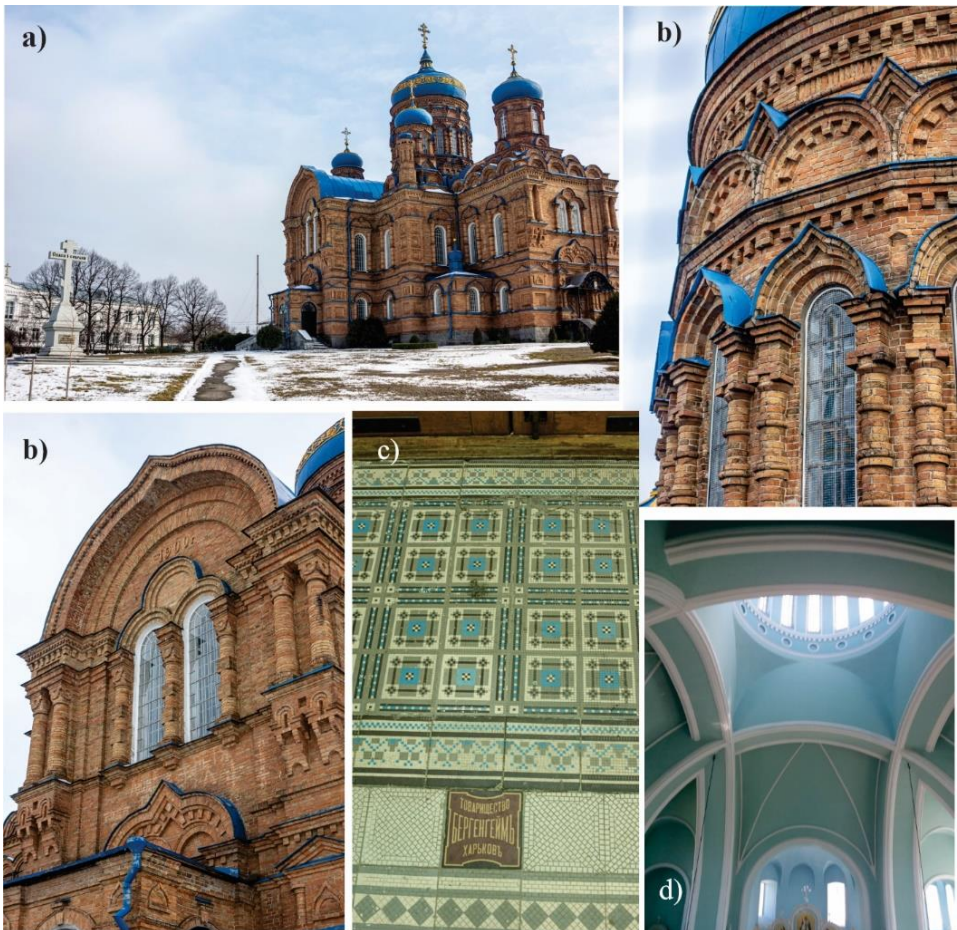
Fig. 4. The current state of the Cathedral of the Nativity of the Virgin: a) view of the cathedral from the northwest; b) brick decoration of the facade; c) authentic floor tiles; d) the construction of the intersection of four arches that supports the drum of the main dome, freeing the interior space from columns. *Source:* own study

The Cathedral of the Nativity of the Virgin is recognized as the most valuable structure within the monastery complex. This building holds historical, town-planning, and architectural

significance as an example of a temple constructed in the pseudo-Byzantine style. It is a five-domed masonry structure with a multi-tiered belfry. The cathedral was built using engineering calculations and technologies that were innovative at the time. With dimensions of 52 arshins in length, 43 arshins in width, and 27 arshins in height, the building was constructed without internal supports, allowing approximately 1,200 worshippers to attend services simultaneously. The interior featured an iconostasis made of white marble by the Italian company Menzioni. The iconostasis was adorned with embossing, gilding, mosaic work, and green onyx inserts, though it has not been preserved. It originally contained 89 icons painted by the artist Gurianov. The design and execution of the interior decoration and paintings were carried out by the Kyiv artist M. I. Murashko [49]. The ceramic floor tiles were produced at the Kharkiv plant of the Bergenheim Company, with a total of 10 types of tiles used in the flooring. Some of the original floor tiles have been preserved in the cathedral. The uniqueness of the material used in the cathedral's construction was also confirmed. The brick, made with expanded clay admixtures, was produced at the monastery's own factory [50] (Fig. 4).

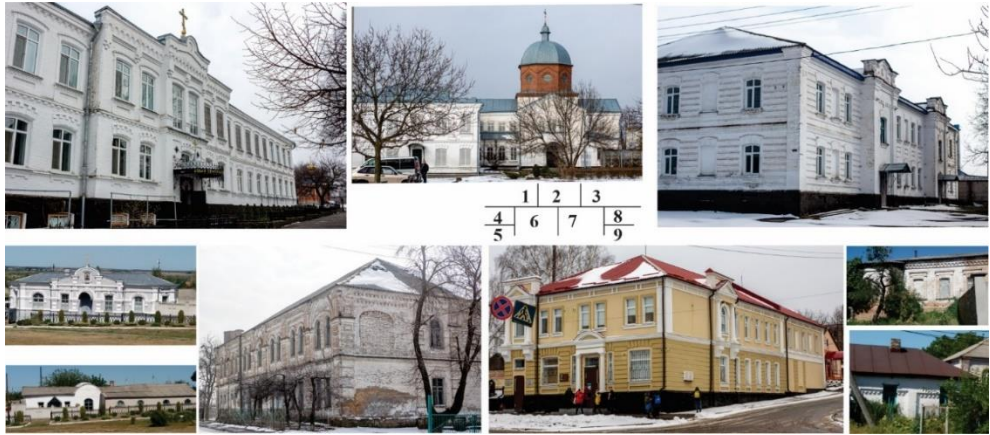
Fig. 5. Identified cultural heritage objects in the monastery complex: 1, 2 – the warm house church of the Transfiguration of the Lord at the abbess's cell and various workshops (2), eastern and southern facades; 3 – office with nuns' cells, treasury building (3); 4 – candle-making and icon-painting workshop (4); 5 – the Holy Gate with shops (5); 6 – nuns' cells on Monastyrskya Street (6); 7 – new parish school for boys (7); 8 – pilgrimage building (17), typical decoration of residential buildings; 9 – corner house (13), remnants of the monastery wall decoration. The numbers of objects correspond to those in Table 1 and Fig. 6, indicated in parentheses. *Source:* own study

The identified cultural heritage objects are classified as follows: a) the most valuable objects (an existing architectural monument - the Cathedral of the Nativity of the Virgin), b) a valuable historical building recommended for inclusion in the State Register of Architectural Monuments of Ukraine, c) a significant historical building, and d) an ordinary historical building (Fig. 5).

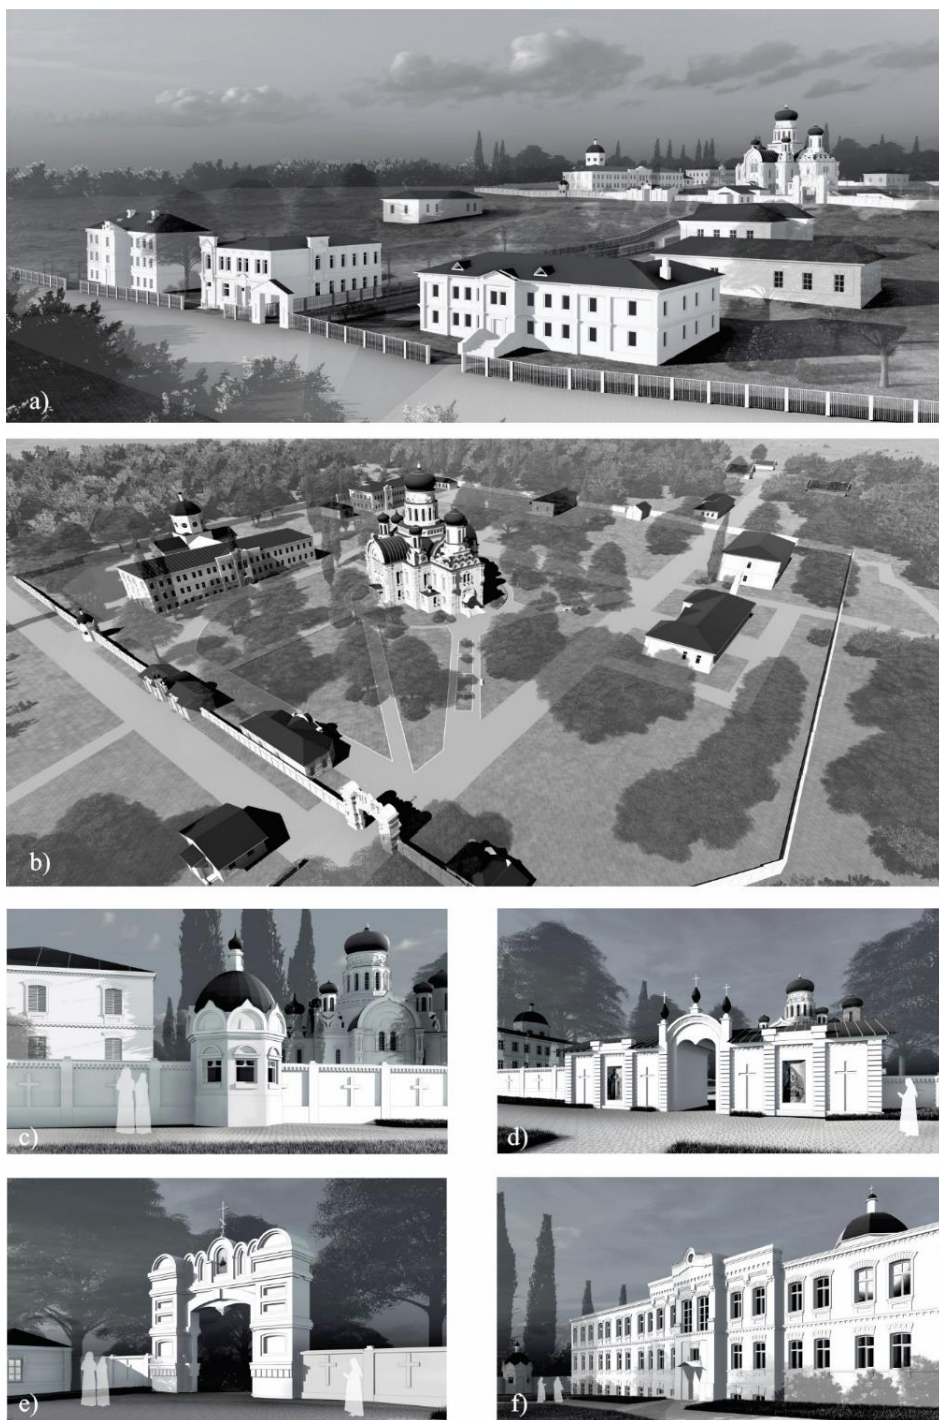
Fig. 8. 3D reconstruction of the original appearance of the monastery: a) general view; b) view from above of the central part; c) near the chapel of the monastery; d) the Holy Gate of the monastery; e) the Red Gate of the monastery; f) the abbot's building of the monastery. *Source:* own study

Using the Archicad program, information models of the identified heritage objects were created. Drawings of the most valuable objects of the monastery's cultural heritage, including the reconstruction of the original appearance of the lost objects and elements of preserved buildings, are presented in Fig. 7. The information models of the buildings allowed for the reproduction of the original appearance of the monastery in the Archicad program (Fig. 8).
