## Difficulties in rebuilding historic bridges after conflicts: the case of the Mosul stone bridge

## 5. The case of the Mosul Stone Bridge

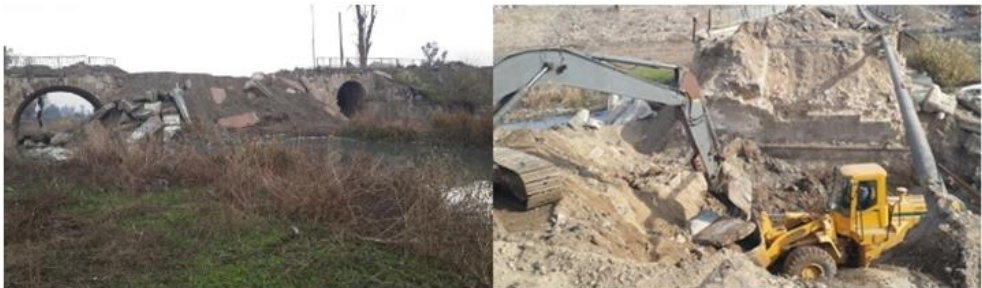
Fig. 3. The bridge before reconstruction and the beginning of rubble removal. *Source:* [researchers]

5.2.4. Once the debris was cleared from the site, the remains of the destroyed pillar were revealed (see Fig. 3). The outer shell was constructed using stones with regular geometric shapes, while the core was filled with stones, cement mortar, and additives (see Fig. 4). The bridge abutments were reinforced and protected from collapse due to erosion caused by water runoff near the abutments through the construction of a gravel foundation. Additionally, capillary baskets (BRC baskets filled with coarse gravel) were installed at both the upstream and downstream locations of the bridge, before and after the installation of the gravel foundation. Grouting operations were also conducted near the abutments after the completion of the gravel foundation to fill voids beneath the stone abutments and prevent potential future collapse.

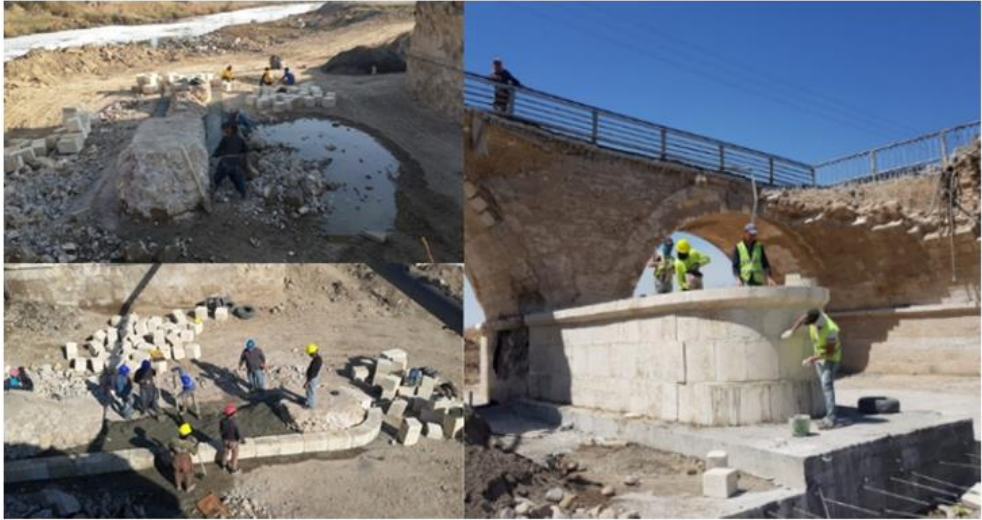
Fig. 4. Locating the destroyed pillar and rebuilding it. *Source:* [researchers]

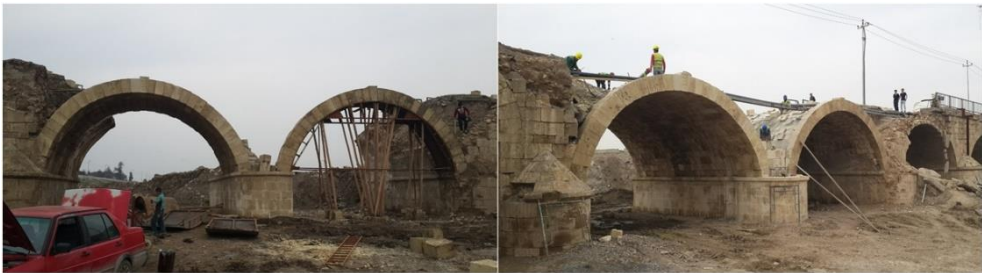
Fig. 5. Installing iron molds and constructing arches for destroyed vaults. *Source:* [researchers]

5.2.5. In the subsequent phase, an iron mould was constructed to replicate the original arch of the stone vault. The initial row of keystone stones was installed without the use of a binder, with the keystones securing the arch. To prevent the formation of longitudinal joints between the rows, stones of varying sizes were used for the remaining components. Additionally, cement mortar was applied between the stone units, with additives incorporated to improve the mortar's properties and enhance adhesion between the stones (see Fig. 5).

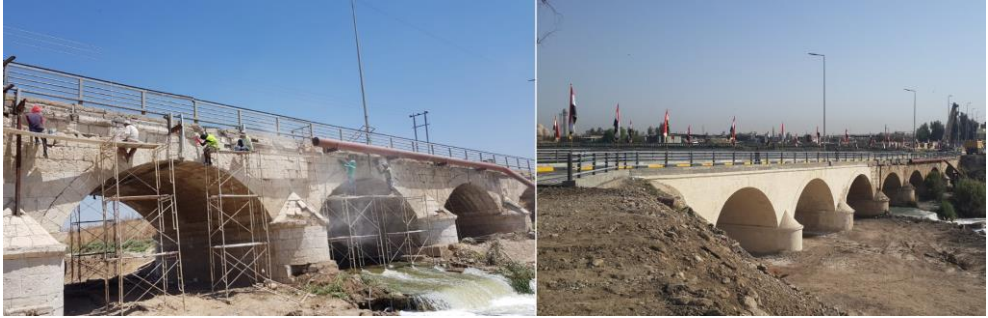
Fig. 6. Mosul Stone Bridge during the final stage of reconstruction. *Source:* [researchers]

5.2.7. In the final stage, finishes were completed on the bridge. All of the bridge's stones were polished, the street was paved, and the sidewalks, lighting installations, and painting works were carried out (see Fig. 6).
