## The full-scale test of bearing structures of the shelter to assess the possibility of its further operation

### Abstract:

shelter, columns, crossbars, precast reinforced concrete roof slab, soil backfill, strength quality of concrete, strength quality of reinforcement, bearing capacity, mechanical opening, ultrasonic study

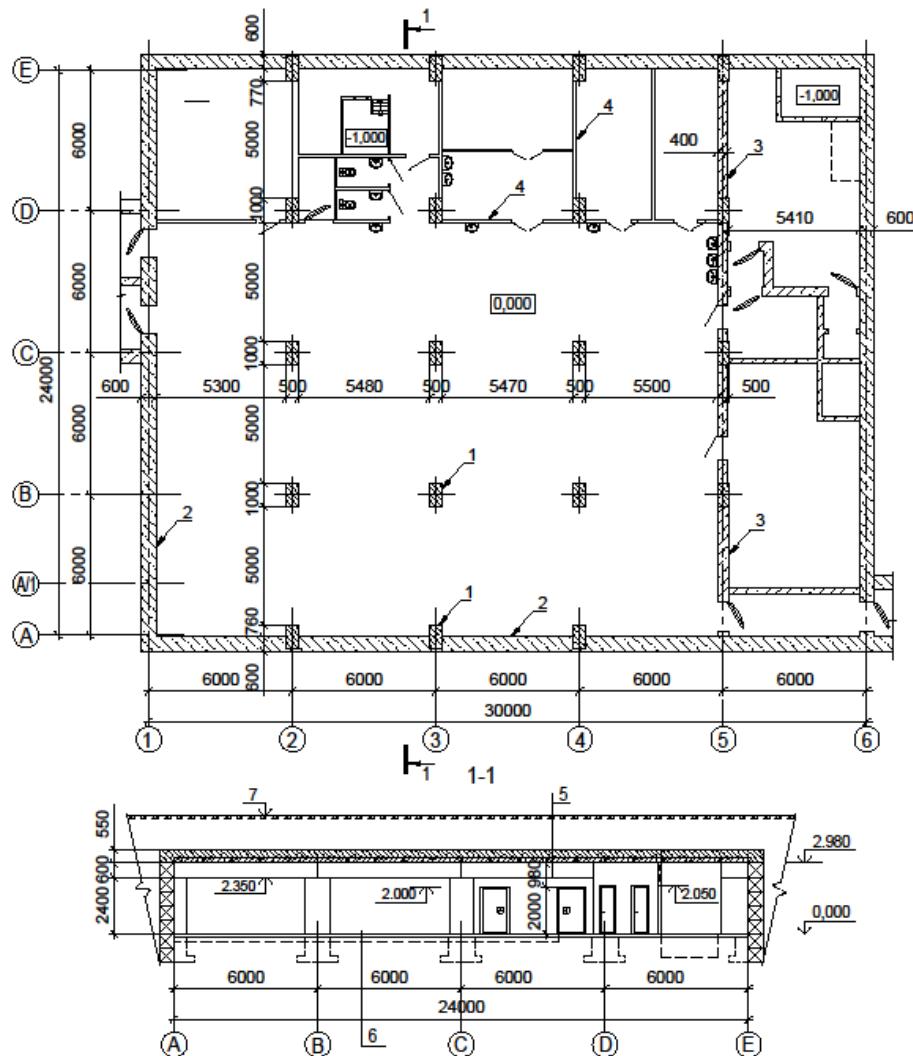
Fig. 1. The plan of shelter and cross-section 1-1:

1 – column (its size is 500 x 1000 mm);

2 – external precast-monolithic reinforced concrete walls (its thickness is 600 mm);

3 – inner monolithic reinforced concrete walls;

4 – brick partitions;

5 – roof structure (it consists of soil compaction (its thickness is 2000-3000 mm), waterproofing asphalt concrete (its thickness is 35-45 mm), precast-monolithic reinforced concrete slab (its thickness is 550 mm), precast-monolithic reinforced concrete crossbar (its size is 800 x 630 (h));

6 – floor structure (it consists of concrete floor, screeded with "Topping" type, concrete on compacted soil (its thickness is 120 mm);

7 – ground surface

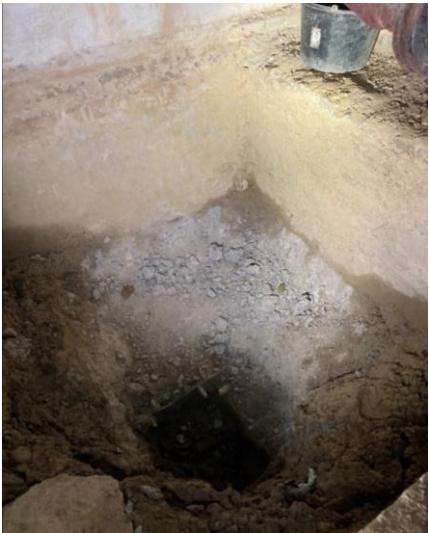
The precast-monolithic external wall of axis "E" rests on a strip foundation. The width of the foundation bearer is 1900 mm. The cantilever protrusions from the wall edge are 650 mm, and the height of the strip is 300 mm (Fig. 3).

**Fig. 3.** Digging of foundations at the intersection of axes "2"- "E"

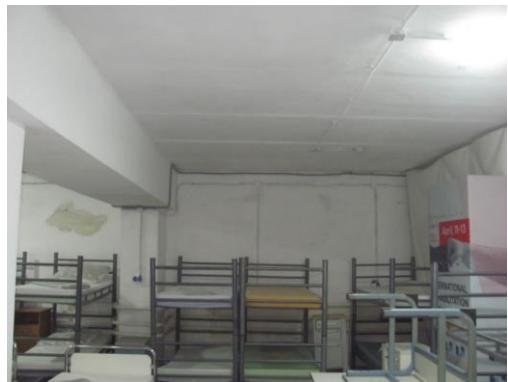
According to the results of ultrasonic and instrumental studies with the removal of soil embankment and mechanical opening both from the outside and from the inside, the crossbars and the roof slab above the shelter of axes "1"- "6" "A"- "E" are precast-monolithic. Precast solid slabs are supported on the crossbar of axis "2" and the precast monolithic wall of axis "1". The width of these slabs is 1200 mm. The lower part of the roof structure is made in a prefabricated version by installing solid slabs and T-beams with shelves in the tension zone. The precast solid slabs installed in the centre of the premises can be identified by the visible seams between them on the ceiling. The seams are particularly noticeable in areas with no repair work or where the slabs were installed with significant discrepancies (Fig. 4).

**Fig. 4.** Roof's fragment of axes "1"- "2" "A"- "B"

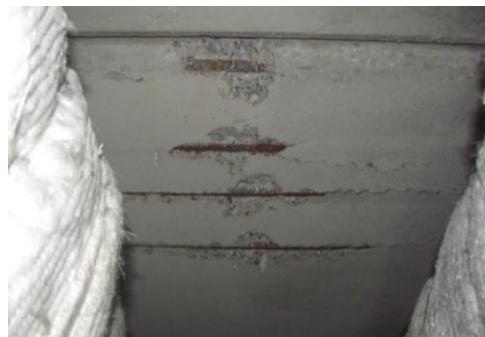
**Fig. 5.** Roof structure's fragment in axes "1"- "2" "D"- "E"

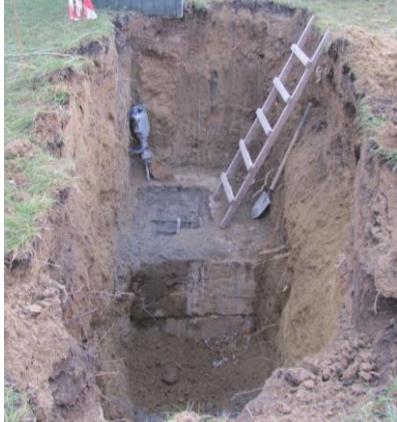
The monolithic component of the roof (slabs and crossbars) was determined by digging with the removal of the soil embankment (Fig. 6). The height of the soil backfill is 2 m. The thickness of the precast concrete roof is 550 mm. The thickness of asphalt concrete is 35-45 mm. The height from the floor level to the bottom of the slabs is 3 m. Walls are made of blocks with monolithic reinforced concrete inclusions.

Fig. 6. The embankment removals above the shelter roof at the intersection of axes "2"- "E"

The crossbars and slabs from the middle of the premises are precast, with reinforcement outlets into the monolithic reinforced concrete part of the slab. The total thickness is not less than 550 mm. The transition line from precast to monolithic reinforced concrete in the shelter roof was difficult to determine. The study site was always filled with water, which was accumulated under a waterproofing layer of asphalt concrete (its thickness is 35-45 mm) and moved to the opening site (Fig. 6).

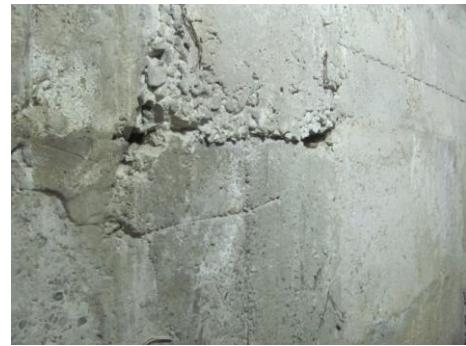
The external walls of the shelter of axes "1"- "6" "A"- "E" are precast monolithic (Fig. 7). They include typical precast concrete blocks (600 x 600 x 2400 mm) and monolithic reinforced concrete inclusions. The width of these inclusions is at least 600 mm. These inclusions are reinforced with six longitudinal rods connected by transverse reinforcement. Monolithic reinforced

Fig. 7. External wall's fragment of the "E" axis

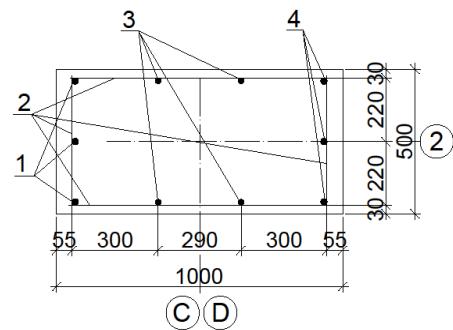
The number and diameter of the column reinforcement were checked by mechanical opening using a perforator. The shelter was operational during the study, so the number of mechanical openings was limited. The longitudinal reinforcement bars were fixed at the intersection of the axes "2"- "C". There are 10 pieces in total. The column reinforcement is symmetrical. Four middle reinforcement rods were Ø20 class AII (A300C), and six extreme reinforcement rods were Ø22 class AIII (A400C) (Fig. 8, Fig. 9).

Fig. 8. Column reinforcement at the intersection of axes "2"- "C" and "2"- "D": for column "2"- "C": 1, 4 - Ø22 AIII (A400C), 3 - Ø20 AII (A300C); for column "2"- "D": 1, 3, 4 - Ø20 AII (A300C), 2 - Ø8 AII (A240C) spacing of reinforcement is 300 mm

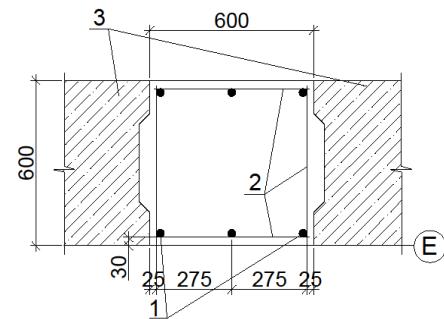
An external wall comprised reinforced concrete foundation blocks FB 24-6 and monolithic reinforced concrete inserts. The dimensions of these inserts are 600 x 600 mm (Fig. 10, Fig. 11).

The blocks are installed one above the other to the entire height of the wall. The reinforced concrete inserts are arranged in the gaps between the blocks. The reinforcement of the monolithic insert is symmetrical (6Ø25 AII (A300C)). The total reinforcement area is  $29.45 \text{ cm}^2$ . The transverse reinforcement is Ø10 AII (A300C). The reinforcement spacing is 300 mm. The concrete grade of the monolithic insert is C20/25, and the calculated concrete compressive strength is  $f_{cd} = 14.5 \text{ MPa}$ .

**Fig. 10.** Construction and reinforcement of the external wall of axis "E":  
1 - Ø25 AII (A300S),  
2 - Ø10 AII (A300C), reinforcement spacing is 300 mm;  
3 - precast foundation concrete blocks FBL 24.6.6-t

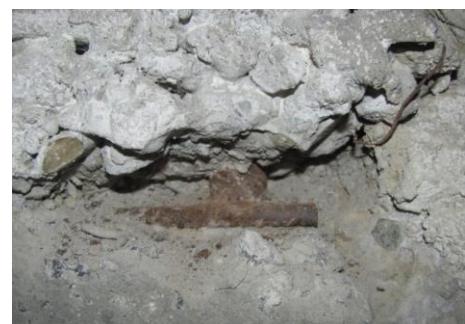
**Fig. 11.** Disclosure of the external wall at the intersection of axes "2"- "E" (general view of the longitudinal rod Ø25 AII (A300C) and transverse reinforcement Ø10 AII (A300C))

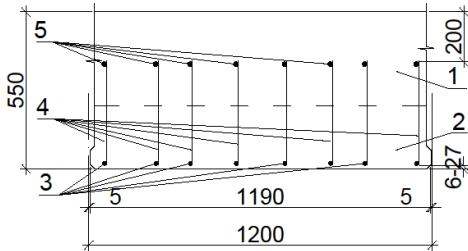
Fig. 12. Construction and reinforcement of a slab (its width is 1200 mm):

- 1 - monolithic reinforced concrete,
- 2 - precast reinforced concrete;
- 3 - Ø28AIII (A400C) or Ø22 AII (A300C);
- 4 - Ø7AI (A240C);
- 5 - Ø12AIII (A400C)

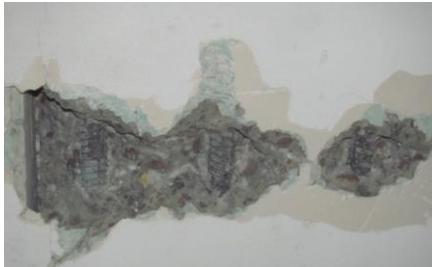
Fig. 13. Disclosure of a precast slab 1200 mm wide (a general view of three longitudinal rods Ø28 AIII (A400C))

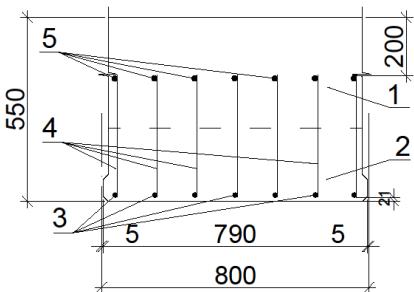
Fig. 14. Construction and reinforcement of a slab (its width is 800 mm):

- 1- monolithic reinforced concrete,
- 2 - precast reinforced concrete;
- 3 - Ø22AII (A300C);
- 4 - Ø7AI (A240C);
- 5 - Ø12AIII (A400C)

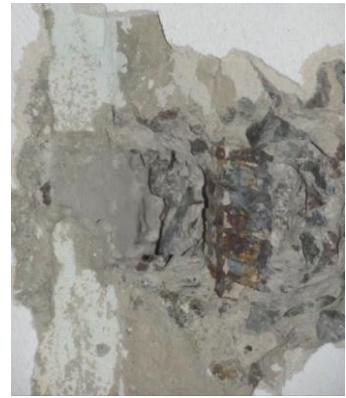
Fig. 15. Disclosure of a precast slab 800 mm wide

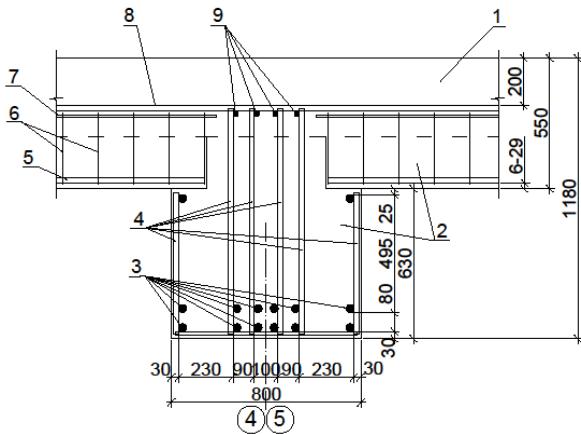
The longitudinal reinforcement for the crossbar between axes "D" and "E" along axis "3" and between axes "B" and "C" along axis "2" was determined through ultrasonic study and mechanical opening. Their number was 12 pieces. The reinforcement is symmetrical. The six rods Ø 32AIII (A400C) were arranged in two rows. The distance between the rods is 80 mm in height (see Fig. 16 and Fig. 17). The total area of the longitudinal tensile reinforcement is  $96.5 \text{ cm}^2$ . The protective layer of concrete for the longitudinal reinforcement is 30 mm. Transverse reinforcement was Ø 22AIII (A400C). Flat welded frames were also used. The reinforcement spacing is 300 mm, while it is 150 mm near the supports (Fig. 16 and Fig. 17). In a study of a monolithic reinforced concrete slab, the soil embankment was removed. The transverse reinforcement of the crossbar was determined as Ø18AIII (A400C) with a consistent spacing. The longitudinal compressed reinforcement of the crossbar was of Ø18AIII (A400C). The supporting connecting reinforcement of the monolithic roof slab is Ø25AIII (A300C).

**Fig. 16.** Construction and reinforcement of the crossbar and the roof slab:

1 - monolithic reinforced concrete,

2 - precast reinforced concrete;

3 - 12Ø32AIII (A400C);

4 - Ø22AIII (A400C) or Ø18AIII (A400C) (its reinforcement spacing is 300 mm and near the supports its reinforcement spacing is 150 mm);

5 - Ø28AIII (A400C) or Ø22AII (A300C);

6 - Ø7AI (A240C);

7 - Ø12AIIII(A400C);

8 - Ø25AII (A300C);

9 - Ø18AIIII (A400C)

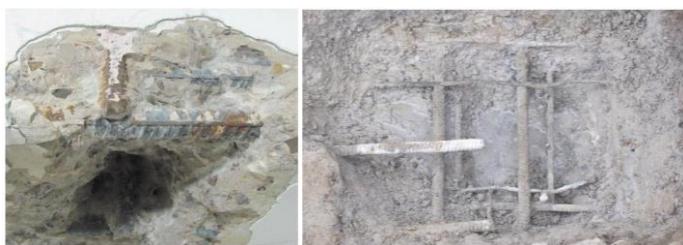
**Fig. 17.** Disclosure of the crossbar from the shelter room and mechanical opening of the monolithic section of the roof (extreme longitudinal reinforcement is 2Ø32 AIII (A400C), transverse reinforcement is Ø22 AIII (A400C))

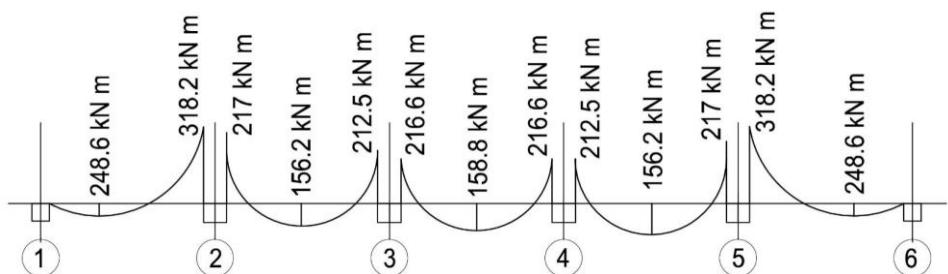
We conducted a static analysis of a multi-span roof slab using a continuous calculation scheme, which yielded the external bending moment values (Fig. 18 and Fig. 19).

**Fig. 18.** External bending moment diagrams from the first loading option  
(load from own weight and backfilling with soil and useful load are  $60 \text{ kN/m}^2$ )

The averaged (redistributed) moments in the extreme spans of the slab of the axes "1"- "2" "A"- "E" and "5"- "6" "A"- "E" for the first loading option is

$$M_{ks} = \frac{248.6 + 318.2}{2} = 283.4 \text{ kN} \cdot \text{m},$$

The averaged (redistributed) moments in the middle spans of the slab of the axes "2"- "3", "3"- "4", "4"- "5" "A"- "E" for the first loading variant is

$$M_{cc} = \frac{217 + 215.5 + 156.2}{3} = 195.1 \text{ kN} \cdot \text{m},$$

Based on these considerations, precast slabs with different cross-sectional areas of longitudinal tension reinforcement must be provided in the precast monolithic roof for both middle and extreme spans.

For the extreme (first) spans of axes "1"- "2" "A"- "E", and "5"- "6" "A"- "E", the area of working tensile reinforcement should be bigger. The area of working tensile reinforcement for all middle spans must be smaller.

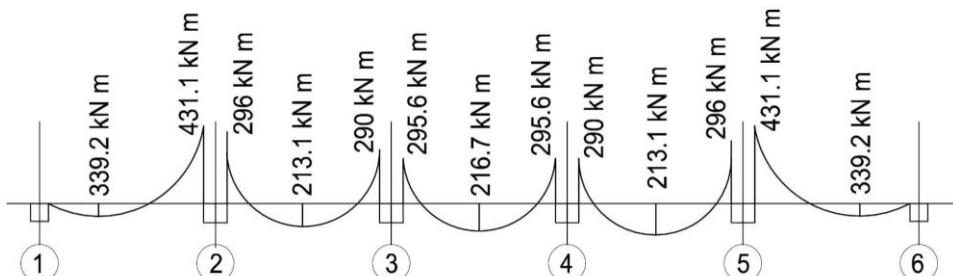
**Fig. 19.** External bending moment diagrams from the second loading option  
(load from own weight and backfilling with soil and useful load are  $100 \text{ kN/m}^2$ )

and for the second option is

$$M_{ks} = \frac{339.2 + 431.1}{2} = 385.2 \text{ kN} \cdot \text{m}.$$

$$M_{cc} = \frac{296 + 290 + 213.1}{3} = 266.4 \text{ kN} \cdot \text{m}.$$
