Numerical modeling for slope stability analysis: a case study of the landslide on RN12 at PK 119+000, Adegar, Béjaïa, Algeria

Badreddine Bousbia^{1,*}, Kamel Goudjil²

Abstract:

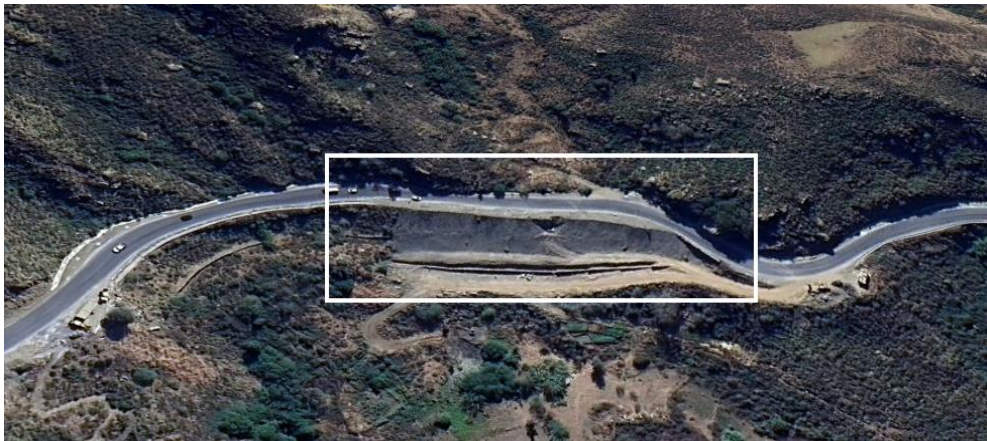
The site investigated in this study is located in the municipality of Adekar (Béjaïa Province, Algeria) at PK 119+000 within the Djurdjura Mountain range. It is situated along National Road RN12, which connects the provinces of Béjaïa and Tizi Ouzou. The geographic location of the research site is illustrated via satellite imagery in Fig. 1. The site's coordinates are 36°43'31.91" N, 4°36'59.48" E, at an elevation of 3,177 ft.

Fig. 1. Satellite image (Google Earth) of geographical location of the landslide site

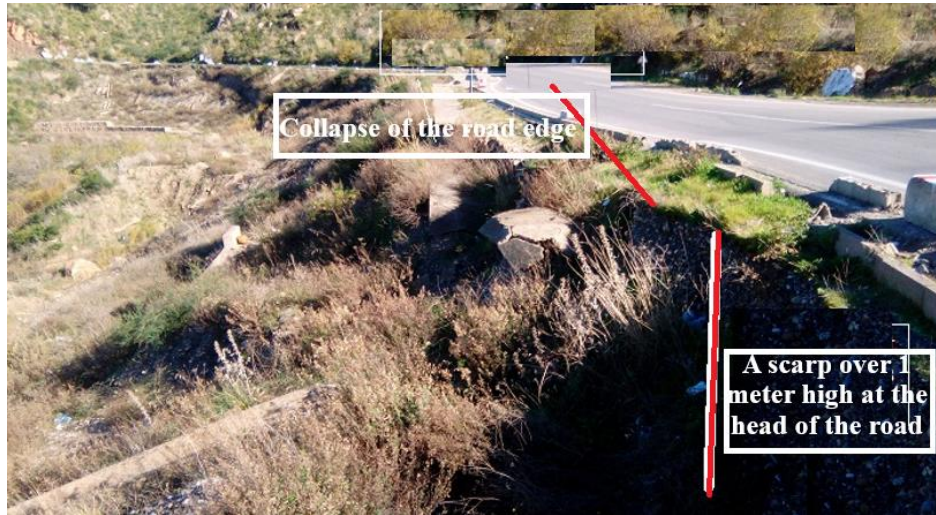
Fig. 4. Shoulder collapse and embankment failure along the roadway

- Rupture of half of the roadway over a 50-meter stretch due to the landslide movement;
- Complete detachment and loss of the roadside shoulder;
- Collapse of the culvert and drainage structures on the lower part of the slope.

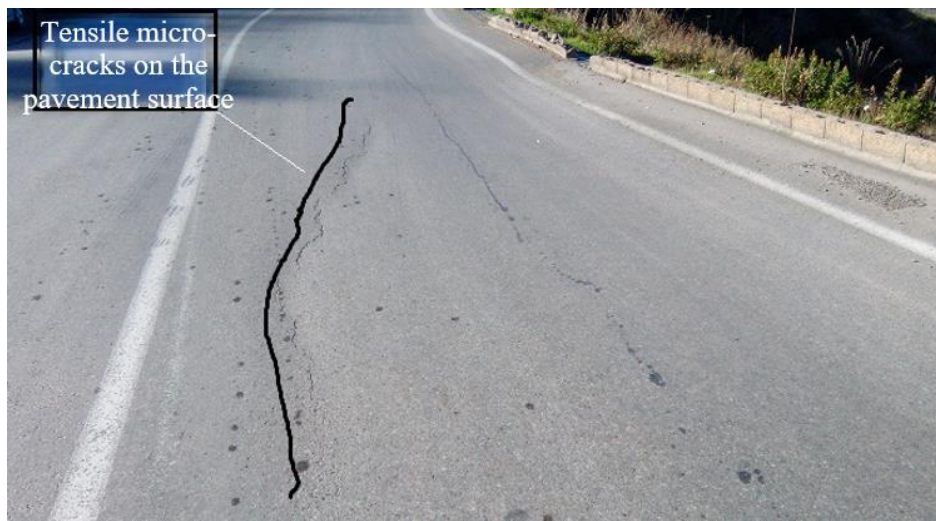
Fig. 5. Tensile microcracks along the pavement surface

The investigated area extends over approximately 200 meters along the down slope section of the roadway (Fig. 3). The landslide is characterized by the development of a well-defined rupture surface along which mass displacements have occurred, indicating a large-scale failure in terms of mobilized volume. The slope instability is predominantly manifested at the lower part of the embankment, where a scarp approximately 1 meter high has formed at the road edge, accompanied by accumulation ridges (bulges) at the toe of the down slope embankment (Fig. 4). Additionally, tensile cracks of oblique orientation have developed along the pavement over a stretch of approximately 60 meters (Fig. 5), with variable aperture widths ranging from 1 to 2 cm. The affected road section exhibits a cut-and-fill profile, with a significant elevation difference between the road level and the toe of the slope, reaching up to 18 meters in height. The critical slope angle is estimated to be between 35° and 40°, with a maximum vertical displacement observed at 4.2 meters (Fig. 3). Visible distress and structural damage were recorded along the affected segment of the roadway, particularly at the toe of the embankment, indicating ongoing instability processes (Fig. 6). Notable observations include:

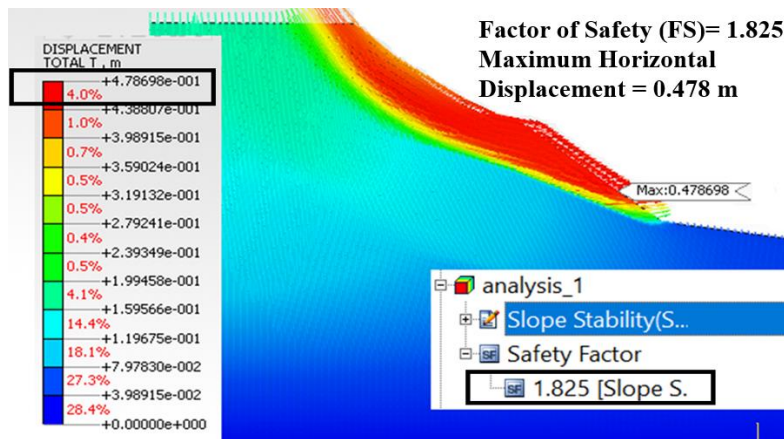
Fig. 8. Total displacement and factor of safety under natural slope conditions

state. The results, shown in Fig. 8, indicate that vertical displacements remain limited under gravity loading alone, with a calculated Factor of Safety (FOS) of 1.86. This value suggests a marginally stable slope in its natural state, implying that additional external loads or adverse environmental conditions could significantly reduce stability.

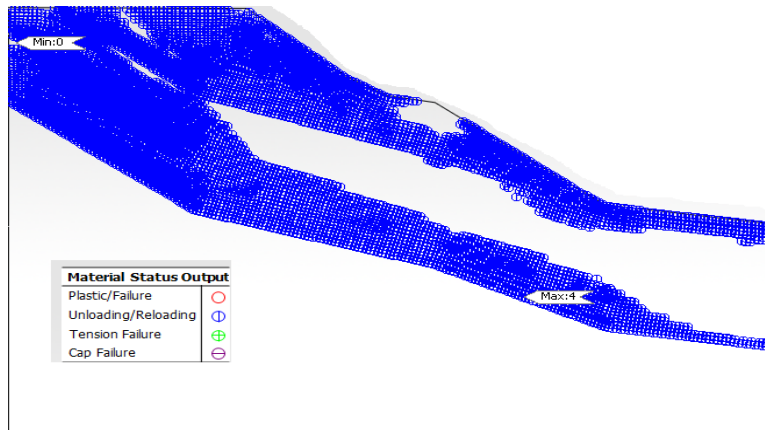
Fig. 9. Plastic point distribution and potential failure surface (Phase 1)

Figure 9 illustrates the distribution of plastic deformation zones within the slope under natural loading conditions, revealing localized plastic points mainly concentrated near the slope toe. These zones suggest the initiation of shear deformation along a potential slip path; however, no continuous failure surface is observed. The computed safety factor of approximately 1.85 confirms that the slope remains globally stable under self-weight conditions. The limited and non-progressive nature of the plastic deformations indicates that the slope exhibits adequate

resistance to gravitational forces in the absence of external surcharges. Overall, the results demonstrate that, although the slope is close to a critical state, its stability is maintained under natural conditions.

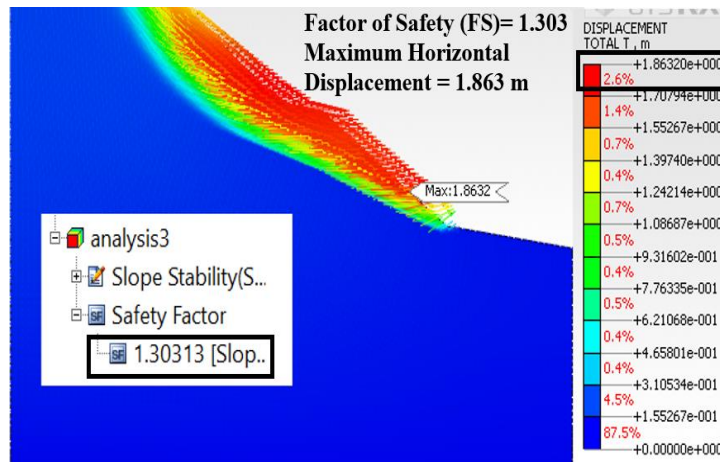
Fig. 11. Computed factor of safety for the slope under traffic surcharge (Phase 2)

In the second phase of the simulation, a uniform vehicular traffic surcharge of 37.14 kN/m² was applied to the roadway platform (Fig. 10). The results (Fig. 11) show that the traffic load significantly affects the slope's behavior, reducing the Factor of Safety from 1.82 under natural conditions to 1.303. This indicates a notable decrease in stability and highlights the critical impact of external loading on the slope.

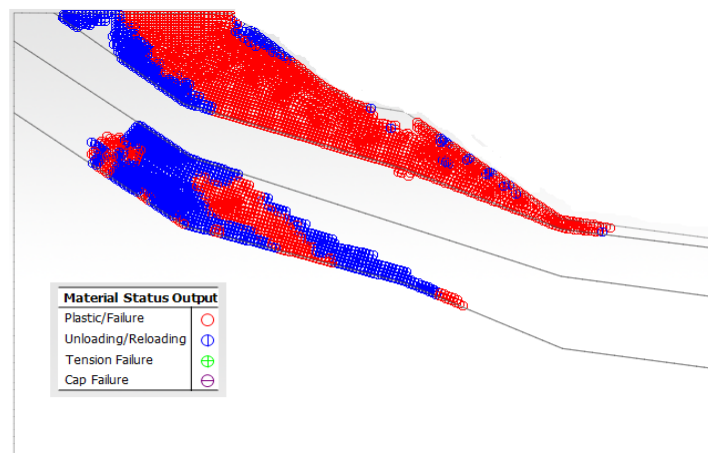
Fig. 12. Plastic point distribution and failure plane under traffic load

Fig. 13. Equivalent plastic strain under plane strain conditions

Figures 12 and 13 illustrate the development of plastic deformation within the slope under traffic-induced loading. The emergence of a well-defined failure plane and the concentration of plastic points along preferential shear zones indicate a progressive reduction in shear strength and a decrease in slope

stability. These visualizations highlight potential instability zones and demonstrate how external loading redistributes stresses, supporting the observed reduction in the Factor of Safety in Phase 2.

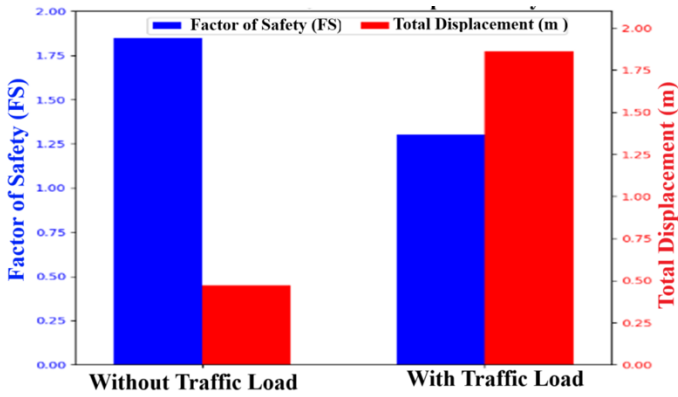
Fig. 14. Effect of traffic load on slope stability

The comparison of the two simulation phases highlights the slope's high sensitivity to external loading. Under self-weight (Phase 1), the slope is relatively stable, with a maximum vertical displacement of 0.47 m and a Factor of Safety of 1.82. Introducing the vehicular surcharge (Phase 2) reduces the Factor of Safety to 1.303, indicating a critical approach to failure. These

results demonstrate the significant destabilizing effect of traffic loads, especially in layered or weathered soils, and emphasize the importance of considering live loads in slope stability assessments. Static analysis alone may underestimate real-world behavior, justifying the use of reinforced stabilization measures (Fig. 14)

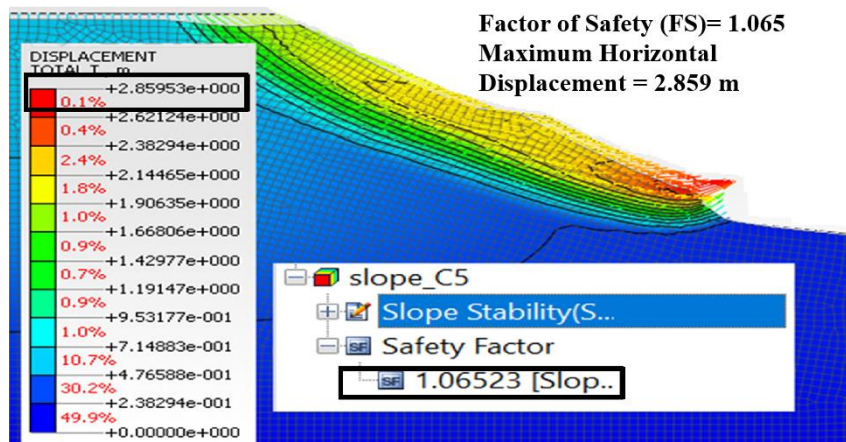
Fig. 17. Total displacement and computed safety factor for the case ($C = 5$ kPa, $\phi = 25^\circ$)

The results illustrated in Fig. 17 correspond to the scenario with low soil cohesion ($C = 5$ kPa) and an internal friction angle of 25° . The numerical simulation yields a Factor of Safety (FS) of 1.065, which approaches the critical threshold of instability.

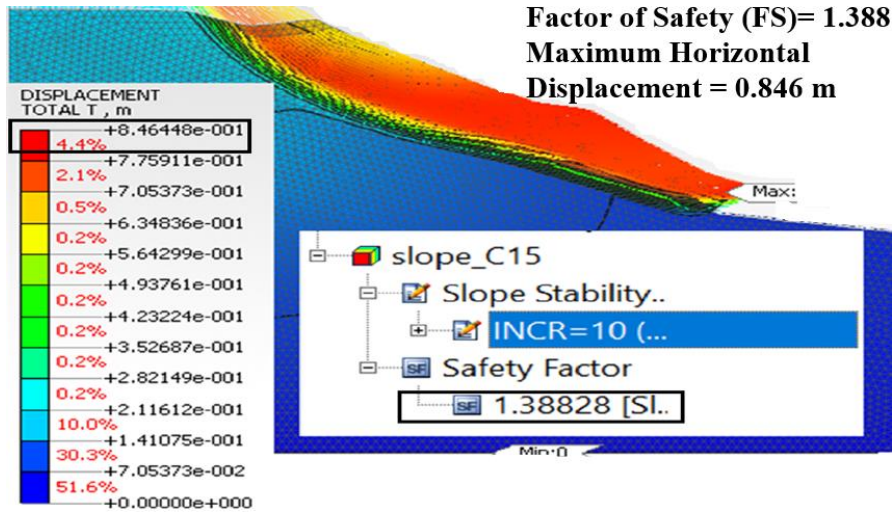
Fig. 19. Total displacement and safety factor values for the case ($C = 15 \text{ kPa}$, $\phi = 25^\circ$)

The parametric analysis conducted on four slope configurations differing solely in the cohesion value ($c = 5, 10, 15,$ and 20 kPa) with a constant internal friction angle ($\phi = 25^\circ$) has provided valuable insights into the influence of soil cohesion on slope behavior under static surcharge loading (Fig. 10). Figure 21 illustrates the evolution of total displacement and the corresponding Factor of Safety (FS) across the analyzed cases. The results demonstrate a consistent enhancement in global stability as cohesion increases. For the lowest cohesion value ($c = 5$ kPa), the slope exhibited critical performance, with a maximum displacement exceeding 0.84 m and an FS of 1.293, indicating proximity to failure conditions. As cohesion increased to 10 and 15 kPa, displacement values were reduced to 0.76 m and 0.65 m respectively, while the FS improved to 1.365 and 1.388, reflecting gradual stabilization. The case with the highest cohesion ($c = 20$ kPa) achieved the best performance, with a relatively lower maximum displacement of 0.732 m and an FS of 1.465.

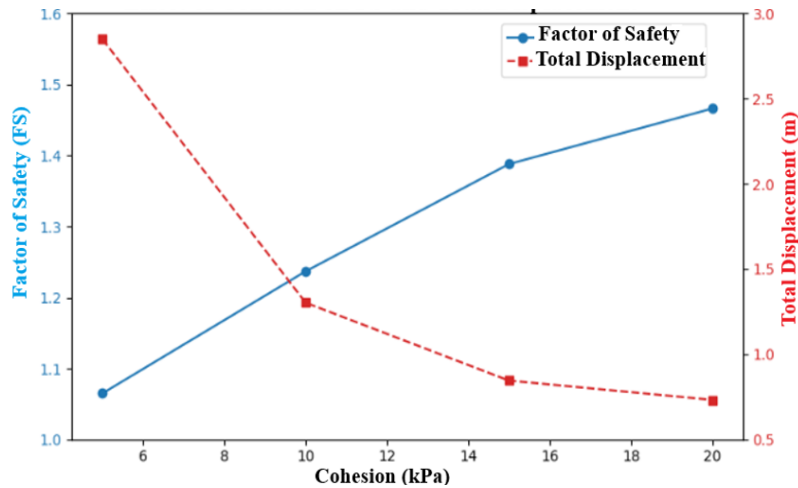
Fig. 21. Effect of cohesion on FS and total displacement

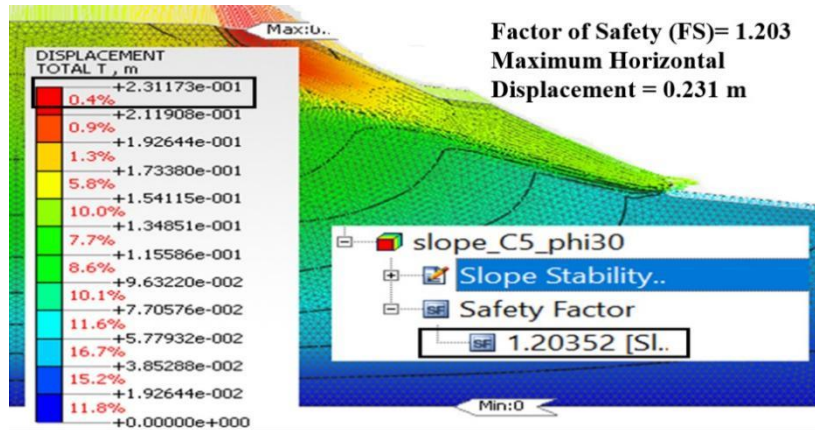
Fig. 22. Total displacement and safety factor values for the case ($C = 5$ kPa, $\phi = 30^{\circ}$)

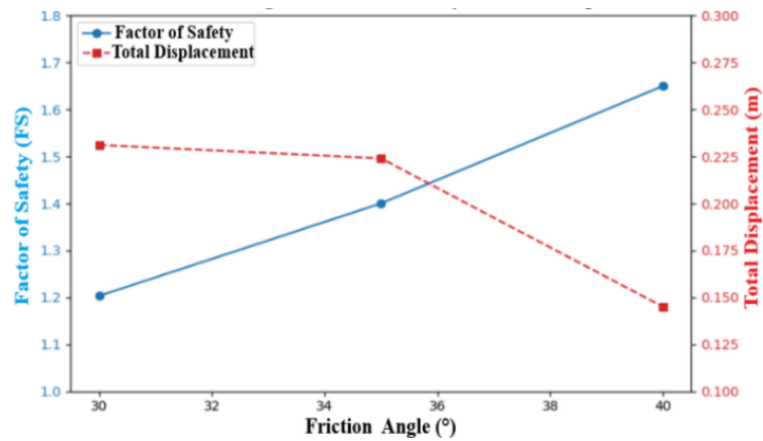
Fig. 25. Effect of friction angle on factor of safety and total displacement

Figure 25 presents the influence of the internal friction angle (ϕ) on the Factor of Safety (FS) of embankments modeled with a constant cohesion of 5 kPa under linear surcharge loading. A clear positive correlation is observed between increasing ϕ and

the FS, while displacement shows a monotonic decrease. Specifically, as ϕ increases from 30° to 40° , the FS improves significantly from 1.203 to 1.650, while the corresponding total displacement declines from 0.2311 m to 0.145 m. This trend underscores the dominant role of frictional resistance in enhancing global slope stability and minimizing deformation, reaffirming the importance of precise geotechnical characterization for safe and efficient design.
