## Seismic vulnerability and dynamic response of the minaret of Sidi M'hammed Cherif Mosque: insights from a detailed finite element model

This study presents a seismic assessment of a historic masonry minaret in Algeria using an integrated workflow combining Terrestrial Laser Scanning (TLS) and Finite Element Analysis (FEA). The research focuses on the minaret of the Sidi M'hammed Cherif Mosque, located in the UNESCO-listed Kasbah of Algiers, an architecturally significant structure whose dynamic behaviour and seismic vulnerability had not been quantified despite ongoing restoration initiatives. Although Algeria is exposed to a considerable seismic hazard, the seismic performance of historic masonry structures remains largely unexplored, with only a limited body of research addressing this critical issue. In contrast to the extensive literature on Turkish and Egyptian minarets, research addressing seismic assessment in the Algerian and Maghreb contexts remains scarce. We developed a restoration-oriented methodology that evaluates seismic response by combining high-resolution TLS surveys, in-situ material characterisation, and detailed finite-element modelling. Linear static, moda

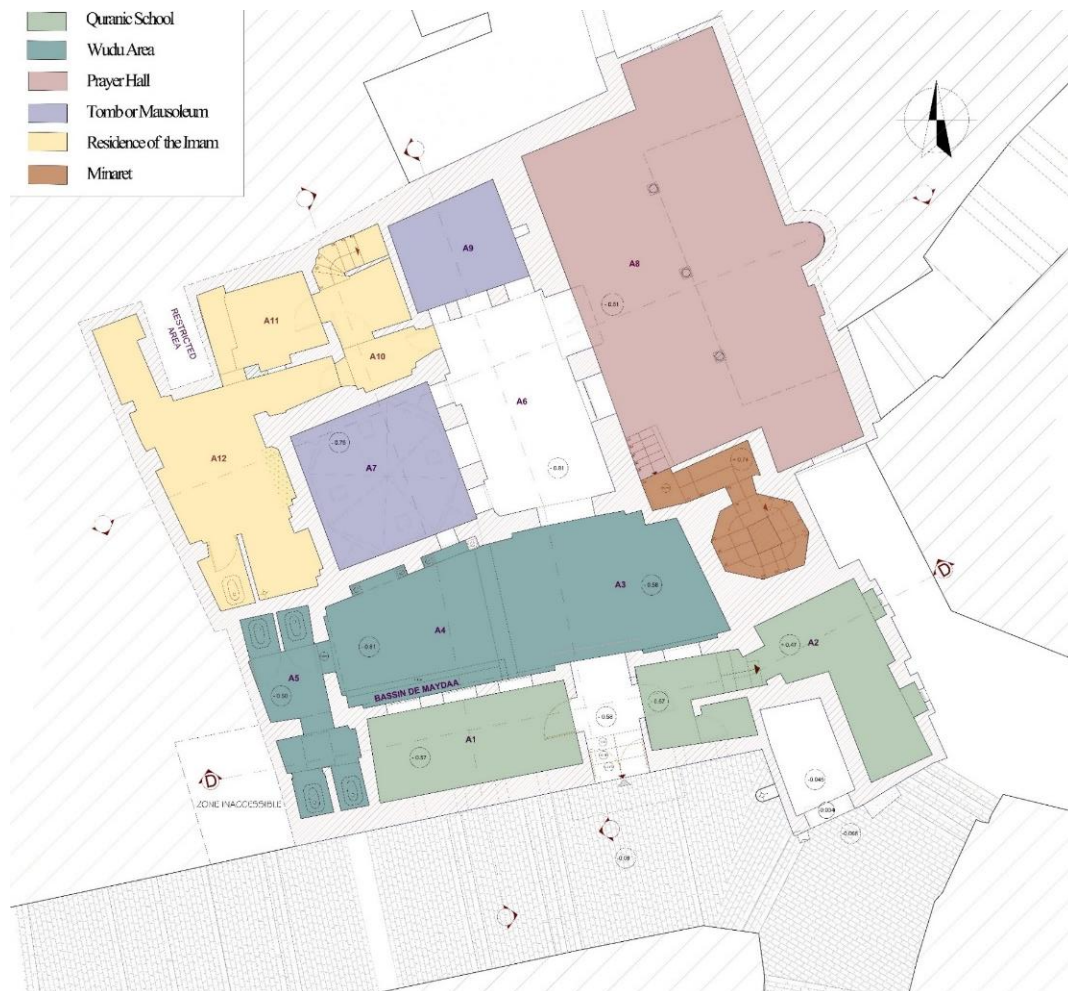
Fig. 4. Plan of the Sidi M'hammed Cherif Mosque, source: the authors, 2018

The mosque follows a restrained and harmoniously ordered plan (Fig. 4), centred on a rectangular prayer hall divided into two parallel naves by a colonnade supporting semicircular arches and articulated into three bays. The entire structure is covered by a flat roof made of thuya beams and compacted earth. The mihrab, embedded in the qibla wall, features discreet ornamentation consistent with the overall sobriety of the interior and is crowned by a richly decorated stucco half-dome.

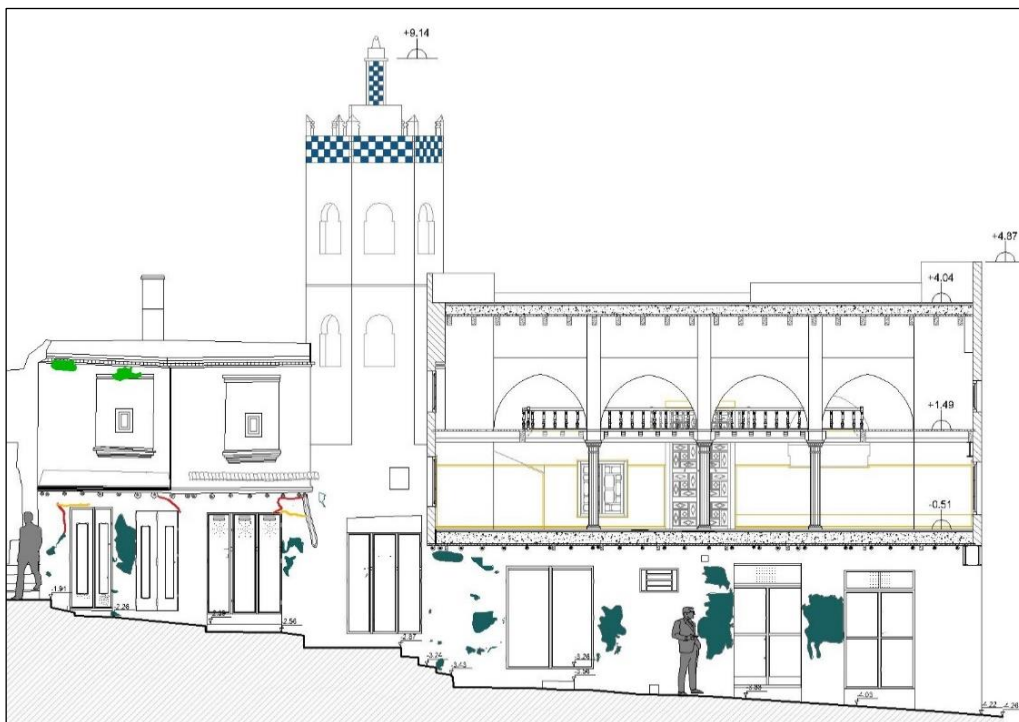
**Fig. 7.** Recorded deteriorations in the prayer hall and basement shops, source: the authors, 2018

On-site inspections revealed multiple structural pathologies affecting various components of the complex. External renders are partially detached or eroded, exposing the underlying masonry. Vertical and diagonal cracks (Fig. 6 and Fig. 7), generally superficial but occasionally structurally significant, are visible on the main façades, particularly in the lower sections that formerly housed ancillary spaces. Paint layers are flaking, and

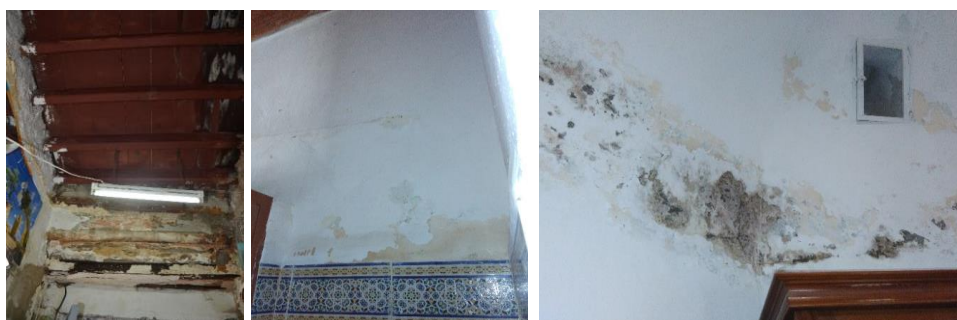
**Fig. 8.** Moisture-related deterioration inside the building (plaster removed), source: the authors, 2018

the combined effects of rising damp and water infiltration have caused significant deterioration of surface finishes (Fig. 8).

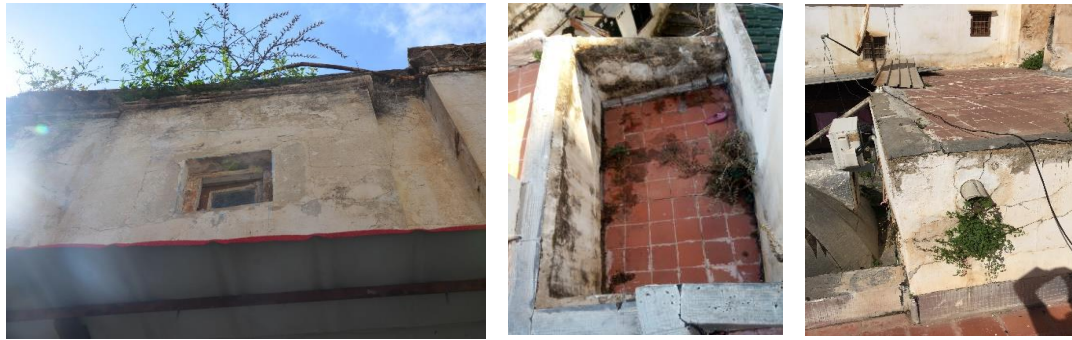
**Fig. 9.** Vegetation growing on the façades and at the terrace level, source: the authors, 2018

At terrace level, decay includes detachment of tiles, blistering of surface coatings, appearance of vegetation within cracks and above lintels, and mortar disintegration (Fig. 9). These disorders are compounded by previous inappropriate interventions using incompatible modern materials such as cement and reinforced concrete, notably in the madrasa annexes and the imam's residence, which introduce additional mechanical stresses and exacerbate crack propagation (Fig. 10 and Fig. 11)

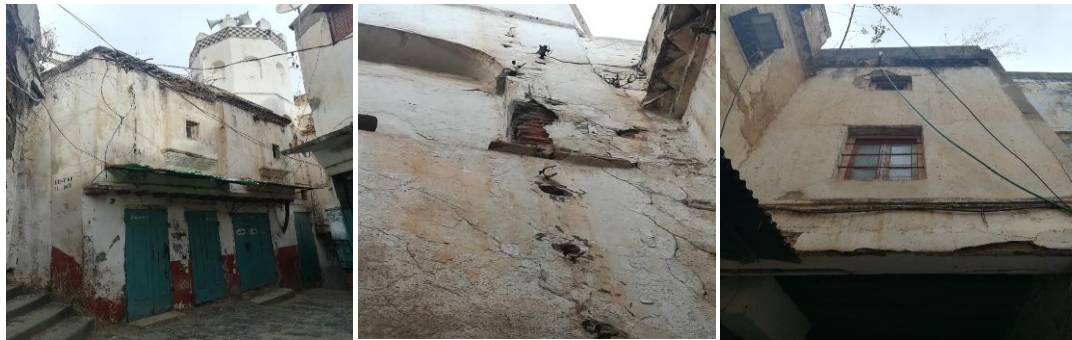
**Fig. 10.** Cracks and structural damage observed on the exterior of the mosque, on the minaret and prayer hall sides, source: the authors, 2018

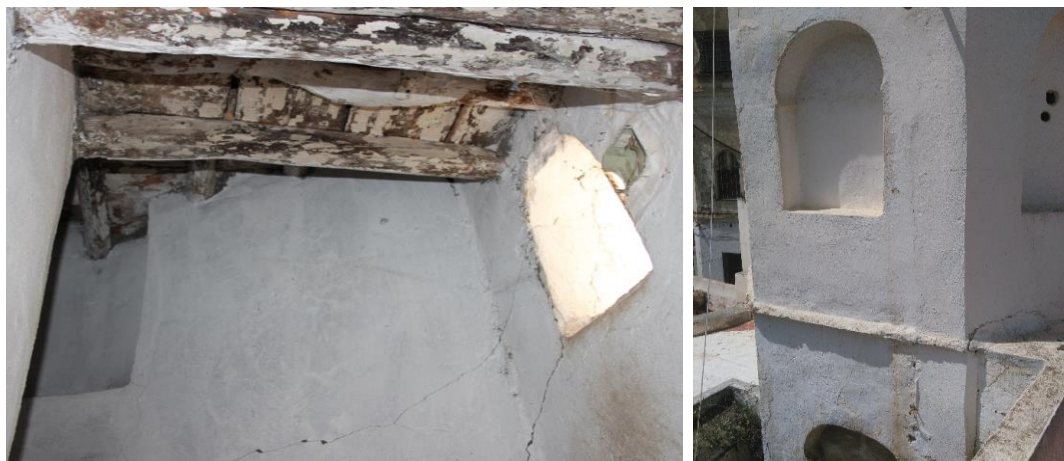
**Fig. 11.** Cracks recorded on the exterior and interior of the minaret, source: the authors, 2018

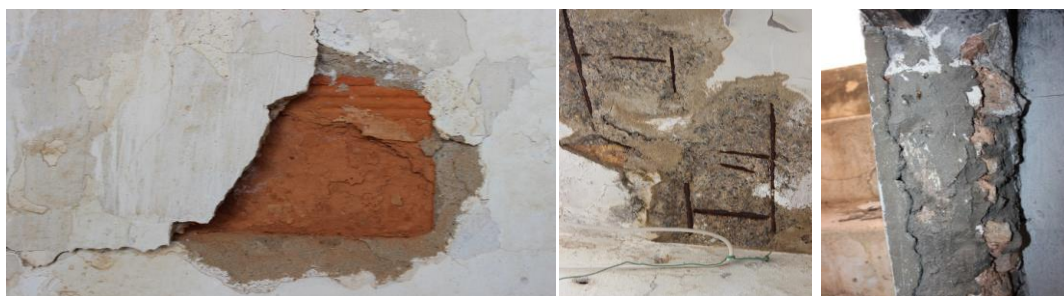
**Fig. 12.** Incompatible materials used to patch cracks and other defects in the mosque, source: the authors, 2018

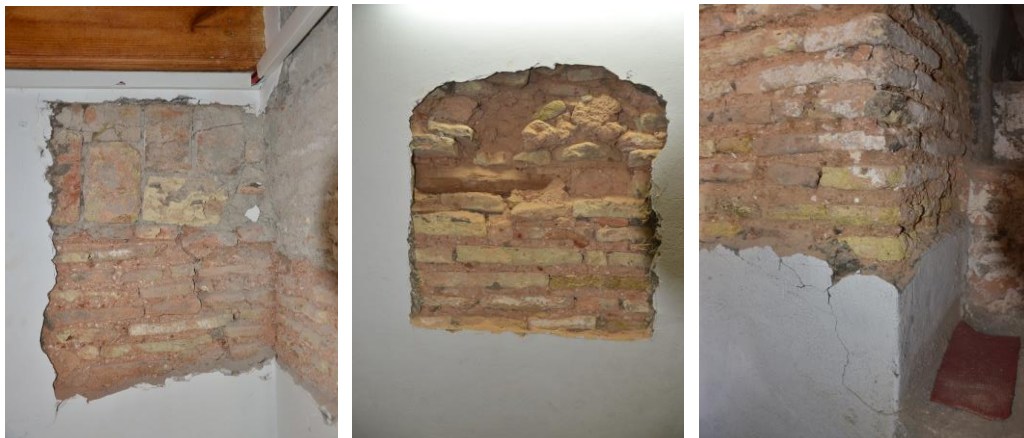
**Fig. 16.** Masonry of one of the walls of the Qur'anic school and the basement Shops, source: the authors, 2018

Accurately defining material properties and boundary conditions is essential for developing reliable finite element models. The construction system of the Sidi M'hammed Cherif Mosque, typical of Ottoman-period architecture in the Kasbah of Algiers, was identified through on-site observations and previous studies of similar buildings [48]. The load-bearing walls are composed of traditional rubble masonry made of fired bricks bonded with lime mortar. In structurally sensitive areas, such as corners and highly loaded zones, horizontal ashlar blocks are used to improve structural cohesion and enhance resistance to lateral forces, as illustrated in Fig. 16.
