USE OF THERMAL IMAGING IN CONSTRUCTION

Danuta Proszak-Miąsik

Rzeszów University of Technology, The Faculty of Civil and Environmental Engineering and Architecture/Department of Heat Engineering and Air Conditioning

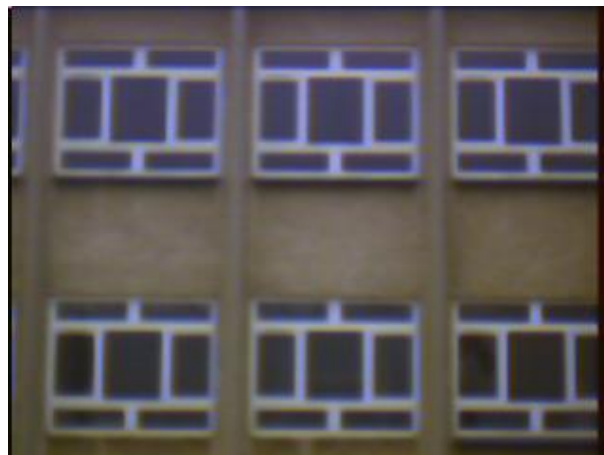
Fig. 1. A fragment of a wall of a thermal upgrading building (before thermal upgrading)

Measurements were made for the thermomodernized facility of the Rzeszów University of Technology. The measurements were carried out on 31 January after sunset (after midnight - the previous cloudy day) and a year later on 14 February, in similar weather conditions. The photos (Fig. 1–2) show a selected fragment of the building K, Rzeszów University of Technology at Powstańców Warszawy Street. The measurements were taken before and after the thermal modernization of the building. The obtained thermograms were corrected due to the emission of windows and the surface of external walls. The correct ambient temperature has also been taken into account. Thermograms were performed (depending on the terrain possibilities) from a distance of 10 m.

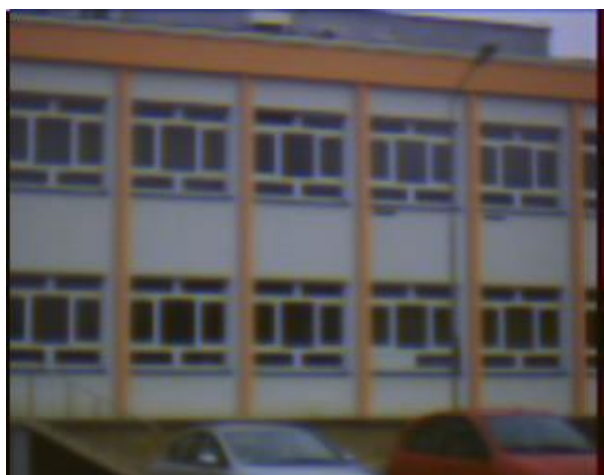
Fig. 2. A fragment of a wall of a thermal upgrading building (after thermal upgrading)

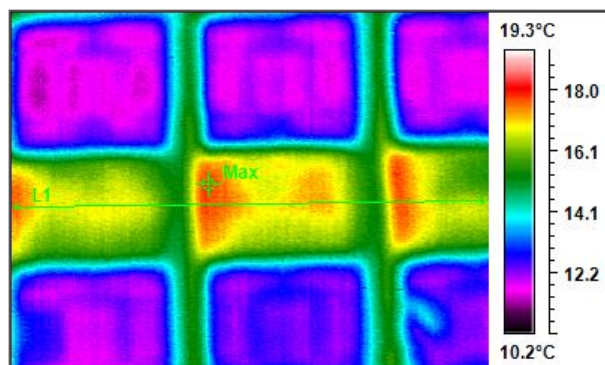
Fig. 3. Thermographic image of a selected fragment of the partition before thermal upgrading

As can be seen in Fig. 3-4, the average temperature of the wall between windows at the temperature outside -6°C is 17.7°C , max. temp. 19°C and min. 15.8°C . After insulating the wall with 8 cm layer of polystyrene foam, the partition temperatures decreased in the same place during similar weather conditions (Fig. 5-6). The average temperature was 10.6°C , maximum 11.2°C and minimum 10.5°C . The heat losses through the walls decreased. The partition image became almost homogeneous. The assumed effect was obtained.

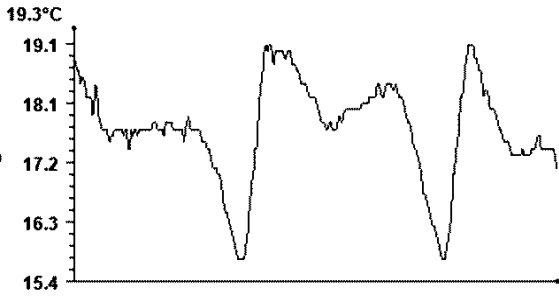
Fig. 4. Temperature linear profile

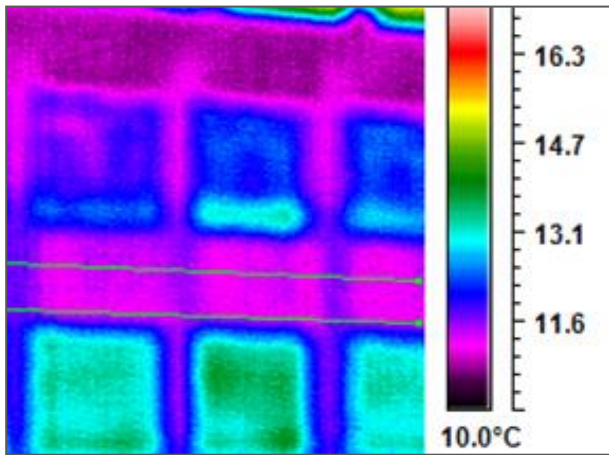
Fig. 5. Thermographic image of a selected fragment of the partition after thermal upgrading

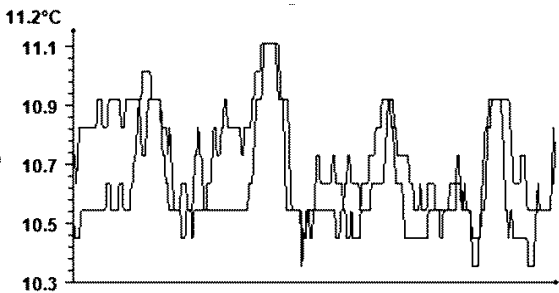
Fig. 6. Temperature linear profile

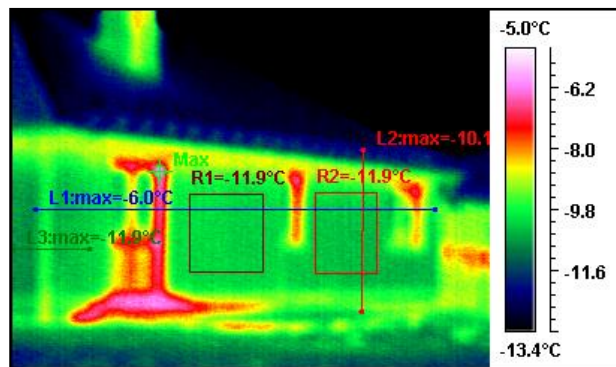
Fig. 8. Thermal imaging

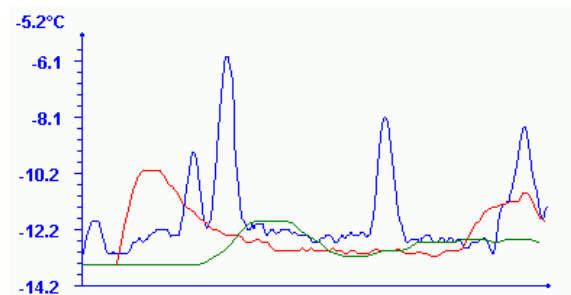
Fig. 9. Temperature linear profile

The temperature linear profile (Fig. 9) shows that there is an increase in temperature at the connection of the roof with the external wall, and at the connection of the external wall with the foundation (red line), at the corner (green line), losses at windows and balcony (blue line).

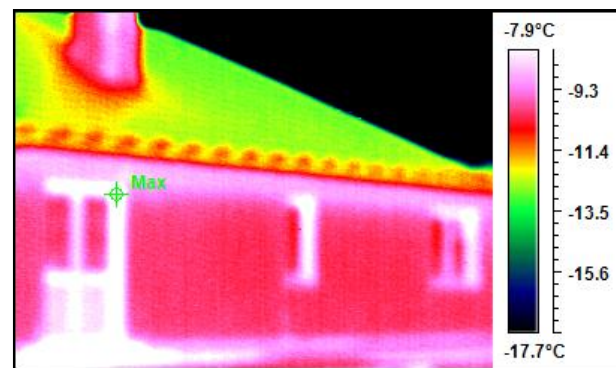
Fig. 10. Thermal imaging

Fig. 10 shows intensive thermal bridges at window and door lintels and thermal bridges at the connection of the wall with the foundation and the roof. A higher temperature at the roof (about 2°C higher than the elevation temperature) is also a result of warm shade (surfaces shielded from the radiation influence of the cold sky). The setting of the balcony is not very effective in terms of thermal insulation.

Higher temperature of the upper part of window openings (at lintels) is also influenced by two phenomena: the phenomenon

of warm shade and the accumulation of warmer air (which is why the upper edges of window openings are warmer, first of all). The windows themselves, on the basis of thermograms analysis, perform relatively well.

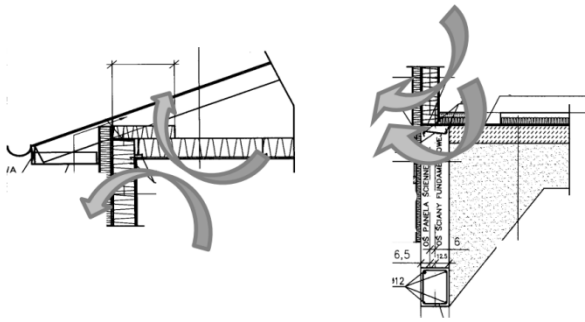
Fig. 11. Details of the connection: a) walls with a roof b) walls, foundations and floors

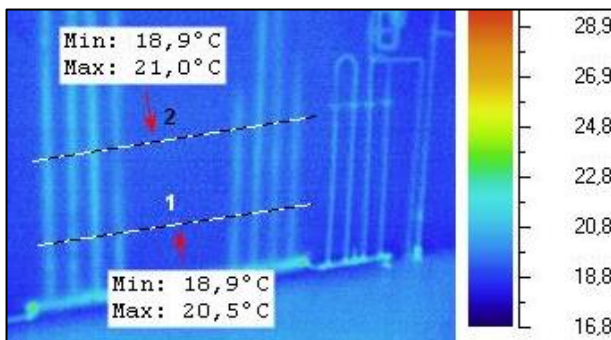
Fig. 12. Thermal imaging of heat pipes

Thanks to thermal imaging we can easily check and locate wires and pipes under the surface. On the photo (Fig. 12) there is a preview of the wall in which heat pipes are installed. Heat pipes are filled with low boiling liquid, which heats up from the heating medium flowing in the lower part of the pipes and changes its state of concentration to steam. The steam rises upwards and releases heat to the environment and cools and condenses, flowing down the tube and the cycle repeats itself. As you can see (Fig. 12), the middle tube was damaged during assembly, it is not filled with low boiling liquid, so it does not heat up. The linear section (Fig. 13, 14) confirms this.

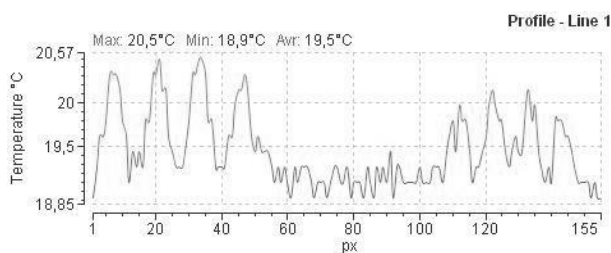
Fig. 13a. Temperature linear profile – profile-line 1

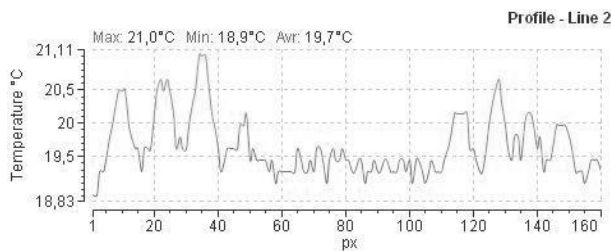
Fig. 13b. Temperature linear profile – profile-line 2

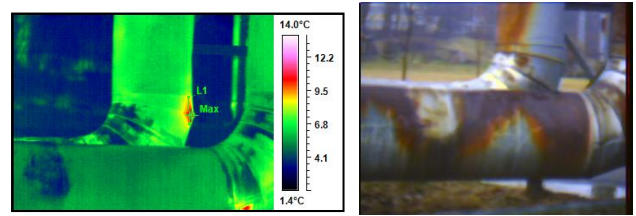
Fig. 14. Temperature distribution on the corroded heat pipe

Another example shows how thermal imaging can be used to locate heat losses on a corroded heat pipe (Fig. 14, 15). As you can see in the visible picture, the heat pipe is strongly corroded. But only the thermovision photo indicated exactly where the largest heat losses are.

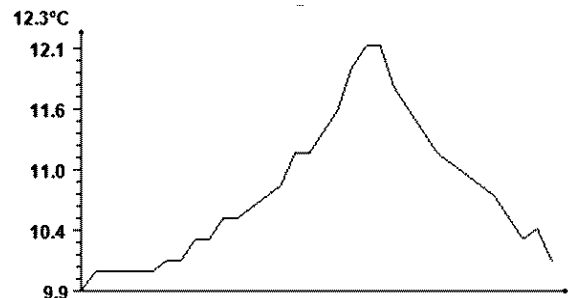
Fig. 15. Temperature linear profile
