THE CONSERVATION-RESTORATION OF ARCHITECTURAL STATUARY IN ACCORDANCE WITH THE ETHICAL REQUIREMENTS FOR SCULPTURE AND ARCHITECTURE

ABSTRACT: Between the conservation-restoration of several disciplines like sculpture and that of architecture differences in the application of the general ethical guidelines exist. Because some “objects” like architectural statuary cannot be classified under one specific discipline this paper attempts to outline the parallels between the applicable disciplines and to point out any inconsistencies, thus encouraging an environment in which the cross-pollination of the principles of a minimal, reversible and stable intervention can thrive and bridging the existing gap between the different fields. Two case studies undertaken by KIK-IRPA Brussels of the treatment of architectural statuary from around 1900 in Brussels are used to illustrate some of these aspects.

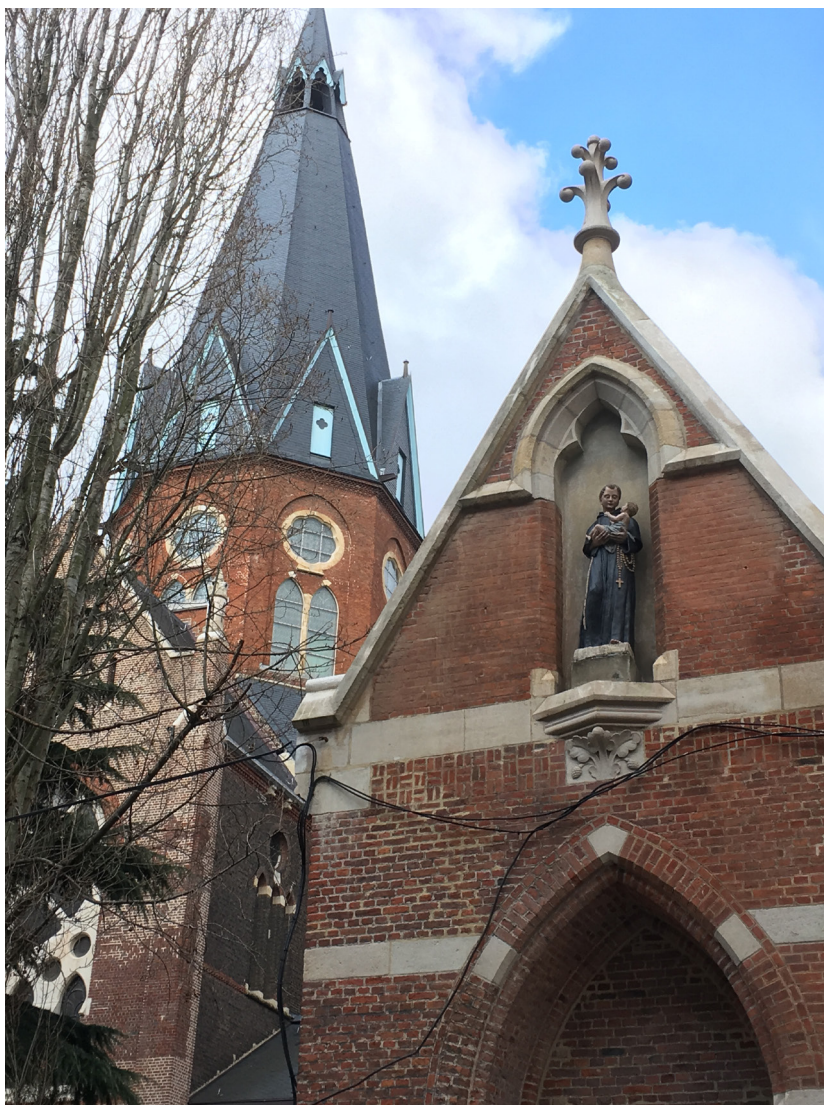
Fig. 2 Statue of Saint Anthony in situ, Georges Houtstont, ca. 1868 (© KIK-IRPA, Brussels, Sam Huysmans). After treatment

After an outdoor exposure of 150 years, the conservation state of the sculpture was problematic. The most badly weathered parts are situated at the bottom of the right arm and at the base. Infiltration

of rainwater and rising damp in combination with frost action provoked a series of small cracks and delamination resulting in material loss. The terracotta surface of the sculpture was largely unprotected as a large part of the paint layer was missing. Stratigraphic investigation however showed that the sculpture was originally finished with a paint layer. The realistic effect of the statue was emphasized by this elaborate polychromy. The soutane resembled black velvet with a yellow-brown rosary and the Infant Jesus wore a light blue loincloth. The original polychromy is well preserved on the flesh tones but largely disappeared on the robes vestments, especially on the front side. The statue was overpainted twice. First in colours similar to the original polychromy and later with a whitish paint layer. The binding media were not fully identified. However, there is evidence that all the paint layers were bound in an oil medium.

It is obvious that the priority of the conservation treatment is to stabilize the terracotta support. The cracks where rainwater could infiltrate were filled and the statue's partly broken base was consolidated. To keep the intervention to a minimum, broken parts that do not have a supporting function such as the monk's sleeve and the Child's limb have not been restored.

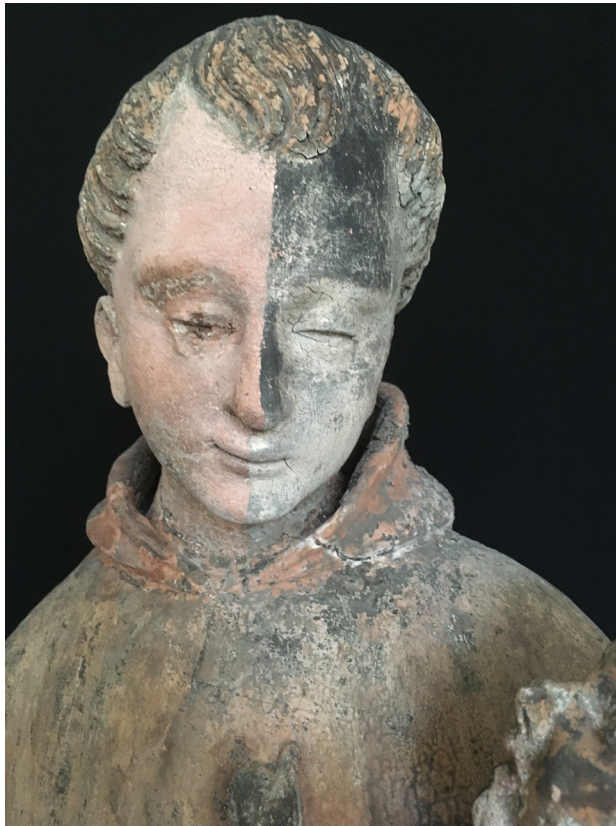
Fig. 3 Statue of Saint Anthony, Georges Houtstont, ca. 1868, polychrome terracotta. The group during the treatment, still covered by greyish overpaint on the right; on the left, the polychromy cleared of the overpaint which weighed down on it (© KIK-IRPA, Brussels, Camille De Clercq)

Since the expression of the face of Saint Anthony was completely lost, we decided to test the possibility of removing the whitish overpaint. The result was aesthetically very satisfying (Fig. 3). Unfortunately, this approach could not be applied on the other parts of the sculpture as the polychromy had largely disappeared. On the front side of Saint Anthony's robe for example, there were hardly any remains of the original paint layer.

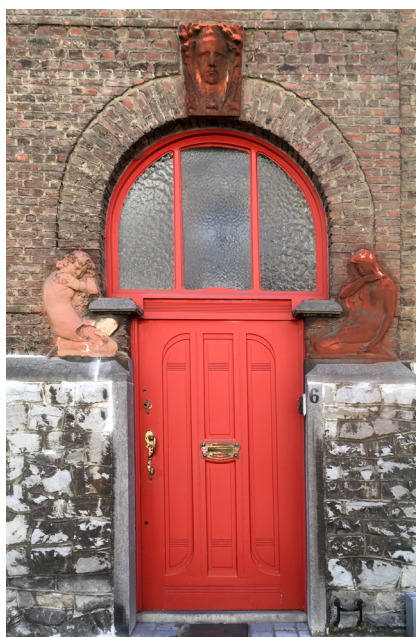
During our inspection, it appeared that only one of the three reliefs from the façade was still the original made out of red baked terracotta. Apparently, the two others were replaced by replicas in a terracotta-coloured mortar. It was only during our study that the landlords informed us about an unexpected and interesting fact: another copy of the central figure was kept in their garden. After our examination it appeared that the 'garden relief' was not a copy, but the original terracotta representing the portrait of the painter (Fig. 6). So instead of three original terracotta reliefs on the façade, there was only one original on the façade, one original in the garden and furthermore two replicas on the façade. Unfortunately, the original terracotta from the second female figure has disappeared.

Fig. 5 Three reliefs, Pieter Braecke, 1902, from the street façade of the private house of the Symbolist painter Emile Fabry in Woluwe-Saint-Pierre. Only one of the three reliefs, the kneeling female on the left, is still the original made out of red baked terracotta. The two others were replaced by replicas in a terracotta-coloured mortar. (Brussels) (© KIK-IRPA, Brussels, Camille De Clercq)

The deterioration of all four of them was advanced. The deterioration pattern of the two terracotta reliefs is mainly determined by the presence of cracks and delamination resulting in material loss on the entire surface. This damage was, as with the statue of Saint Anthony in our first case study, provoked by the combination of water seepage and frost. The thinner parts, such as the flowers in the hair of the left female character seemed to be very sensitive to this process as they were severely damaged. Furthermore, a lot of previous restorations were aesthetically disturbing. Lacunae were filled with gypsum or cement-based mortars. Apart from the colour difference with the terracotta their composition is inadequate for outdoor use or incompatible with the original material. Concerning the two mortar copies we can say that, despite their formal compatibility with the original sculptures, their state of conservation wasn't satisfactory either. The indefinite mortar was damaged by physical and chemical degradation, resulting in an uneven surface. Furthermore, we could observe black crusts.

It was decided that the original reliefs in terracotta were too fragile to be exposed outside in the future. The old mortar copies wouldn't be re-used either because they are also not suited to be exposed in an outdoor situation.

Therefore, we proposed to make three new replicas with a lime-based mortar² in a terracotta colour for the decoration of the façade and preserve the original reliefs in a protective environment. At the moment, the discussion concerning the future place of conservation of the originals is still ongoing. In fact, two options have been suggested. Firstly, as the reliefs were especially specifically designed for this house, conserving them inside this house could be a possibility. Another option would be to display the reliefs in a public space. The originals could be exhibited in the town hall of Woluwe-Saint-Pierre or at the museum of the CIVA foundation in Brussels, specialized in architecture.

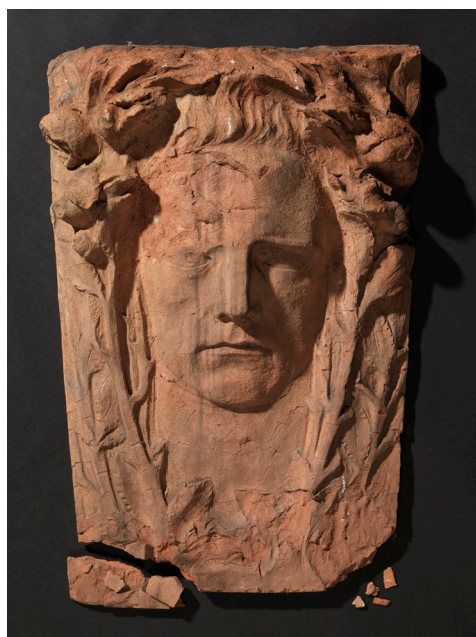
Fig. 6 The original terracotta relief representing the portrait of the painter, for years kept in the garden of the landlords, FIGcliché x108851 (© KIK-IRPA, Brussels)
