## THE TEMPLE OF EPICURIUS APOLLO AT BASSAE: PRESERVE THE STONE OR UNCOVER ITS TRUE NATURE?

KAPADOUKAKI Eva<sup>1</sup> SOUMAS Michail<sup>1</sup>

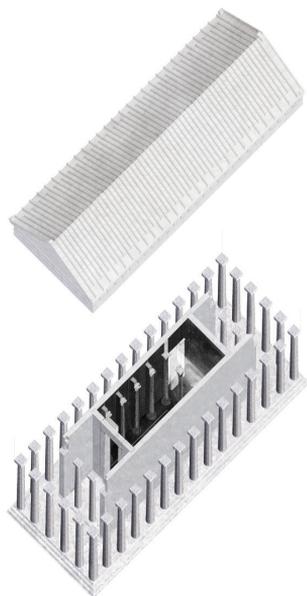
Fig. 1 Graphic Reconstruction of the Temple (Kapadoukaki E., Soumas M., 2017)

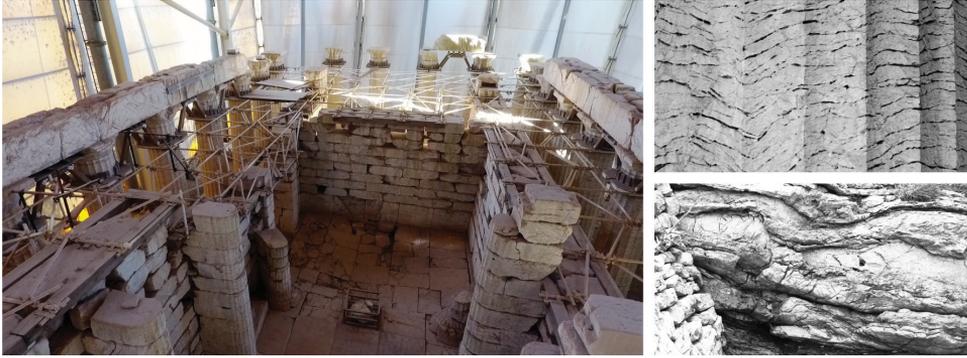
Fig. 2 Deterioration Modes of the Stone (personal archive of the authors, 2017)

The temple, being isolated in the mountainous landscape, has managed to finally be one of the best-preserved structures of Antiquity in terms of the amount of original material (60%) that remains in situ, undergone no intervention until the 20th century. It is built mostly of local sedimentary limestone (Maastrichtian), originating from the rock formation in the immediate vicinity of the monument. The stone, set in the high altitude of 1130m a.s.l., suffers severe deterioration mainly due to frost in the winter and large diurnal temperature width in autumn-spring (8-0°C, humidity 80-100%, summer 20°C-humidity 60-30%, generally NW or NE winds). The numerous discontinuities, weak planes or superimposed weak veins facilitate ingress of rainwater (CO<sub>2</sub> included) within the pores and external mechanical stresses such as earthquakes have a shear effect whenever discontinuities run parallel to the exposed surface. The result is a capillary cracking pattern, gradually widening and ending up in detachment of flat pieces (Theoulakis, 1995). Today's conservation-restoration works combine stabilising clay mixture, pozzolanic cement grout and lead sheets (C.C.T.A.E., Papadopoulos, 2015).

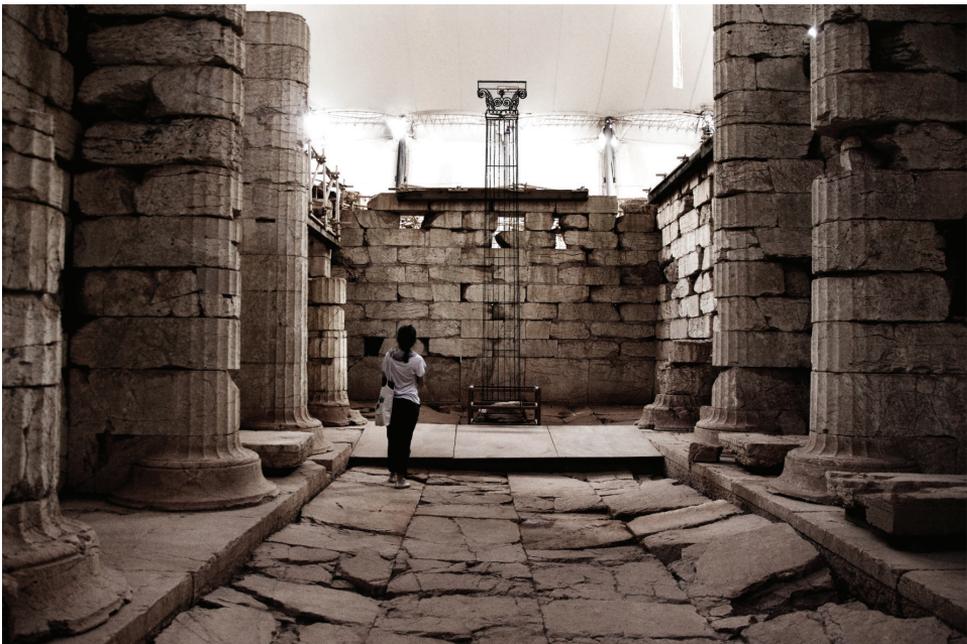
Fig. 3 The Materiality of the Temple, Cella (Kapadoukaki E., Soumas M., 2017)

The contemporary synthetic PVC canopy levels out the temperature fluctuations (+1-2oC) but has a serious misleading effect upon the building's features. The temple's colour as seen in open-air conditions has a wide tone variety from grey to orange and violet, even with deep blue shadows (F.A. Cooper, 1996) meant to stay naked, without stucco or paint. While today's scattered parts of the temple on site are decolorised by white spots due to the microfauna, the standing parts of the temple undergo a very different discoloration. The shelter filters the sunlight, applying a yellowish shade on the original grey stone, giving an extremely false impression to the visitor, while the new stone supplements, which are used for the conservation-restoration, are whiter.

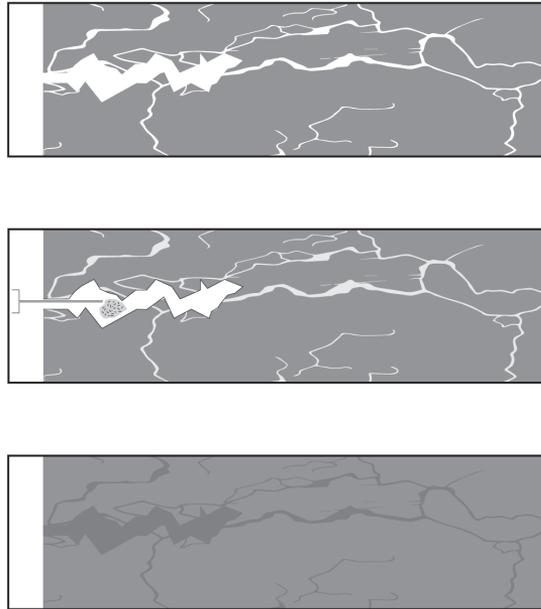
Fig. 5 Visualisation of the Proposed Bacteria-Based Reconstruction (Kapadoukaki E. & Soumas M., 2017)

The current conservation-restoration program has maintained the building's original structural system using reversible but strictly conservative methods (in the spirit of the Venice Charter 1964). Its documentation and evaluation criteria took place in 1990 but contemporary conditions including climate change suggest a need for new considerations. Experimentation according to this extreme case of material erosion and hostile environment is necessary. The authors suggest a turn to synthetic biology as it already has its footprint in architecture and archaeology. Instead of repairing the authentic parts by hand with new differentiated patched stone, genetically modified bacteria can be designed and injected in the cracks producing the exact same Maastrichtian limestone. Filling deep cracks would be far more accurate, and the new monolithic result will re-establish the integrity of each member having mechanical and aesthetic characteristics inherent to the building. This conservation-restoration method is technically doable and philosophically compatible with the monument's apparent present-day value of newness and art-value as a whole.

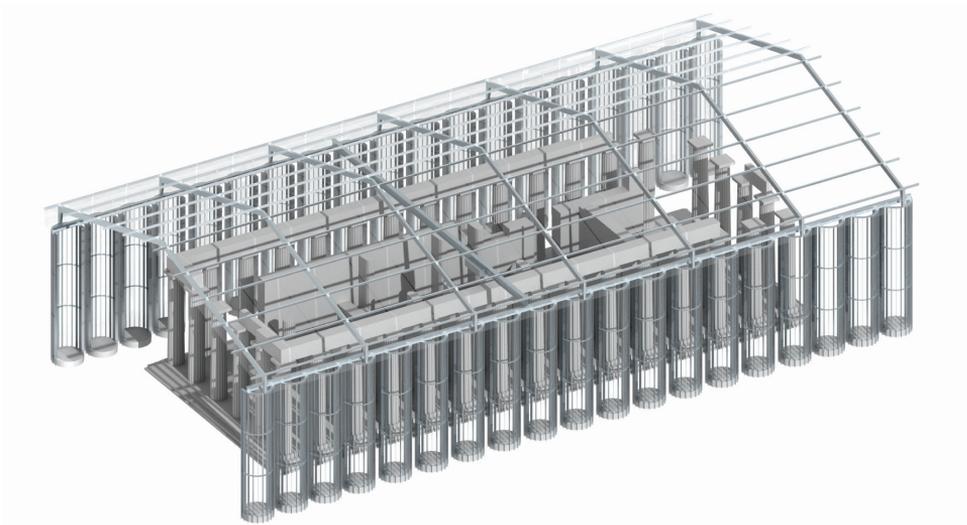
Fig. 7 The Design Proposal for the New Shelter (Kapadoukaki E., Soumas M., 2017)

The present dilemma is that of keeping the temple covered destroying its connection with the stone ridge, or letting it stand visible in its landscape conserving its integrity as a whole artifact. The current management plan stands weak as there has been no alternative suggestion since 1987, supporting the “temple-canopy differentiated image” concept. Regarding the authors’ proposal for a new shelter, the selection of transparent material for keeping the temple visible is considered necessary. While side covering isn’t critical for temperature balancing, the short flanks of the temple can and should have their original visual contact with the ridge. As the temple’s plan is open and inviting but also sets a limit as the eye slips between the column shafts and tries to enter the cella, the proposed superstructure is offering a similar filtered view macroscopically, modifying the circular column plan into a hollow semi-circle. It’s hollow in order to accommodate each of the full-height columns during their conservation-restoration (current restoration methodology, C.C.T.A.E., Papadopoulos, 2015). This way not only they are respectively placed to their relative position helping the observer to visually reform the temple, but also one can examine each column as an independent sculptural unit. Vertical blade-like beams assemble together the long stripes of glass, as an abstract reference to the flutings. Furthermore, the overhead crane for the temple’s parts relocation is integrated fully into the shelter’s structure.

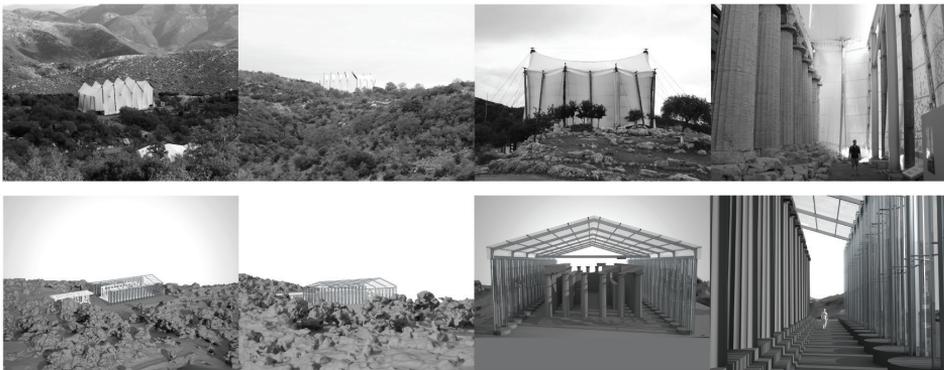
Fig. 8 Comparison of Current and Proposed Shelter, Critical Views (Kapadoukaki E., Soumas M., 2017)
