## MOISTURE INSULATION WITH CLAY OF UNDERGROUND BUILDINGS ON THE EXAMPLE OF MODERN ERA FORTIFICATIONS AND WARSAW ELIZEUM

NARĘBSKI Lech <sup>1</sup>

<sup>1</sup> mgr Lech Narębski, Committee of Military Architecture, Polish National Committee ICOMOS

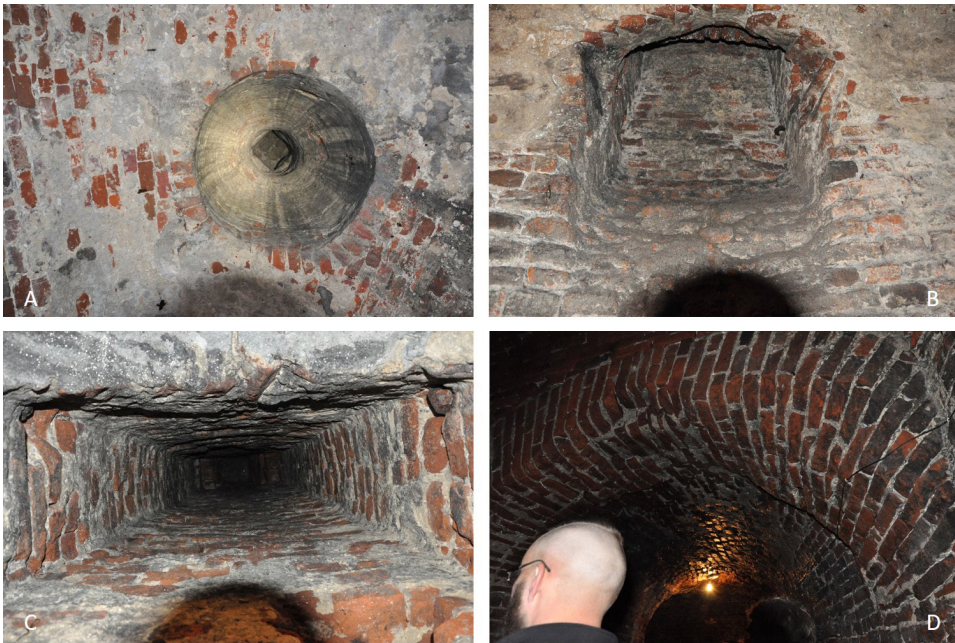
Fig. 6 Elizeum, perimeter corridor, ventilation. A - ventilation hole in the vault of the corridor, B - ventilation hole in the wall below the vault, C - ventilation duct with a blocked outlet, D - vault of the perimeter corridor 'shining' with moisture above the visitors' heads. Photo: L. Narebski, 2017

The Elizeum's perimeter corridor is not only a fragment of the "artificial grotto" leading the prince's guests on a mysterious, winding and dark road to the even more surprisingly beautiful, luxurious lounge, it was not only a way for the servants serving "friends and beautiful ladies". (lower level) and a place for a band of musicians (upper level), but also cutting off the comfortable (and thus heated) interior of the lounge from the cold and moisture of the ground covering the building. Above the corridor, a continuation of this separation is the double-mantel dome, i.e., containing the built-in thermal air insulation [Fig. 6, 7].

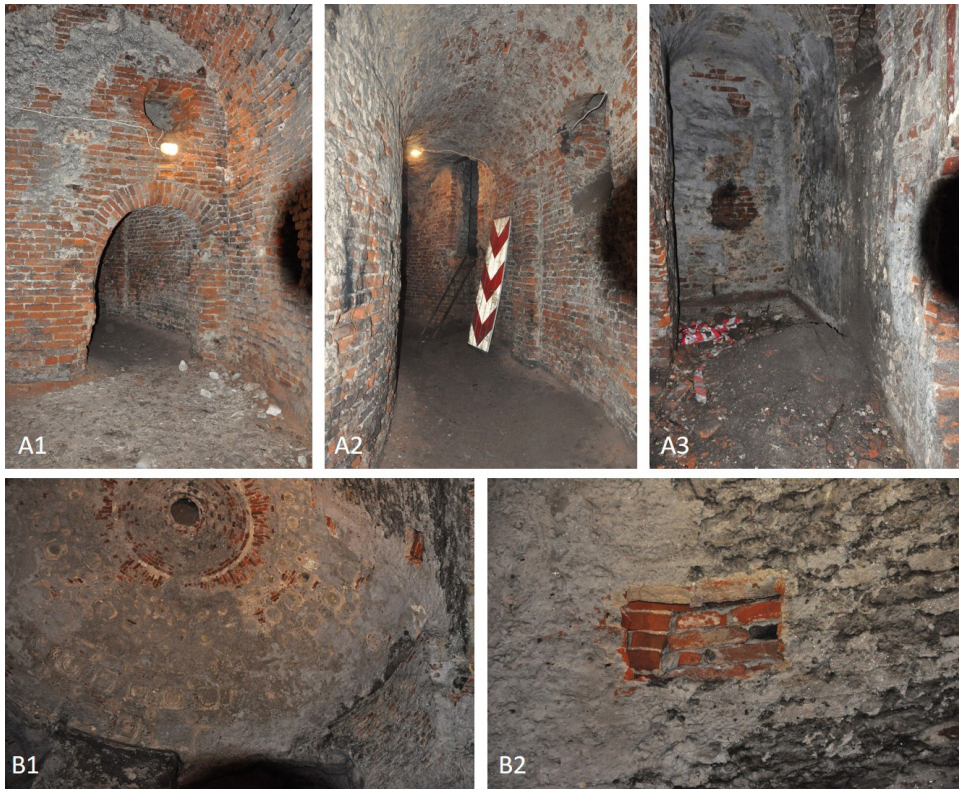
Fig. 7 Elizeum, A - perimeter corridor: lower, to the right of the contemporary entrance (A1), lower, western section, visible inlet of the ventilation shaft and entrance to the upper storey (A2), upper, view of the left wall closing the corridor (A3); B - dome: general view, visible traces of the original decor and outline of the original oculus (B1), uncovered wall fragment in the inner mantle of the dome (B2). Photo: L. Narębski, 2017

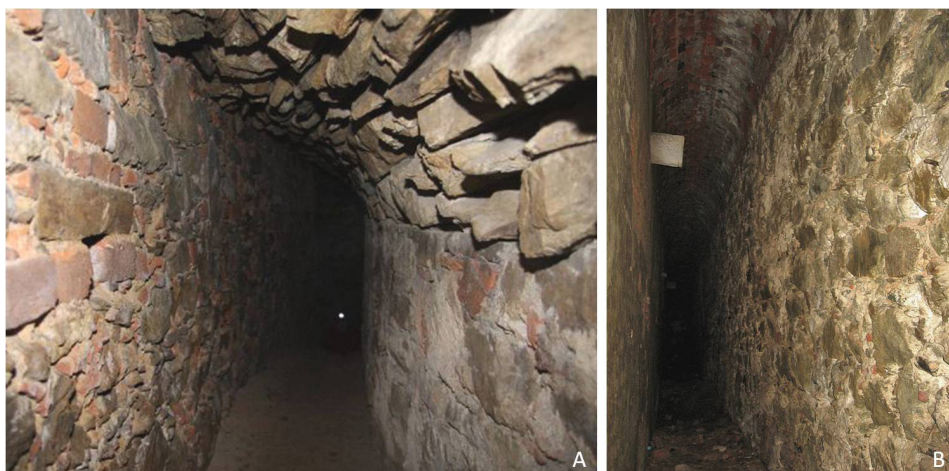
Fig. 8 Silver Mountain Fortress, insulation and ventilation corridors. A - a corridor with a 'drip' vault. (Photo: G. Basiński); B - corridor with a gargoyle of vault drainage of adjacent casemates (Photo: W. Szymański)

<sup>14</sup> In the case of Srebrna Góra, effective and efficient drainage of the fortress casemate was particularly important due to local climatic conditions in the Góry Sowie mountains. On the edge of the mountains over the Ząbkowicka Valley, on Góra Warowna mountain, the average annual rainfall is almost twice as high as in the town of Srebrna Góra. Therefore, the peripheral insulation and ventilation corridors in the fortress also play a drainage role; they are covered with vaults made of flat stones laid without mortar (dripping vaults), and/or water flowing down the vaults is directed to them [see Fig. 8].

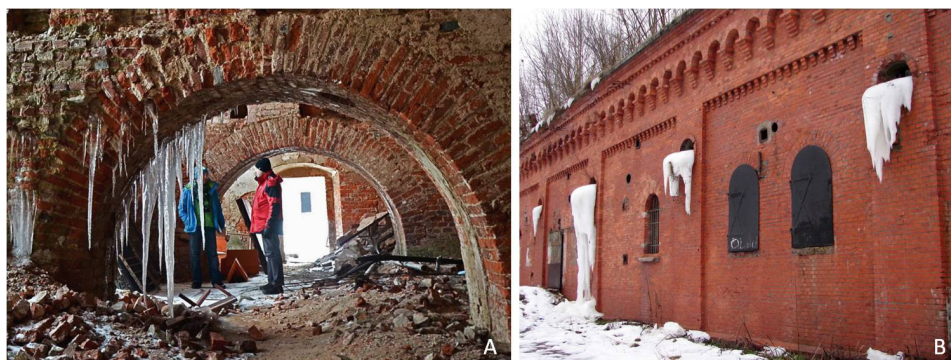
Fig. 9 Fortress buildings in winter. "Fixed" water leaks: A - from the earth-covered vaults of the Lower Bastille of the Silver Mountain Fortress Donjon (photo: G. Basiński); B - from the gargoyles on the elevation of the barracks of Fort I of the Toruń Fortress (photo: L. Narębski)

- All-season climate studies<sup>13</sup> (spring/summer/autumn/winter), consisting of recording temperature and humidity of indoor and outdoor air in correlation with the temperature and humidity of perimeter walls and vaults: A/ in the existing (present) condition, and B/ after opening the dome and ventilation shafts in the perimeter corridor. Control of time of condensation appearance on the dome, vaults and walls after opening the entrance, in correlation with external conditions; in winter conditions, observation of possible icing (ice infiltrates, icicles - Fig. 9).

One must not forget that even if we use the underground structure only as a seasonal attraction - it must survive the whole year, even in winter conditions. Winter reveals all the weaknesses of the waterproofing and thermal insulation by "stopping" the penetrating water in the solid state [Fig. 9].
