## IMPACT OF THE NARA DOCUMENT ON AUTHENTICITY – CASE OF THE UNESCO WORLD HERITAGE SITE BANSKÁ ŠTIAVNICA

**ABSTRACT:** Banská Štiavnica – an ancient mining town in Slovakia – has been internationally recognized as having an outstanding universal value and it has been included in the UNESCO World Heritage List. This fact represented a challenge which accelerated the process of its protection and restoration. In 2002 in the framework of the international conference *Materials, Techniques and Technologies in Built Heritage Conservation* participating renowned experts adopted the *Banská Štiavnica Appeal*. This key document transmitted the principles of the *Nara Document on Authenticity* (1994) and applied them to the specific cultural conditions in Slovakia. In the spirit of the *Appeal*, in 2007 a plan was set up to save and restore the Banská Štiavnica Calvary complex.

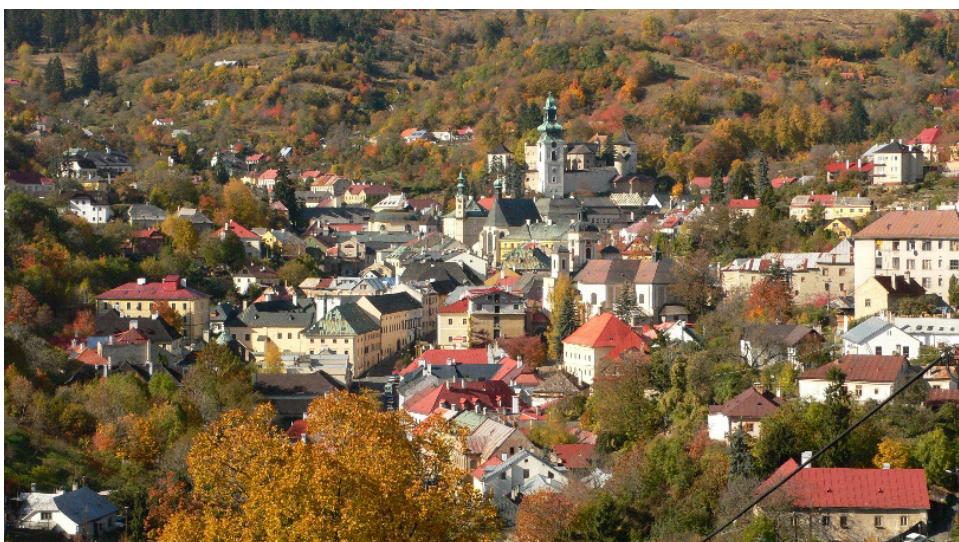
Fig. 2. Banská Štiavnica – The specific urban concept – wealthy burgher houses in the centre, artisanal architecture on the edges and miners' small houses are scattered on the slopes around the historic core. Photo: Katarína Terao Vošková

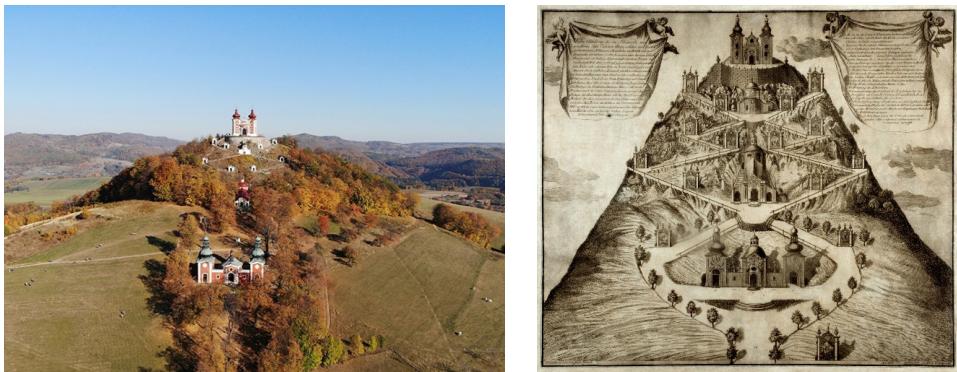
Fig. 3 Banska Štiavnica Calvary, situated on the hill Scharffenberg above the town. Copper engraving of the Calvary complex from 1751<sup>17</sup>. Photo: Vladimír Rupeldt

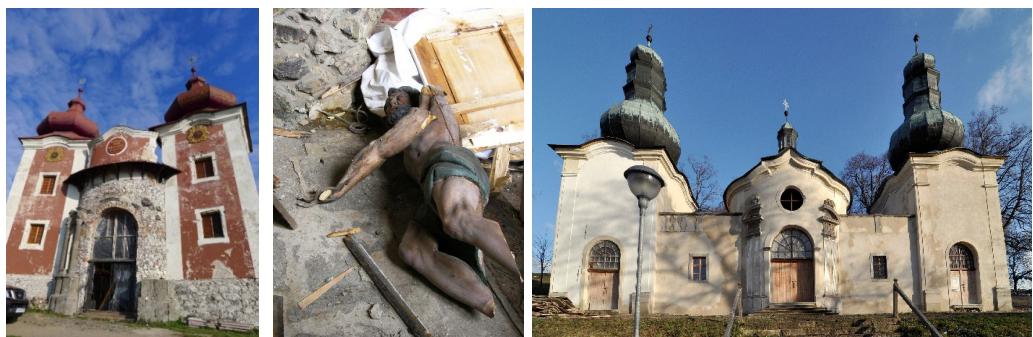
Fig. 4, 5, 6. Condition of the Baroque architecture and art before 2007: Façade of the Upper Church, Wooden Baroque sculpture from the altar, Façade of the Lower Church. Photo: Lubomír Lužina (4, 6) and Katarína Terao Vošková (5)

The consequences of long-term neglect and the past unprofessional repairs led to problems such as vandalism (destroyed roofs, stolen and destroyed furniture); abandoned state with no maintenance, overgrowing greenery and no water management; use of inappropriate materials and technologies during the communist regime (concrete and cement technologies in 1978 – 1981); inappropriate modifications of the original urban concept – three chapels had been relocated from the original place and the pilgrim road had been shortened; lack of public interest.

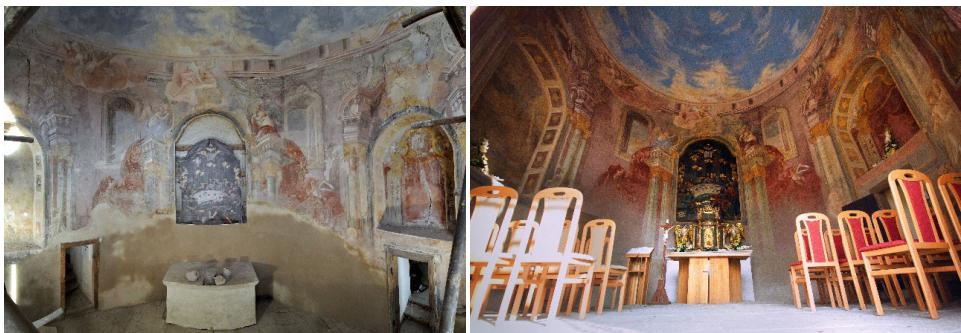
Fig. 11, 12. The principle of authenticity was applied during the restoration of architecture and the fresco decoration of churches – the preservation of the maximum of the original substances with the respect for the materials and technologies used. Interior fresco restoration of the Lower Church. Photo: Lubomír Lužina

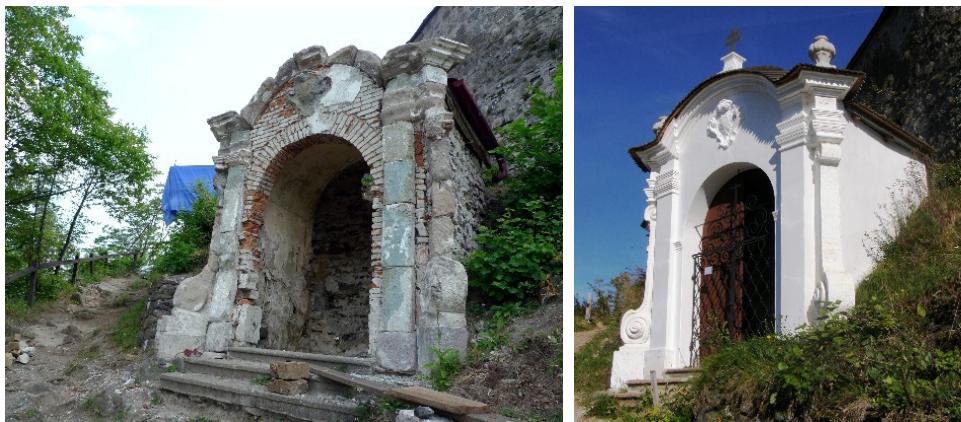
Fig. 13, 14. During the conservation process of the Baroque chapels from the Calvary complex, inappropriate interventions from the 1980s were removed and lime technologies were applied for rehabilitation. Photo: Katarína Terao Vošková

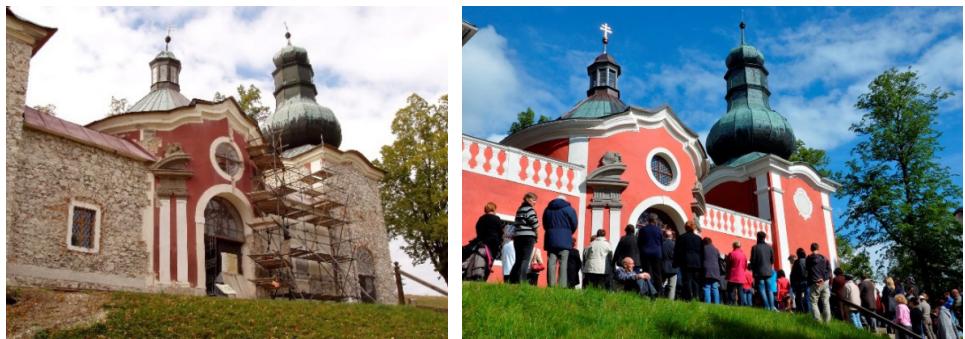
Fig. 15, 16. Comparison of the condition of Lower Church from the Calvary Complex before and after restoration. Photo: Archive of Authors

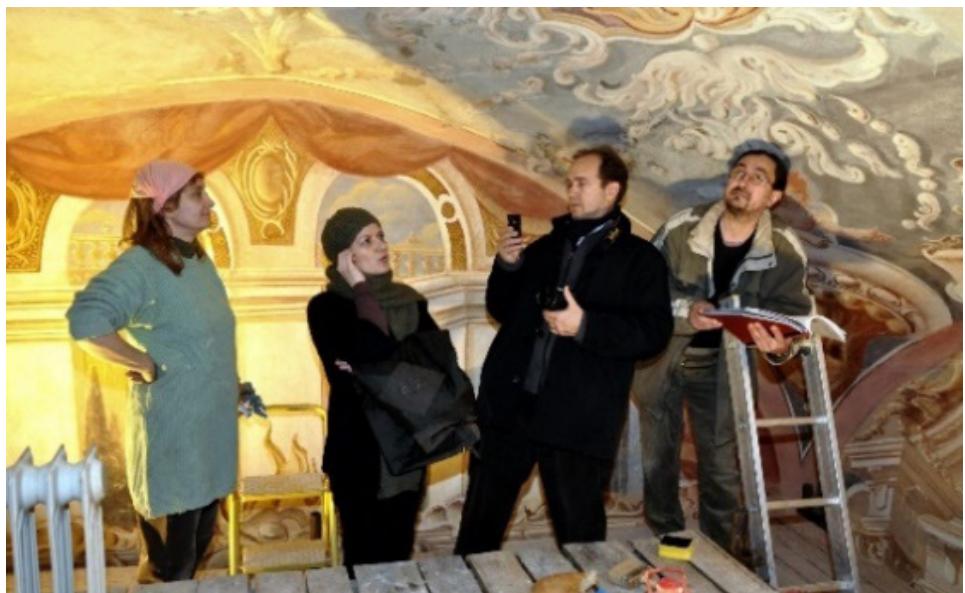
Fig. 17. The restoration process accompanied by a discussion between experts (conservator-restorers and World Monuments Fund representative) – restoration of the frescoes in the Lower Church. Photo: Lubomír Lužina
