Conservation and reconstruction of art paintings of the late nineteenth century in the lobby of the academic building of L'viv Polytechnic National University

Abstract: The research of artistic decoration and practical works of restoration of wall paintings of the main lobby of former building of the Galician Highest Regional Court presented in the article. The building used today as academic korp for the needs of L'viv Polytechnic National University. The first part of the restoration work was carried out in this building during 2012–2014 years.

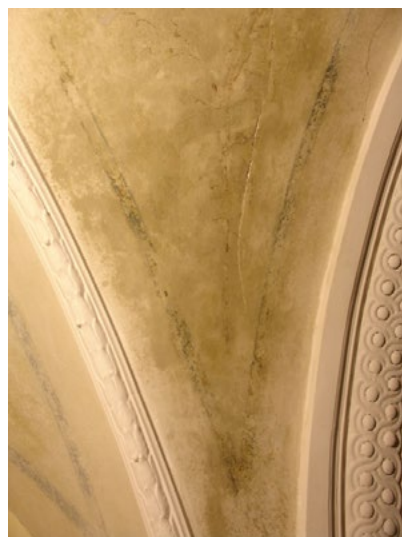
Fig. 4. Saved under a later covering a fragment of art paintings of the XIX century (photo by M. Bevz).

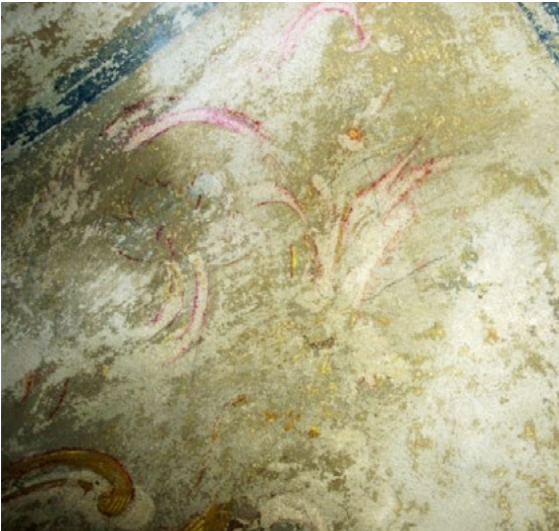
Fig. 5. Decorative element of the ornament. Probing before the conservation, 2013. Photo by S. Hetmanchuk.

The discovered fragments of the ornaments had features of Neo-Renaissance paintings, as evidenced by plant elements in the form of acanthous leaves, volute, silhouette of cartouch in a large triangle (Fig. 5), and oak branch with a ribbon in small triangles (Fig. 6). The remains of paintings were transferred to tracing paper and used in further work on reconstruction (Fig. 8, 9, 10).

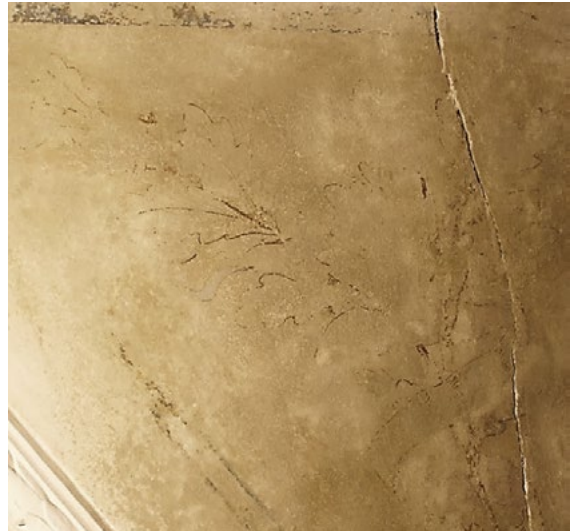
Fig. 6. The fragment of a decorative branch with oak leaves. Probe before conservation, 2012. Photo by S. Hetmanchuk.

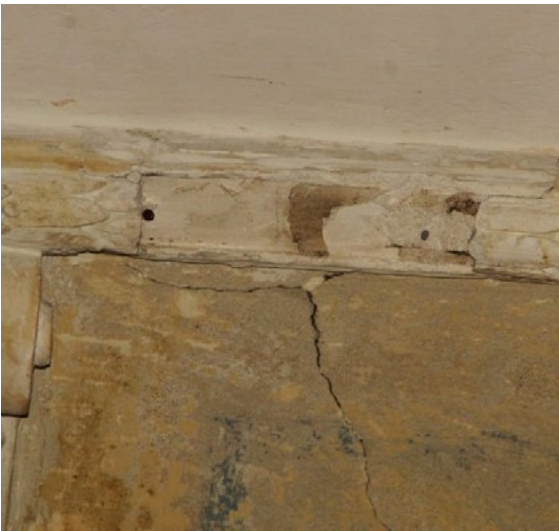
Fig. 7. Cracks on the surface of the vaults and loss of the molded ceiling decoration. Probe before the conservation, 2012. Photo by S. Hetmanchuk.

During the probing the remains of art paintings were found on the vaults of the lobby. The state of the remnants was different. In most 'fields' of the vaults the remnants of the paintings were barely readable. Only in the corners of the ceiling, the state of the paintings was a bit better. It was in these fields that in several surfaces, mechanically cleared with the help of brushes and scalpel from the later cretaceous-glutinous layer. Due to this method, the elements of the ornament were discovered, which made it possible to more accurately characterize the type of paints and the style of painting and reconstruct the original drawing pattern on tracing paper. It was discovered that the fields of the vaults were covered with repeating painted floral compositions. Unfortunately, the state of preservation of paintings in most fields was very bad (see photos 5 and 6). In addition, the plaster surface of the ceiling had numerous microcracks. On the ceiling there was also molded gypsum decoration in the form of molds. The molds imitated bay leaves' weaving. There were lost parts in several places and some of the leaves were cracked (Fig. 7).

After previous researches, the surface of the ceilings was prepared for further works on the reconstruction of artistic paintings, during which, using warm water and brushes, the surface was cleaned of dirt, paint residues and cretaceous-glutinous solution. Also, after the completion of the cleansing, mechanical damage and cracks in the surface of the vaults and adjacent moldings (Fig. 7, 8) were identified, requiring urgent restoration measures. The next stage was embroidery of cracks and seams, injection of gypsum and the addition of lost elements of molded decoration, with subsequent toning.

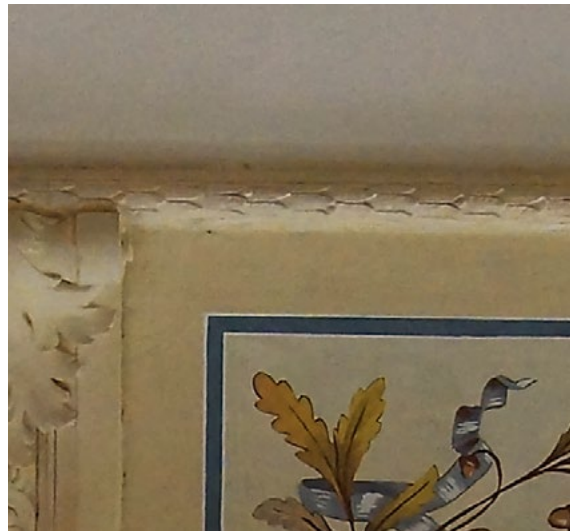
Fig. 8. The same fragment of the vault' surface of the molded decorations after the conservation, 2015. Photo by S. Hetmanchuk.

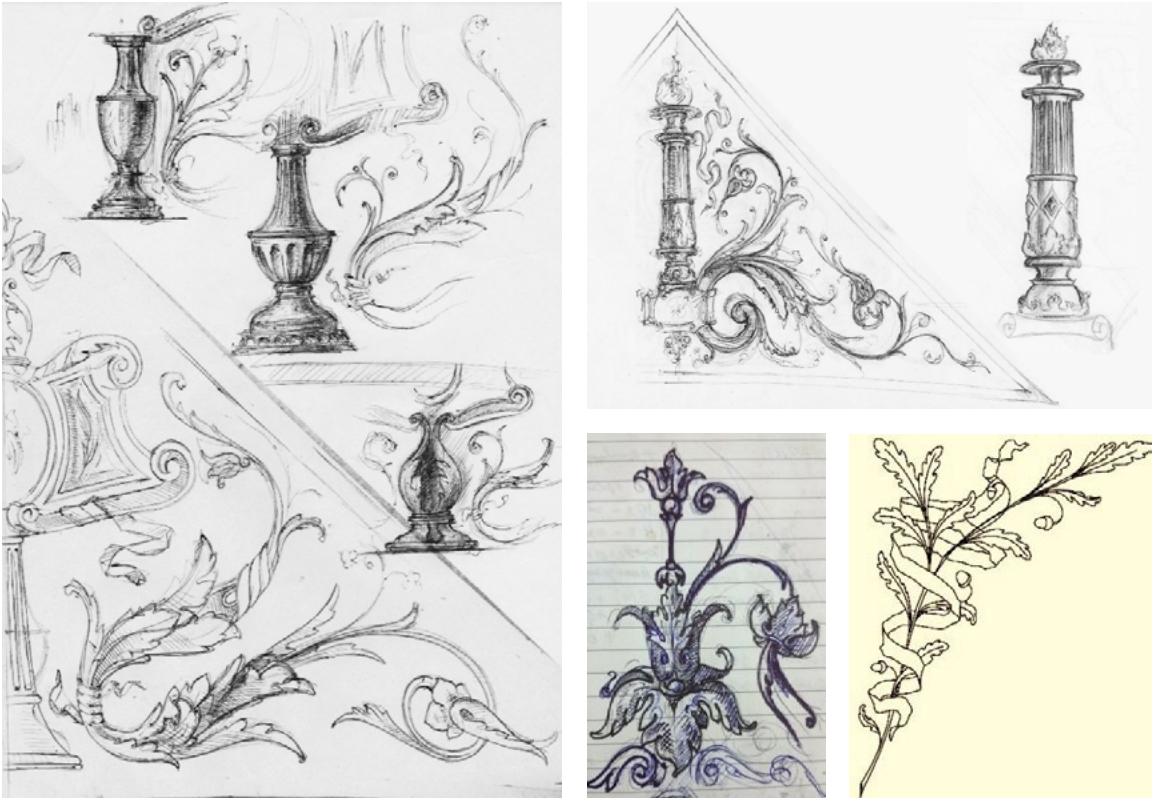
Fig. 10. Sketches of elements of ornamental and plant compositions (S. Hetmanchuk).

On the basis of materials obtained as a result of previous studies, sketches were made and variants of reconstruction of artistic paintings were offered (Fig. 7, 8) of which the ones that best match the style and character of similar ornaments available in other rooms of the same building were chosen the best suitable. Also, the main and secondary colored tones were approved (Fig. 11), sketches of all elements were made (Fig. 9, 10). At this stage, the composition and color scheme of paints, which were to be used for painting the interiors of the main lobby of the 19th building of L'viv Polytechnic were finally explored and approved. Later, drawings, a color proposal for the reconstruction of paintings and ceilings in general were completed (Fig. 10, 13) [Archive of the department..., 2012].

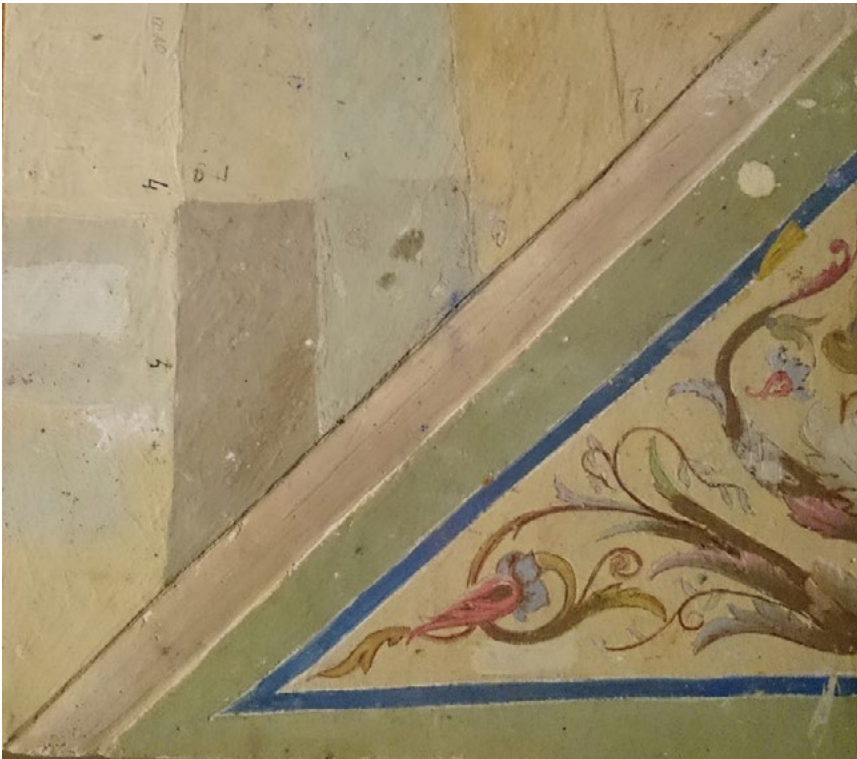
Fig. 11. Tests on colour and the property of casein and cretaceous-glyce paints and their compatibility with each other and the basis (author – S. Hetmanchuk).

Casein paint, which included: casein made from low-fat cheese, hydrated lime, balsam turpentine oil, varnish, boric acid and mineral pigments (mainly cadmium and cobalt) was used for drawings of ornamental-decorative compositions. Also, a sample was performed on the color gamma and the compatibility of colors with each other and the technical and color harmony with the base (Fig. 12). After painting the backgrounds, drawings of the ornament were translated into the surface of the vaults in the technique of pouncing and stencil. Subsequently, art restoration and reproduction works were started. This final stage included: pointing of the contours, drawing of the main tones of the substrate, creating extent in the 'dry brush' technology and the writing of small elements. At each stage of the work, detailed photo fixing and inventory of the processes were carried out.

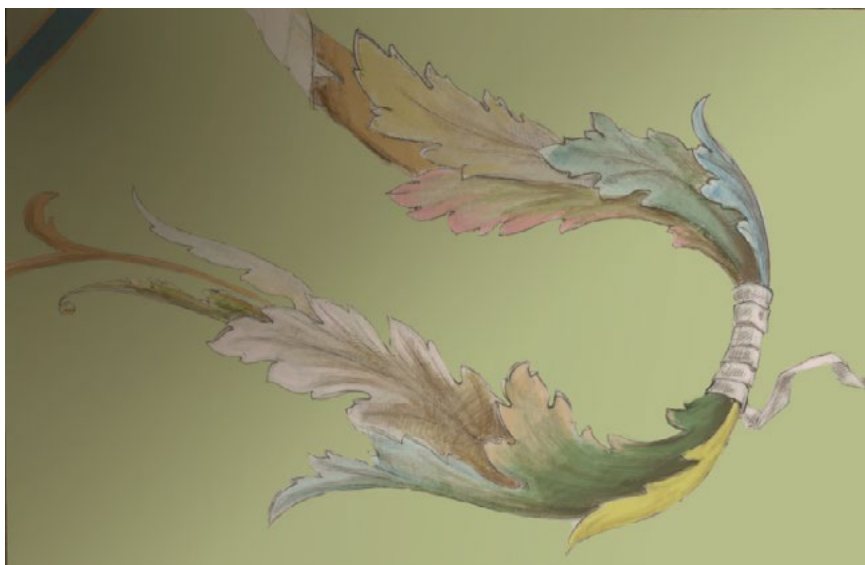
Fig. 12. Coloured sketch in the color of the elements of acanthous leaves (author – S. Hetmanchuk).

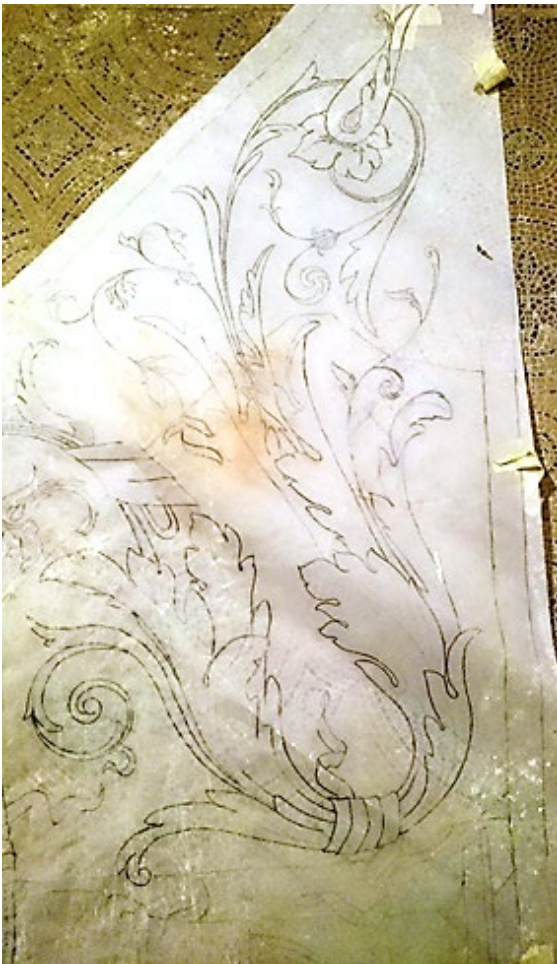
Fig. 14. Tracing with transfer of the patterned ornament on it (scale 1:1).

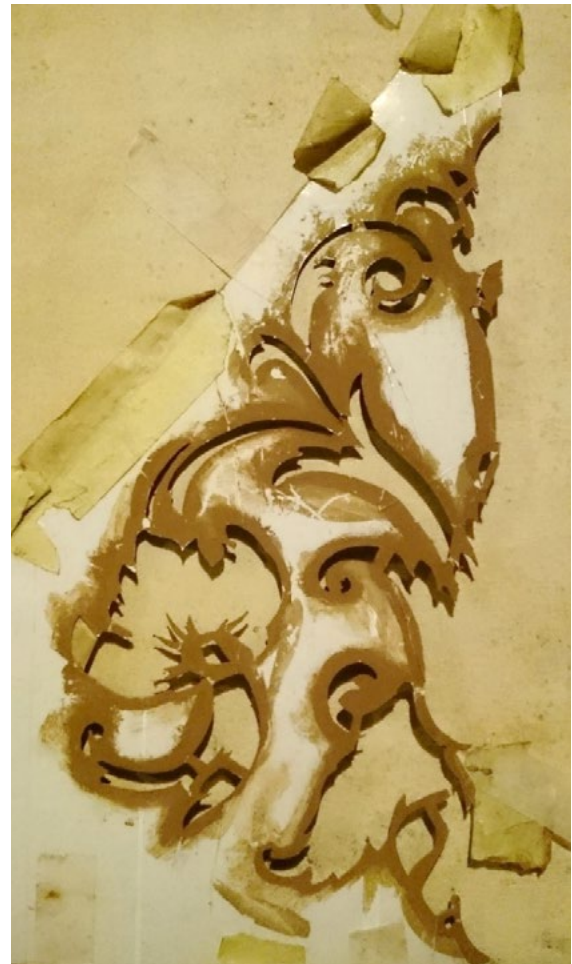
Fig. 15. One of the transferring methods of the drawing to the surface of the vaults, applying paint on a stencil.

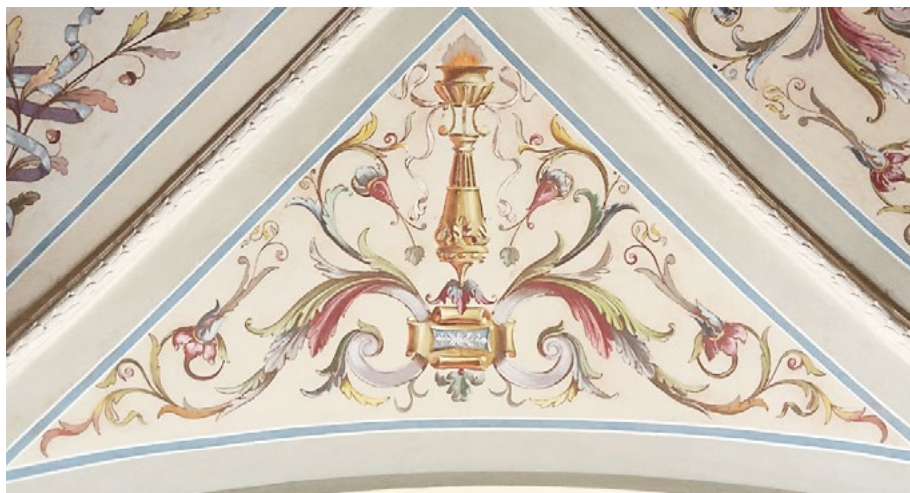
Fig. 16. Conserved and reconstructed triangular field on a vault. Practical work – S. Hetmanchuk.

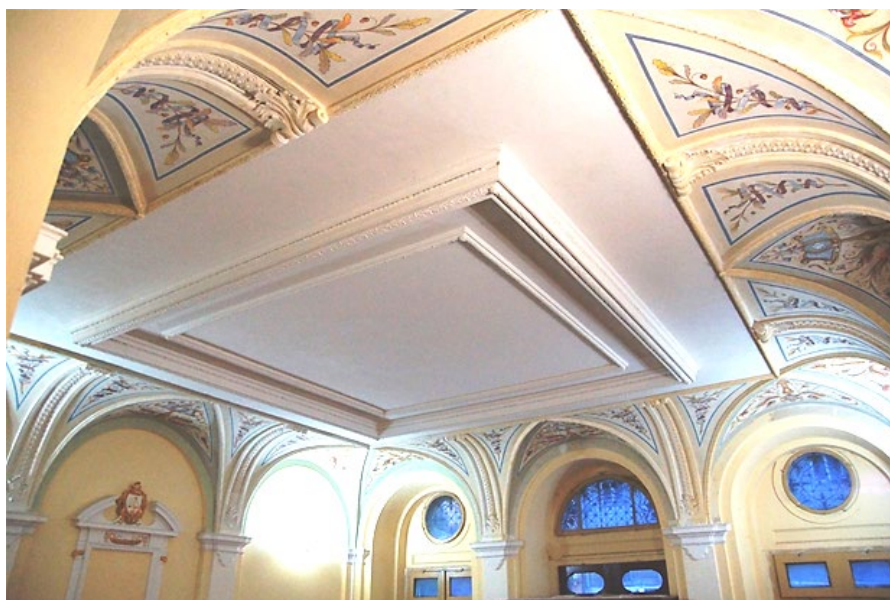
Fig. 17. The main lobby of the 19th academic building of L'viv Polytechnic National University in 2015 after the completion of reconstruction and restoration works (photo by M. Bevz).

The pictures and graphic material of the research, design and execution of the reconstruction and restoration of the paintings of the main lobby of the 19th century academic building are presented on Figures 13–16. Figure 17 shows the state of the interior of the lobby after the restoration and reconstruction of the paintings on the ceiling. The group of authors that executed this project: prof. M. Bevz – a head, S. Hetmanchuk – practical
