Evaluation of the protection status of masonry crowns and proposals for their repairs – the castle in Janowiec on the Vistula

Abstract: The article deals with issues related to the conservational protection of objects in the historical ruin. The article discusses the technical condition of existing protections, their impact on the historical matter and a method for repairing damaged wall crowns.

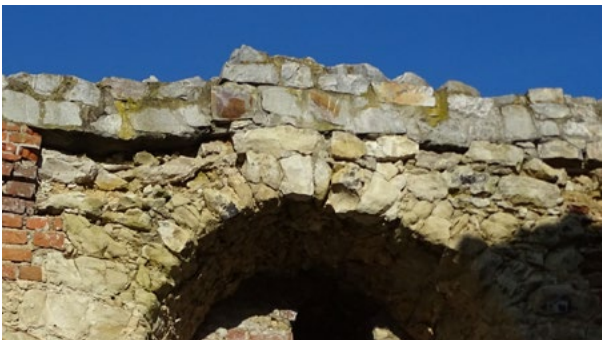
Fig. 2. Photo 1 Bricklaying the crown of the wall with a quartzite stone

The technical condition of the quartzite superstructures is in most cases good or sufficient. There are minor damages, loosening of the quartzite material from the joints, and surface paralysis with the biological corrosion.

In insufficient condition there is a wall made of limestone rock directly under the quartzite superstructure. At the interface there was a strong degradation of the limestone wall. It was found that there were numerous large surface losses of masonry facing layers, losses of individual stone blows, defects and corrosion of joints. Degradation of the wall under the quartzite protection is related to the lack of any insulation at the interface of the layers. Over time, the quartzite superstructures lost their tightness and rainwater penetrates at the interface of quartzite and mortar into the interior of the limestone rock wall. In addition, the lack of drips allows penetration of water flowing down the quartzite superstructures.

An important problem is also the poor technical condition of the superstructures with quartzite for wall faults in the places of wooden ceilings (not existing at present). These superstructures, usually made of one layer of quartzite stone, are locally defective and detached from the face of the wall. Intense damage occurred mainly in the sockets on the ceiling beams.

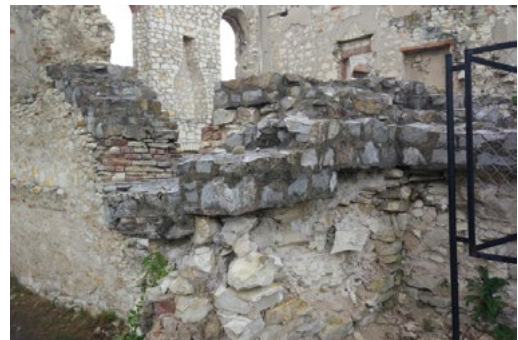
Fig. 3. Photo 2 Bricklaying the crown of the wall with a quartzite stone

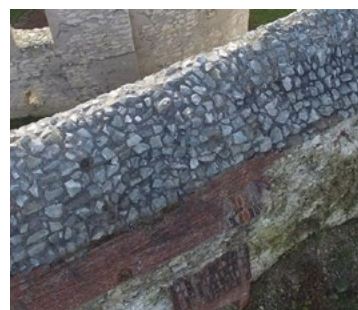
Fig. 5. Photo 3 Shaping the crown of the wall

The crown made of quartzite is in good technical condition. As a part of the inspection, longitudinal fractures of the crown were noticed (several meters long), which were most likely caused by the performance and deformations of the masonry structure. In the poor technical condition, as in the case of the superstructures of the original structures, significant damage was found at the interface between the crown profiled and the limestone rock wall.

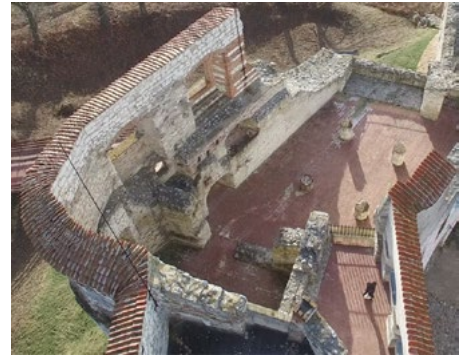
Fig. 7. Photo 4 Shaping the crown of the wall

The walls protected with ceramic tiles remain in a much better condition compared to other types of protections. The roof tiles beyond the face of the wall lead rainwater to the outside of the castle. No significant damage to the face was found directly under the roof. The condition of ceramic tiles is good. Only point damage to the security material was found.

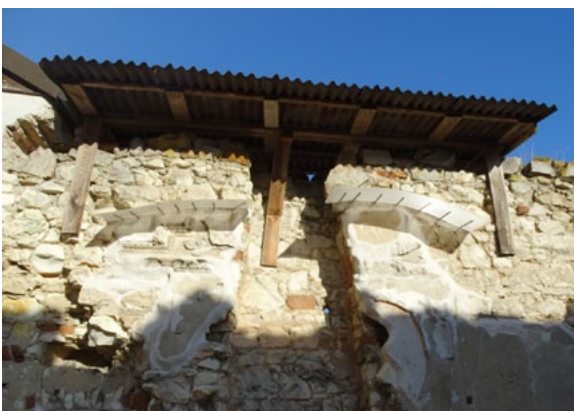
In the case of the castle in Janowiec, a very large variety of applied technological and material solutions was found. The roofs of a wooden structure with roofing paper, corrugated board, and galvanized steel sheet are visible.

Fig. 8. Photo 5 Cross-section of the protection described

The technical condition of the protection system is varied. Elements protected by steel sheets are in good condition in most cases. The extended metal sheets protect the face of the elements being shielded. No significant damage was found to the coating itself. The problem is not the great aesthetics of this type of protection and the color diversity of plates used in the Janowiec castle. Wooden canopies occurring primarily in the southern part and they are in a bad technical condition. Both wooden constructions and cover are damaged. The occurrence of newly erected protection structures has also been found.

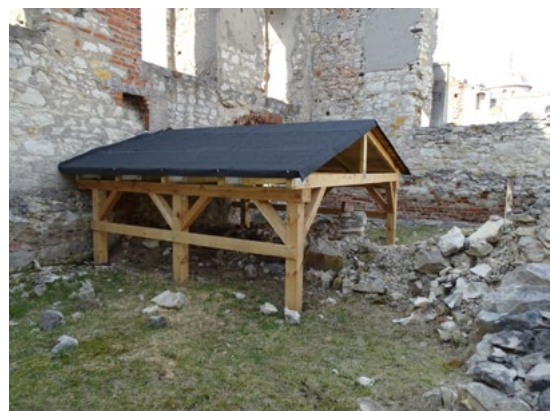
Fig. 9. Photo 6 Shaping the crown of the wall
