Nineteenth-century, non-existent buildings of the Castle Hill in Lublin

Abstract: This article presents the history of no longer existing 20th century buildings against the background of the turbulent history of the Castle Hill in Lublin. It shows the location, appearance and functions of the buildings, which were supposed to serve administrative, residential and technical purposes and some of them became a place of slaughter and executions. The analysis was based on data from archive searches as well as from geo-radar studies.

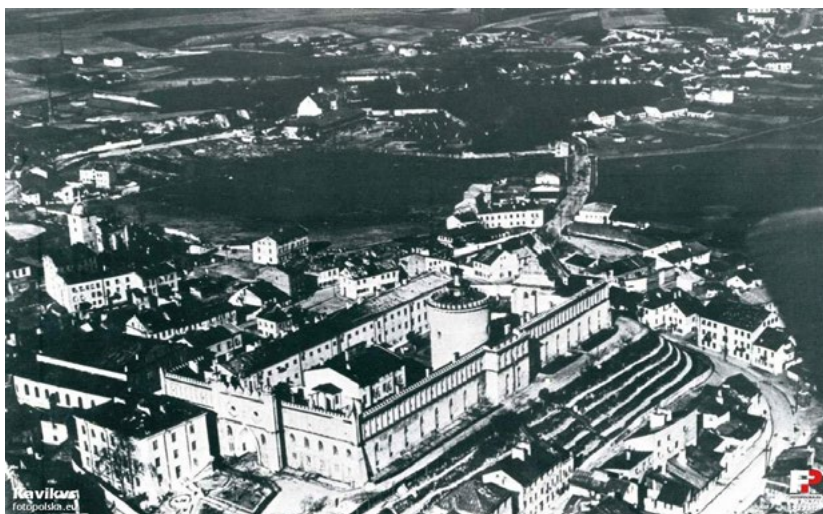
Fig. 8. aerial photography – red arrow marks administration building, green arrow marks bathhouse building

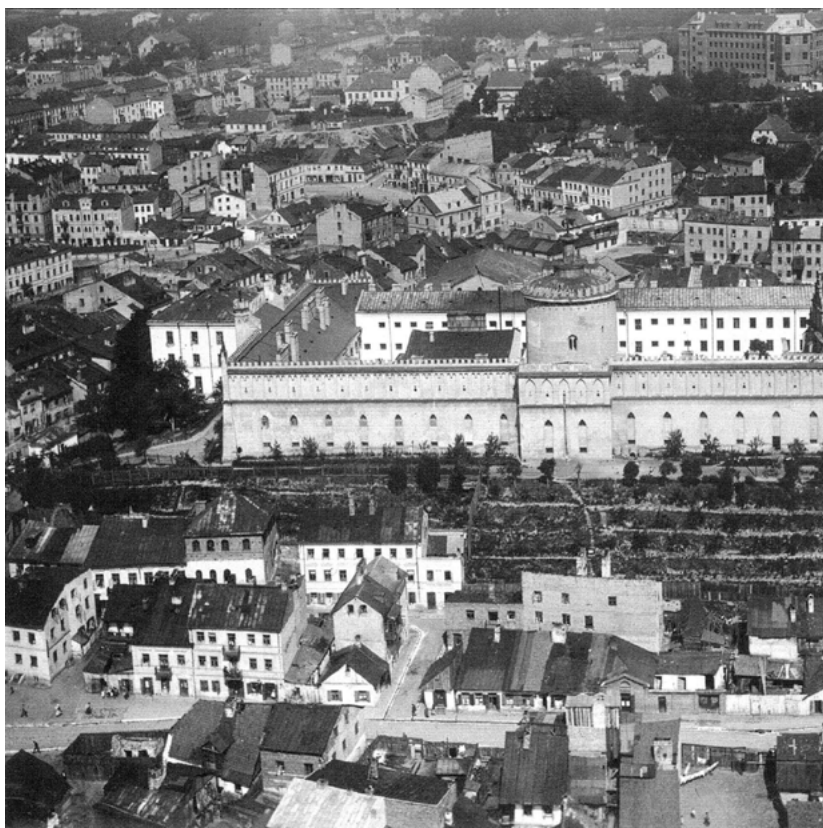
Fig. 9. Aerial photography 1938. – Red arrow marks the administration building, green arrow marks the bathhouse, https://fotopolska.eu/Lublin/b58146,Panoramy_Lublina,24,48.html?f=633676-foto accessed 20.10.2020 r.

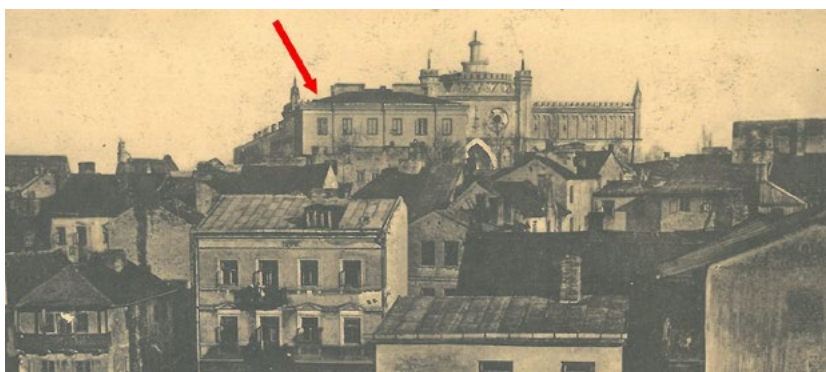
Fig. 11. A fragment of the postcard "Lublin - Castle" – with a red arrow marks the administrative building, owned by the author

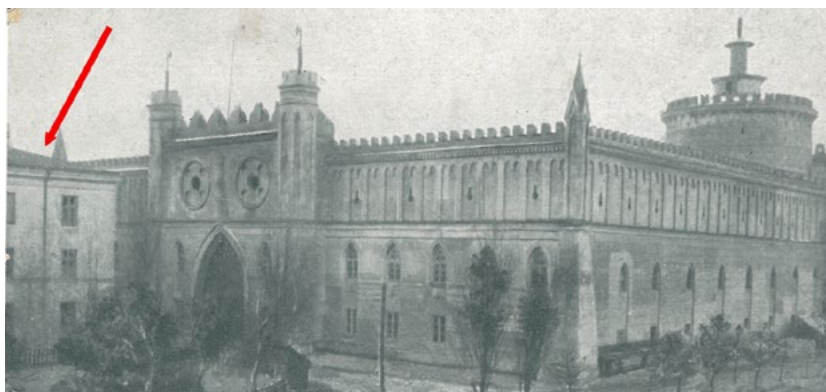
Fig. 12. Postcard depicting the castle hill – the red arrow marks the administrative building, owned by the author

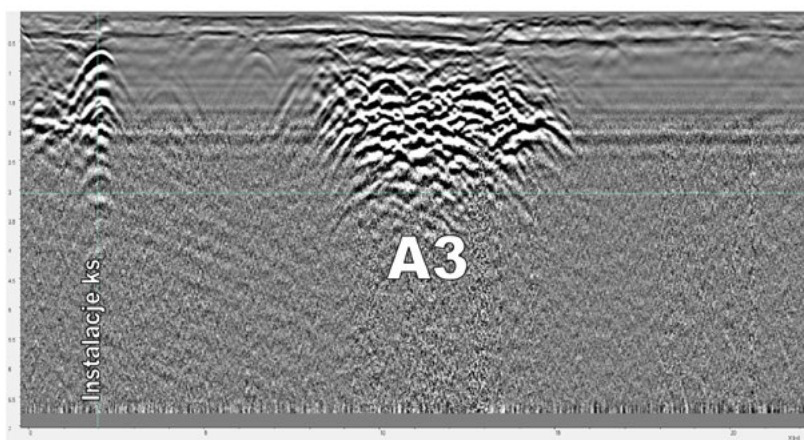
Fig. 14. section W.53 showing a fragment of the inaccurately buried basement of the eastern wing of the administration building – Geo-radar research “Plot of land 41, in front of the Lublin Castle building”, K. Janus, W. Kocki, N. Przesmycka, Lublin 2018, p. 107.

The geo-radar research defined quite precisely the outline of the administrative building, but only in the scope of the east wing (additionally, most of it was located in the inaccessible space of the flower bed). Anomaly A3 (Fig. 13) probably marks the partially buried (but not precisely) basements of the east wing, while it does not show any other unbasement parts¹¹. From here it can be assumed that the stairs from the east led to the basement. In the central part there was a corridor throughout the whole length of the building and the rooms were located on the eastern side. The remaining part did not have cellars or the cellars were completely demolished. An attempt to reconstruct the storey is shown in Fig. 15.
