# Brzezice Manor House as an example of changing the function of a structure from production to a manor house

Krzysztof Janus

*Department of Architecture, Urban and Spatial Planning,  
Faculty of Civil Engineering and Architecture, Lublin University of Technology*

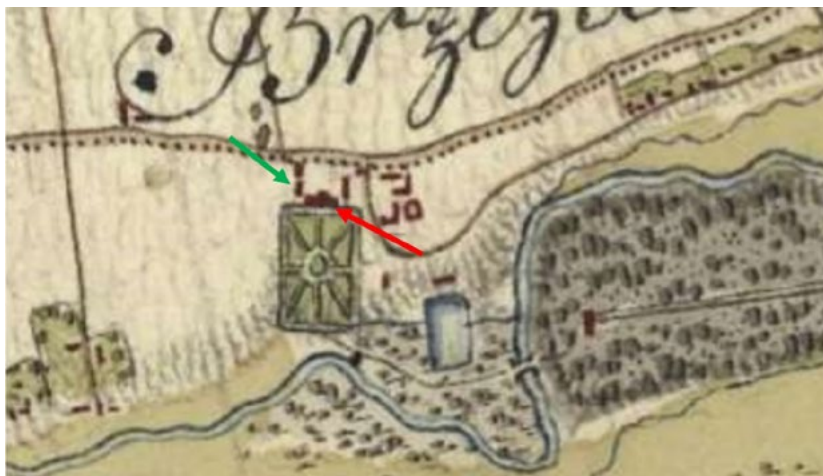
**Fig. 1.** Fragment of the Hendesfeld map from 1802 (the red arrow marks the building of the original manor house (kitchen), the green arrow marks the discussed building), <https://mapire.eu/> accessed 19.10.2020

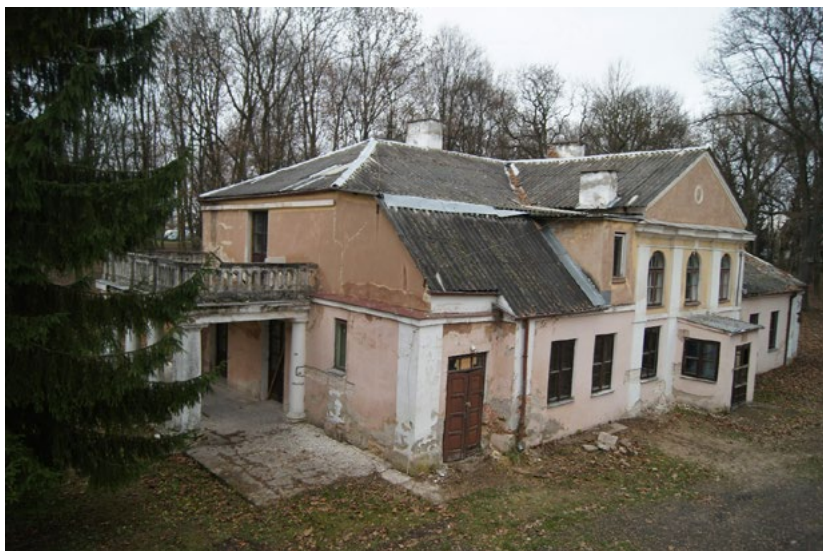
**Fig. 5.** View of the facade from the south-eastern side, photo: K. Janus, 2018

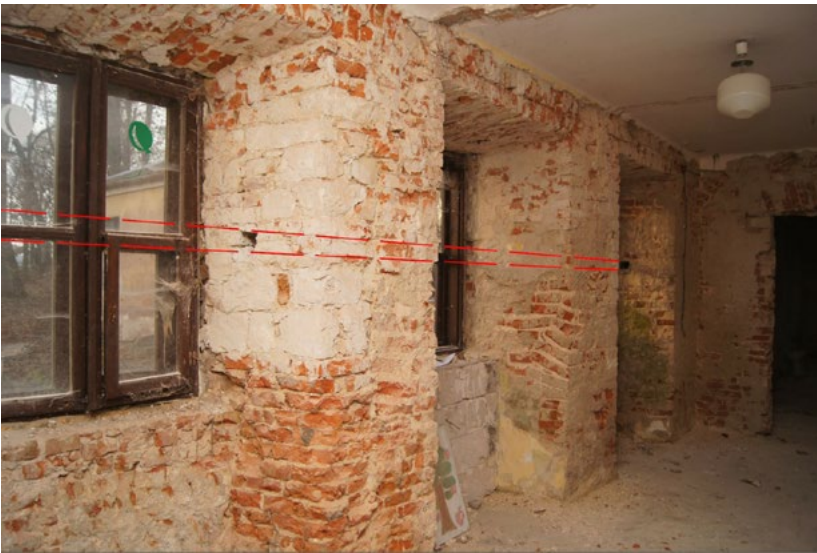
**Fig. 7.** Location of a canal/ wooden box cut with secondary windows, photo K. Janus, 2016.

the whole building was made of brick, which certainly significantly increased the cost of its construction. During the research, an additional chimney was uncovered in the structure of the eastern wall (90x40 cm), on which there are no traces of trenches but only streaks and a wooden canal/box with an undefined function, which was made simultaneously with the wall and destroyed during the execution of the current windows (Fig. 6, Fig. 7). The building had walls 110 cm thick, situated about 110 cm below the ground level (it had no cellars), its interior was single-space with a width of about 7.5 m and length of at least 23 m (the northern wall is a secondary element). It was not possible to determine whether the building could have been only a few metres or a dozen or so longer. The interior of the building was a single-space, vaulted hall about 7 m high (Fig. 8, Fig. 10). The building had no windows in the central part and was covered with a mansard roof. It was not possible to determine precisely what function it could have had at that time, but it can be assumed that it had to have a large hearth and most probably boilers in the central and northern part based on brick arches. During this stage there were numerous changes in the interior in a relatively short period of time, which is characteristic of the production process.

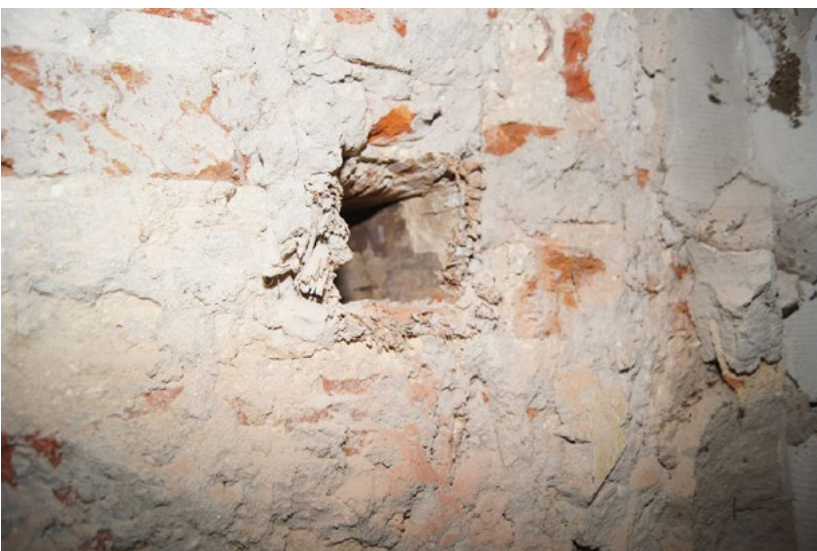
**Fig. 8.** Wooden box/channel cut in the external wall of a building, photo: K. Janus, 2016.
