Building Materials and Architectural Details of Natural Stone used in the 13th Century Castle Buildings of King Daniel in the City of Chełm

Keywords: City of Chełm (Kholm), stone materials, architectural details, construction, the technology of building, 13th century.

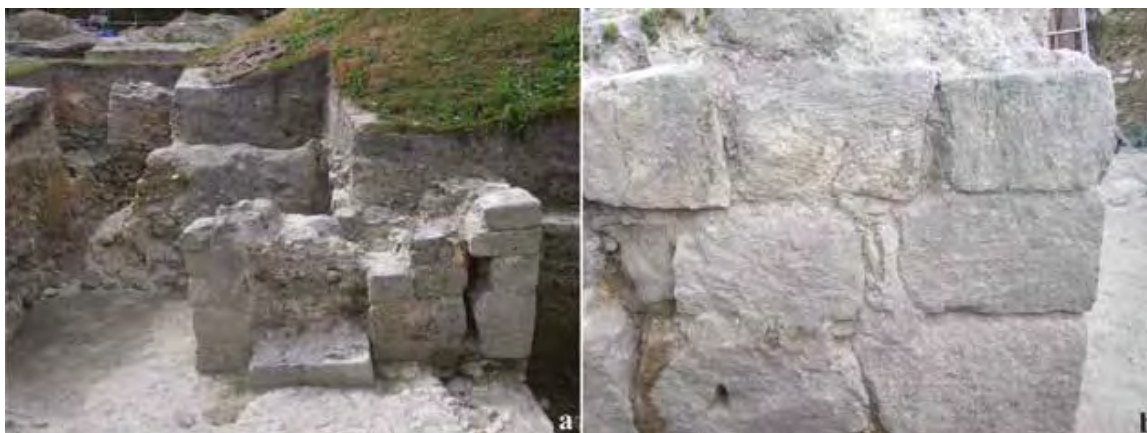
Fig. 2. Preserved elements of buildings made of glauconite: a – the entrance gate to the palace part of the castle, b – a fragment of the wall around the perimeter of the southern part, built of glauconite (photo S. Gołub)

Glauconitic masonry was documented in a preserved fragment of the entrance gate in the opus quadratum technique (see Fig. 2: a) and within the walls along the perimeter in the technique of opus emplectum (see Fig. 2: b). Architectural details made of the same raw materials were excavated in the early twentieth century by Petro Pokryshkin and today during archaeological research conducted in 2010–2018. All the finds come exclusively from the destruction of various buildings. It should be noted that a large number of them (several dozen) were also recorded during the study in the southern (Fig. 4 and 5) and the northern part of the castle hill. The details found so far (including fragments of the archivolt that probably decorated the northern portal of the southern part of the castle) are characterized by similar surface treatment and suggest the existence of one workshop or one stonemason and confirm the chronicle mentioning the master Avdiy [Dąbrowski, Jusupović, 2017: 205]. The person of the master stonemason Avdiy is mentioned only once in the Galician-Volynian chronicle as the performer of the portals with relief images of saints – Christ the Savior and John the Chrysostom in the Church of St. John [Kotlyar, 2002: 122].

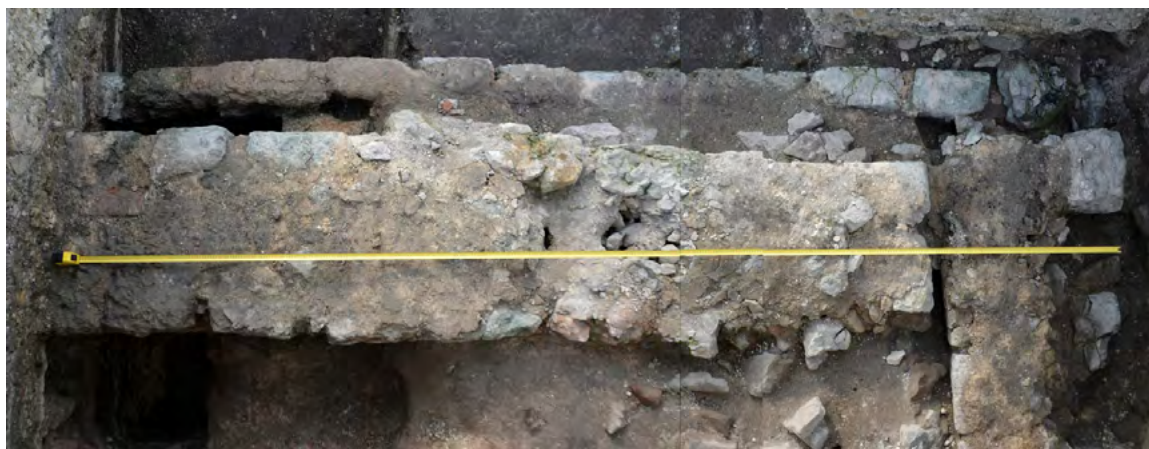
Fig. 3. A wall of glauconite blocks in the archeological excavation of building D in the northern part of the castle. Photo by S. Gołub

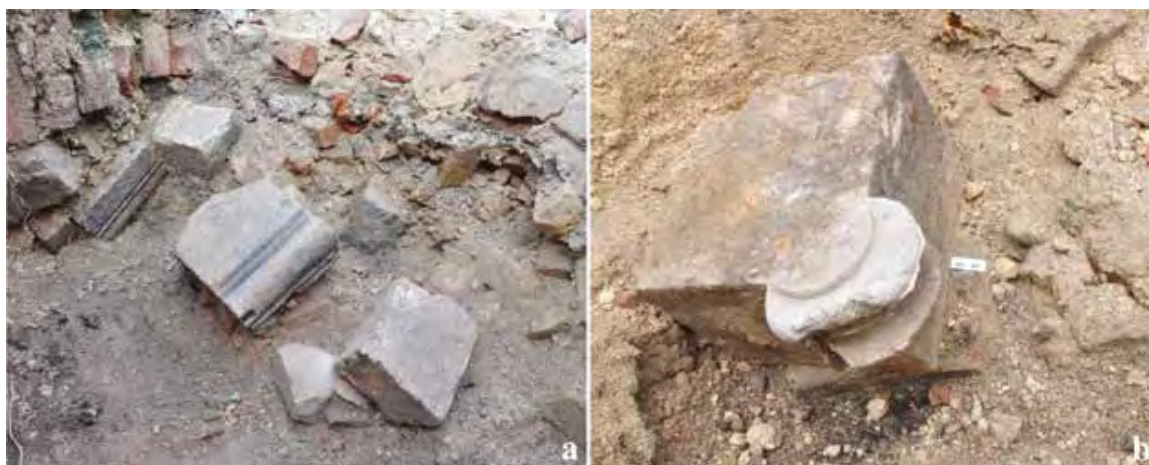
Fig. 4. Architectural details of glauconite from the southern part of the castle: a) from the ruin in the excavation 26; b) from excavation 27 (reused element in the foundation of the building). Photo by S. Gołub

The properties of glauconite as a material acceptable for refined, complex processing are best seen in the refined architectural details (Fig. 4, 5, 7, 8, 9, 11, 18). During archeological excavations in 2011, two iron tools for stone processing were found in the southern part. The next two were found in 2015 in the northern part of the mountain (Fig. 9). They probably served to treat blocks of glauconite as evidenced by perfectly legible traces of mechanical treatment on the surfaces of parts, which traceably correspond to the found masonry tools (fig. 10, 11).

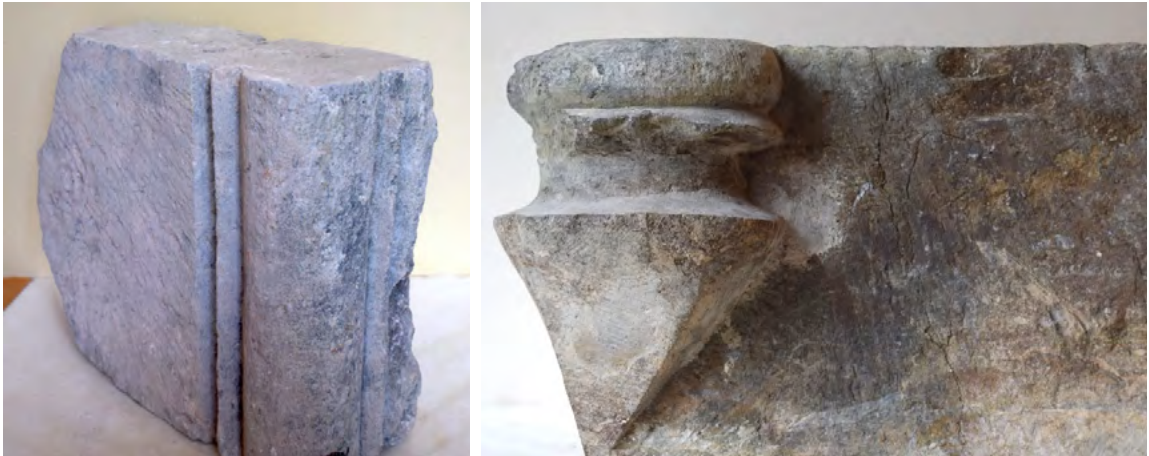
Fig. 5. Architectural details of glauconite from the southern part of the castle after the cleaning: a) from the ruin in the excavation 26; b) from excavation 27. Photo by M. Bevz

During the archaeological research of the remains of the castle, we attempted a hypothetical reconstruction of building elements (windows, doors, columns, cornices, etc.) based on the found stone blocks (fig. 12). In Figure 12, we present a hypothetical reconstruction of a doorway constructed using the details presented in Figures 5b and 9.

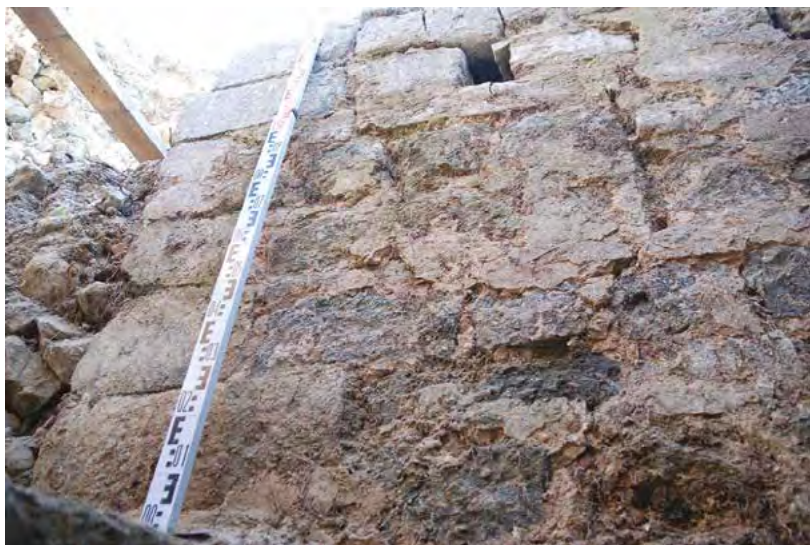
Fig. 6. The outer face of the western wall of the palatium – demonstrates the method of laying hewn blocks in the wall; excavation 35 (photo by S. Gołub)

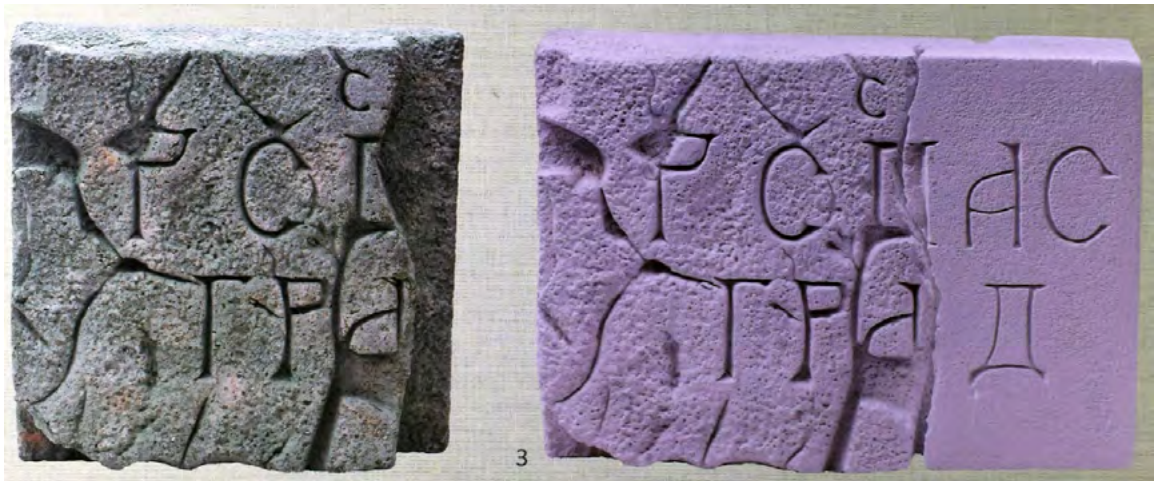
Fig. 7. Details of glauconite from the ruins of buildings in the southern part of the mountain (from the excavations of P. Pokryshkin, 1910–1911). Left: the model of a fragment of the block made according to the photo of P. Pokryshkin on a scale of 1: 1. Right: a hypothetical reconstruction of a lost part of the block with a reproduction of the full inscription on the stone. Work by Yaryna Tsapiak under the promotion of O.Rybchynsyi, V.Melnyk, V.Voloshynets, Y.Dyba, 2014, Architecture and Conservation Department, LPNU [Stasiuk, 2015]. Reconstruction is stored in the Ambrozevich Museum of Chełm land in the city of Chełm

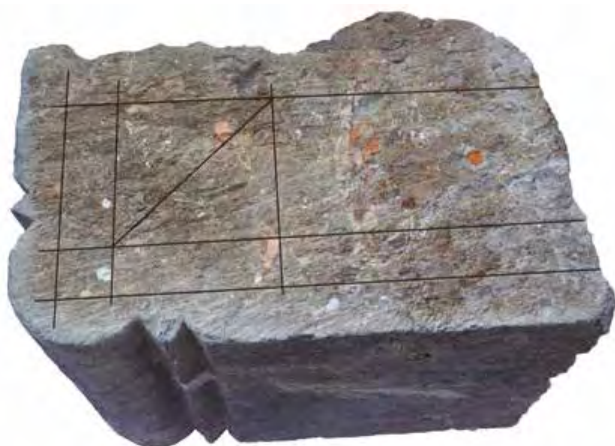
Fig. 8. Excavation 38C, detail from glauconite with dashed marking lines (photo S. Gołub)

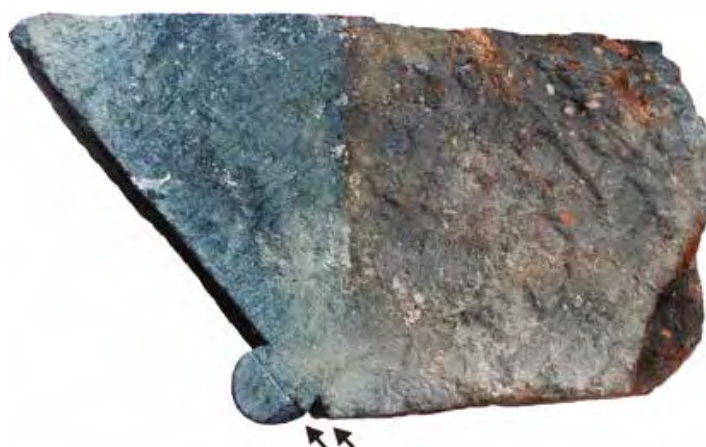
Fig. 9. Excavation 38C, detail of glauconite with marked lines for the construction of a vertical roller (photo T. Sławiński)

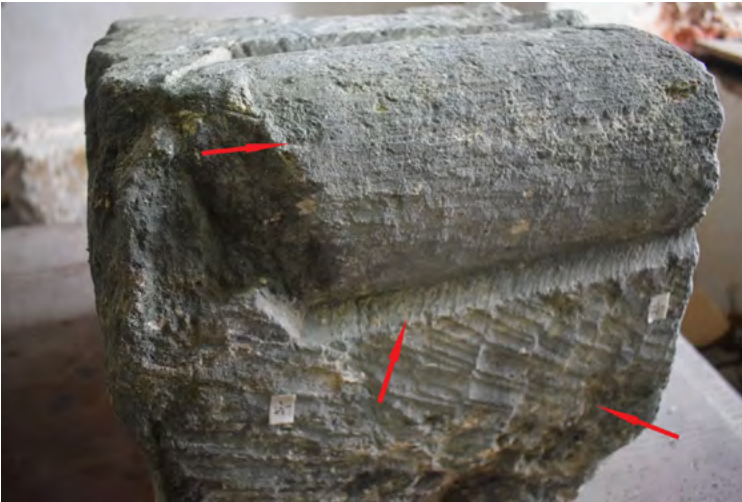
Fig. 11. Detail from glauconite (the corner stone block with a half column) with marked traces of handling (photo M. Bevz).

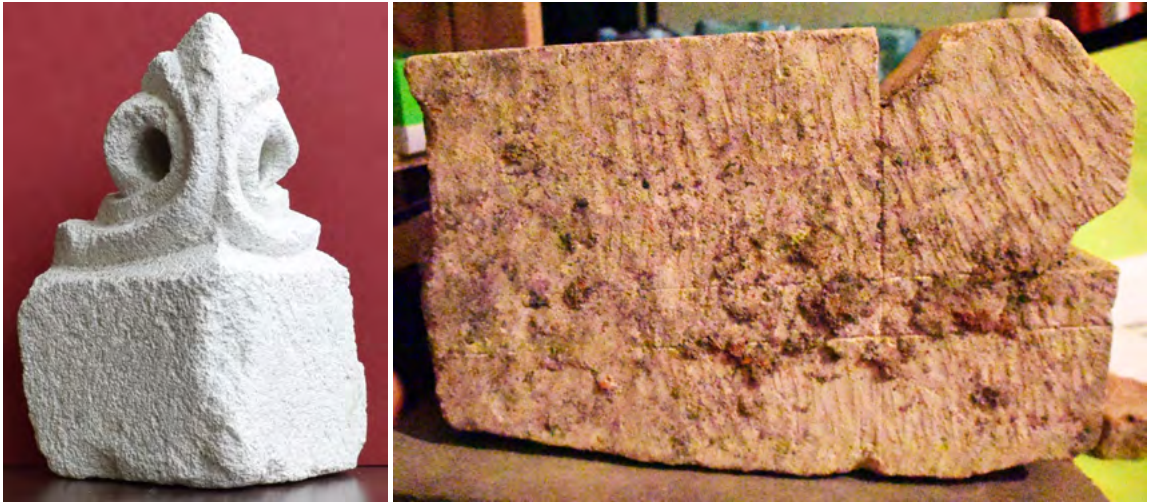
Fig. 13–14. Fragments of the cap and architectural detail made from limestone. Photo by M.Bevz.

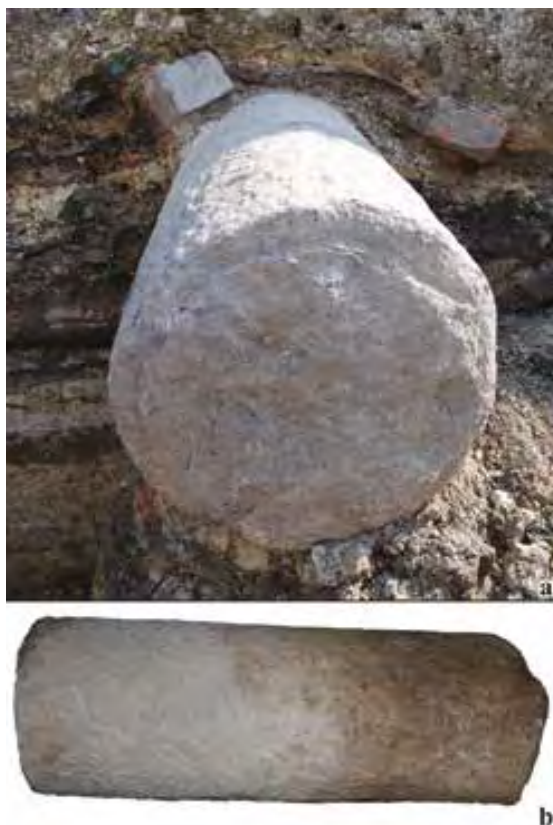
Fig. 17. The fragment of the column from quartz sandstone in the excavation № 40. Photo by S. Golub

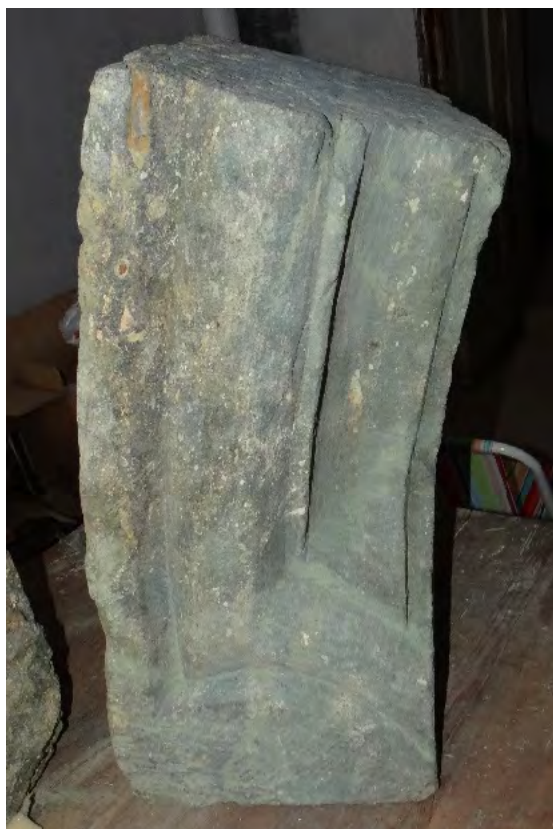
Fig. 18. Profiled block of glauconite. Probably an element of the portal arc. Photo by M. Bezv
