# Dendrochronology and Accelerator Mass Spectrometry (AMS) Carbon 14 Dating: A Novel and Potent Combination

Keywords: dendrochronology, wooden buildings, Hancock-Mitchell house, investigation

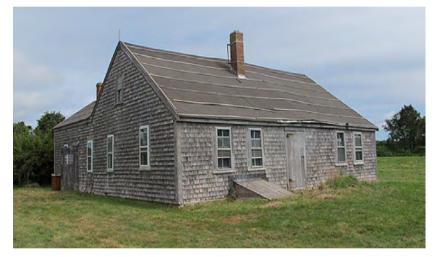
Fig. 2. Hancock-Mitchell House, 2014 (Sheriff's Meadow Foundation, Inc. 2013 [4])

Local knowledge and previous research conducted on the property had identified a portion of the building (Fig. 2) as having been constructed in the mid 17<sup>th</sup> century as a place where noted Indian missionary Thomas Mayhew, Jr., and his son John, also a missionary, preached to the Indians in their efforts to Christianize the native population of the island [8, 9, 10]. I was engaged to conduct a study of the history and evolution of the house and undertook extensive physical and documentary research in a process known as building archaeology. My conclusions, assisted by a dendrochronology study conducted by William Flynt, dated the building as having been initially constructed nearly a century later than believed by everyone, from the previous researchers to the local historical commission, the island's preservation trust, and the property owner.

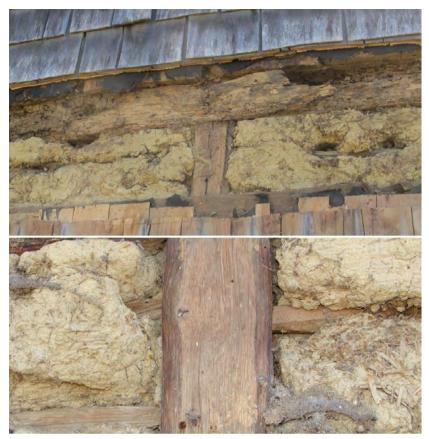
Fig. 5. Top: Clay and straw infill in the exterior wall of the Hancock-Mitchell House, Chilmark, Massachusetts (Myron O. Stachiw, 2015)

**Bottom:** Detail of the clay and straw infill in the exterior wall of the house. The clay and straw mixture were applied over oak splints let into the vertical framing members (Myron O. Stachiw, 2015)

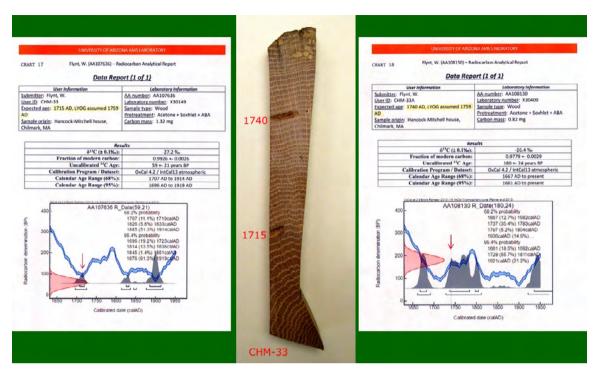
Fig. 12. Radiocarbon Analytic Reports, Sample CHM-33. Confirmation of C14 dating of 1715 and 1740 tree ring dates (University of Arizona Accelerator Mass Spectrometry Laboratory)
