# Dialogue between history and modernity in the preservation of historical ruins: The case of Helfštýn Castle

**Abstract:** The article examines contemporary architectural interventions at Helfštýn Castle in the Czech Republic, which illustrate an attempt to balance the preservation of historical heritage with the requirements of modernity. The castle, one of the largest in Central Europe, underwent a comprehensive restoration by the Czech architectural studio Atelier-r between 2017 and 2020. The work included structural stabilization, masonry repair, sandblasted glass roofing, and the introduction of modern architectural elements such as viewing platforms and pathways. The project was recognized for its creative approach and won numerous awards, including "Building of the Year 2021" in the Czech Republic. At the same time, it generated controversy, especially among conservation groups such as the Czech ICOMOS National Committee. Criticism included interference with the original historical substance, limited roofing exposing the ruins to deterioration, and the destruction of the building's late Gothic elements. The article highlights the complexity of the dialogue between traditio

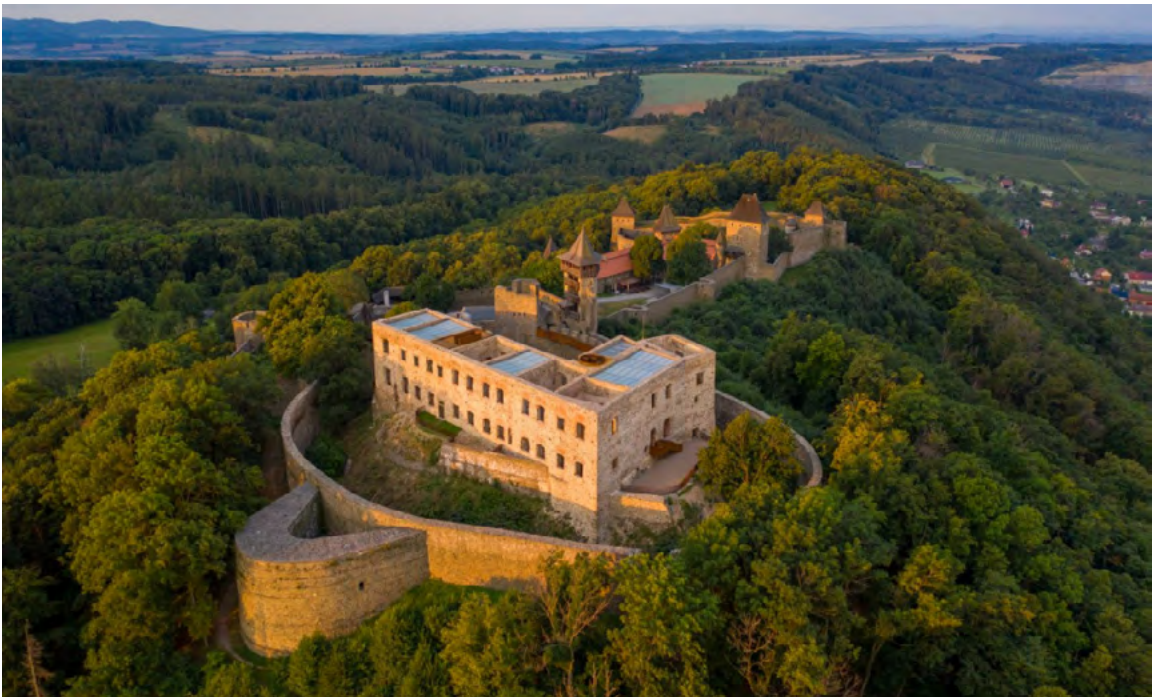
**Fig. 2.** General view of Helfštýn Castle. Author: Olomoucký kraj, Source: [https://www.idnes.cz/olomouc/zpravy/hrad-Helfštýn-ceska-cena-za-architekturu-pospisil-karlik.A211109\\_123136\\_olomouc-zpravy\\_stk](https://www.idnes.cz/olomouc/zpravy/hrad-Helfštýn-ceska-cena-za-architekturu-pospisil-karlik.A211109_123136_olomouc-zpravy_stk)

On the highest level of the building there are glass roofs (Fig. 12) and two viewing terraces (Figs. 14–15). The roofing of the palace was only partially completed, covering five selected chambers, while the remaining spaces were deliberately left open (Fig. 2). The roof structures are supported by steel profiles with sandblasted glass panels installed on top (Fig. 12). The frosted glass diffuses the light, providing softer interior lighting and making it easier to maintain cleanliness. An exception is the roof of the chapel, where transparent glass has been used to emphasize its unique character. The staircases are covered by corten steel platforms, which also act as viewing terraces (Fig. 14).

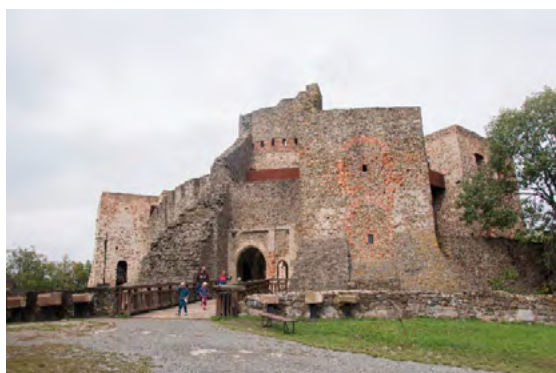
**Fig. 3.** General view of the Helfštýn Castle palace, 2022, by K. Drobek

Helřtřyn Castle is an example of a conscious dialogue between history and modernity, where architectural interventions preserve the character of the historic ruin while enhancing its functionality. From the outside, the perception of the site as a ruin dominates, emphasizing its historical character. A key element in the integration of the contemporary intervention with the historic structure is the corten steel footbridge that crosses the gate passage (Fig. 3). From a human perspective, the footbridge remains the only visible element of the modern addition, and its presence does not disrupt the distinct historic silhouette of the building.

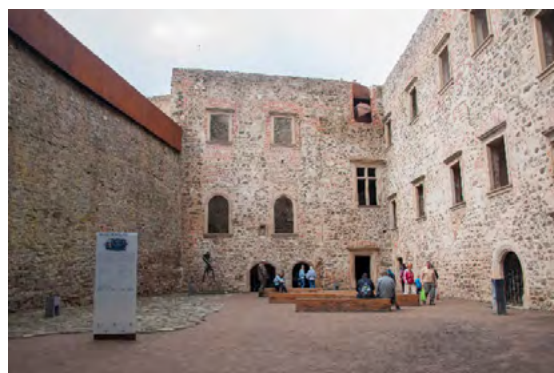
**Fig. 4.** View of the courtyard, 2022, by K. Drobek

A much stronger contrast between the new elements and the historical structure can be seen in the courtyard (Fig. 4). The corten footbridge, which runs along the perimeter wall, stands out as an example of modern architecture. Despite the use of the same material as the exterior elements, the solid form of the railings creates a sharp contrast with the historic background. This design choice is deliberate and aims not only to emphasize the presence of modernity in a historical space, but also to provoke reflection on contemporary methods of preservation and adaptation of heritage.

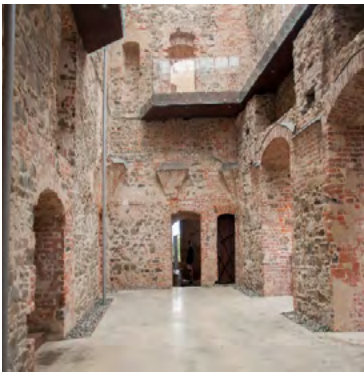
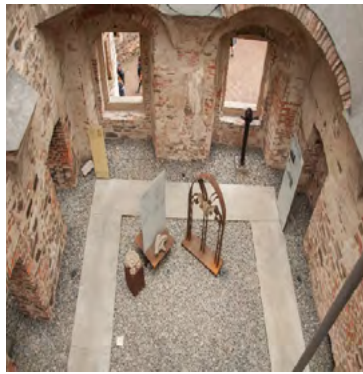
**Fig. 5.** Interior of the former chapel, 2022, by K. Drobek

**Fig. 6.** Concrete pathways and corten exhibits, 2022, by K. Drobek

At ground floor level, the primary material is polished architectural concrete, giving the pathways a minimalist and neutral appearance (Figs. 5–6). The walkways have been separated from the historical walls with corten edging and gravel surfaces (Fig. 7). The interiors on the ground floor have been converted into exhibition spaces, displaying artistic blacksmithing and the history of the castle.

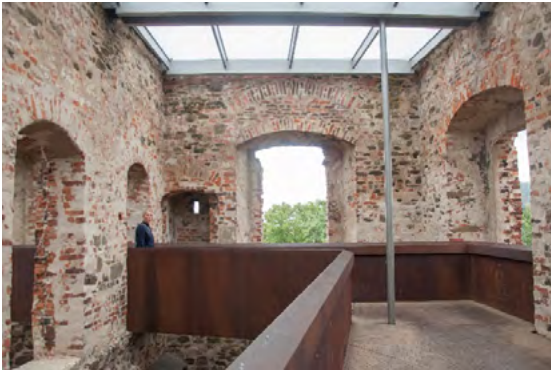
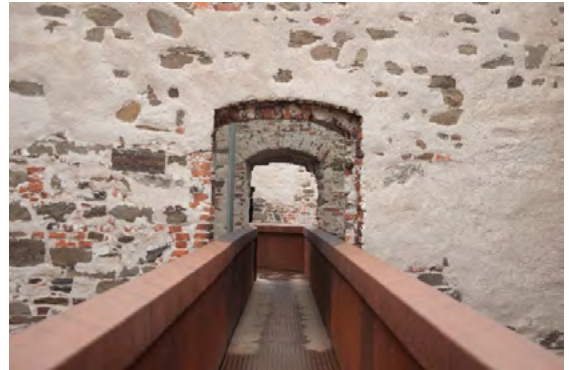
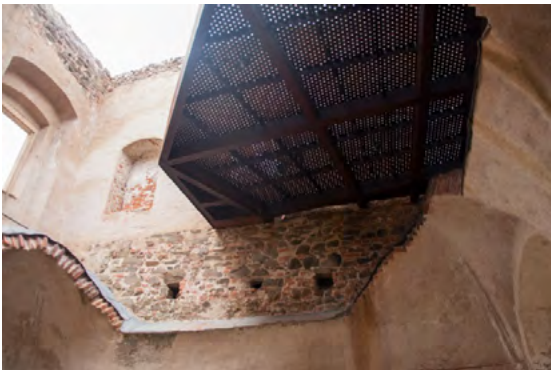
**Fig. 8.** Corten footbridge on the second level of the palace, glass room roofing and roof drainage, 2022, by K. Drobek

**Fig. 9.** Corten footbridge on the second level of the palace, 2022, by K. Drobek

**Fig. 10.** Corten footbridge on the second level of the palace, glass room roofing and roof drainage, 2022, by K. Drobek

**Fig. 11.** Staircase made of corten steel, 2022, by K. Drobek

On the second floor of the palace, new structures have been introduced to reflect the levels of the former floors, allowing visitors to view the palace and its surroundings from unique perspectives. Corten steel was deliberately chosen as the construction material for its aesthetic and functional qualities. The special properties of this material, such as its ability to patinate naturally, made it possible to create harmony with the texture of the historic walls, while subtly referencing the tradition of artistic blacksmithing that is deeply rooted in the castle's history<sup>28</sup>. The design of the floors was conceived in such a way that the beams were arranged irregularly, making the most of the existing wall elements while minimising the impact on the historic fabric.

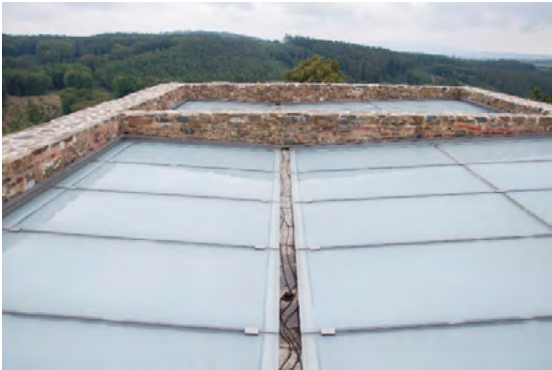
**Fig. 12.** Glass roof hidden below the wall topping line, 2022, by K. Drobek

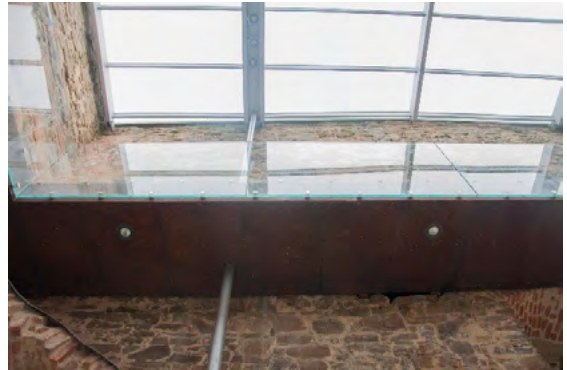
**Fig. 13.** Roof drainage pipe to the inside of the building, 2022, by K. Drobek

The roof drainage system is based on a flat roof design with a slight slope, which directs water into concealed gutters between the steel sections. Despite the functionality of the system, its design has been controversial due to the placement of the downspouts, which in some areas run through the interior of the palace, giving an impression of randomness (Figs. 8 and 13). For example, in some places the drainage runs through the centre of the walkway on the second floor, creating an aesthetically questionable element.

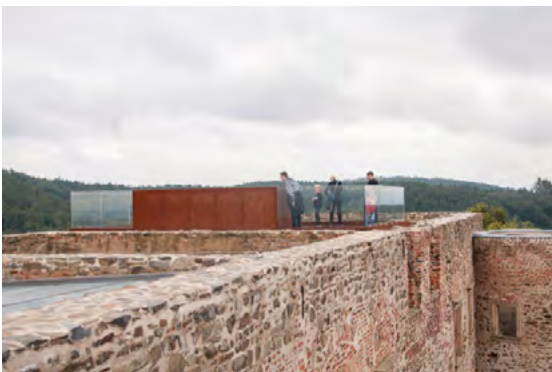
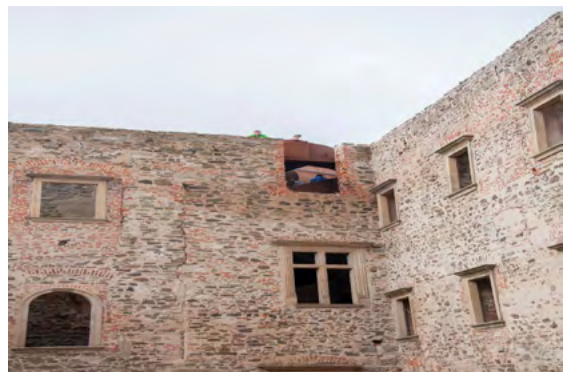
**Fig. 14.** Large panoramic terrace with balustrades made from corten and glass, 2022, by K. Drobek

**Fig. 15.** Viewing terrace at the spiral staircase, 2022, by K. Drobek

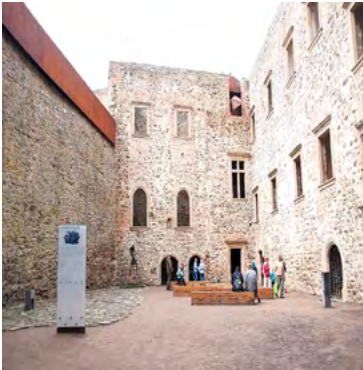
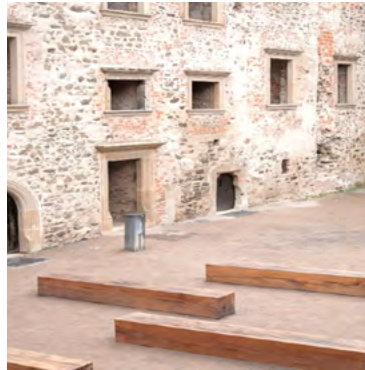
**Fig. 16.** Information board and outdoor lamp located in the courtyard area, 2022, by K. Drobek

**Fig. 17.** Benches located in the courtyard area of the palace, 2022, by K. Drobek

**Fig. 18.** A bench located in one of the chambers of the palace, 2022, by K. Drobek

The courtyard of the Helfstýn Castle features elements of small-scale architecture such as information boards (Fig. 16), benches and lighting installations. The glass information stands, mounted on minimalist steel structures, can also be found inside the building (Fig. 18). The benches, made of monolithic wooden blocks and set directly on the courtyard ground (Fig. 17), are in keeping with the historical context. While their simple form harmonizes with the surroundings, the material used shows little resistance to the climatic conditions of this geographical region. Less than three years after the completion of the project, the benches show considerable signs of wear. The direct contact of the wood with the ground facilitates the absorption of moisture, which accelerates its degradation. A lighter form of bench can be found inside the building (Fig. 18).

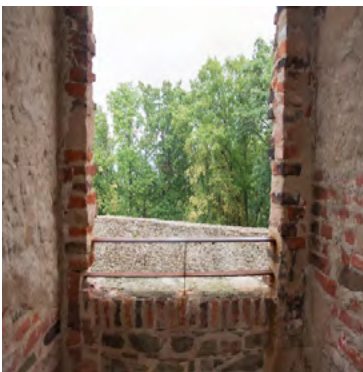
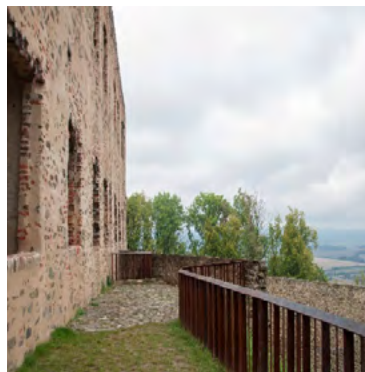
**Fig. 19.** Guard rail at window opening, 2022, by K. Drobek

**Fig. 20.** Openwork railing outside the palace outline, 2022, by K. Drobek

**Fig. 21.** Glass railing in the interior of the palace, 2022, by K. Drobek

The railings and other elements designed to protect users from falling in the palace take various forms (Figs. 19–21). In the accompanying figures (Figs. 18–19 and 21) we can see the use of corten steel elements, both in openwork designs (Figs. 19 and 20) and in solid railings (Figs. 8–9, 15 and 22). In addition, glass balustrades have been installed in selected rooms (Fig. 21) and on one of the viewing terraces (Fig. 14). Although glass can be challenging to maintain, it blends in effectively with the surroundings without detracting from the perception of the preserved historical elements. The transparency of the material, particularly on the viewing platforms, not only allows unobstructed views of the surrounding landscape, but also ensures safety for visitors of all ages, in keeping with current trends in heritage preservation and the adaptation of historic sites to modern needs.

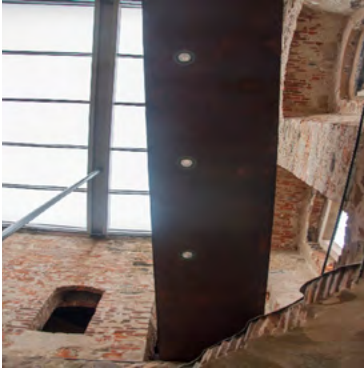
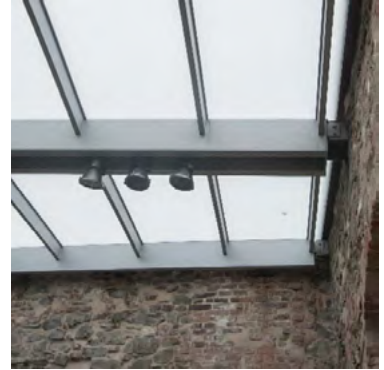
**Fig. 22.** Corten footbridge with lighting, 2022, by K. Drobek

**Fig. 23.** Recessed lighting in the floor, located on the tourist route, 2022, by K. Drobek

**Fig. 24.** Lighting mounted on roof steel beams, 2022, by K. Drobek

There are also several types of lighting (Figs. 16, 22–24). The railings incorporate integrated LED lighting which, together with recessed floor luminaires (Fig. 23) and spotlights mounted on the roof structure (Fig. 23), create a functional exhibition and communication space that meets modern presentation and safety requirements. The overall design is complemented by details such as steel gates and doors, which enhance both the visual and functional aspects of the reconstruction. Exhibition elements (Fig. 25) located in the exhibition rooms further emphasize the integration of modern interventions with the historical context of the site.

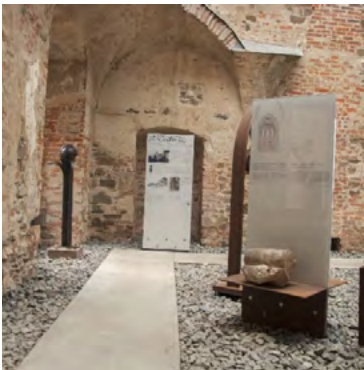
**Fig. 25.** Exhibition located in the palace chambers, 2022, by K. Drobek

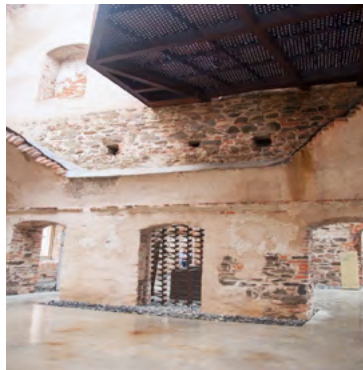
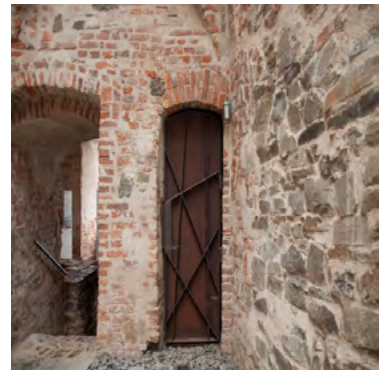
**Fig. 26.** Openwork door made of corten, 2022, by K. Drobek

**Fig. 27.** Solid doors made of corten, 2022, by K. Drobek
