The architecture of the Lublin Bernardine Monastery at the time of signing of the Act of the Union of Lublin

Krzysztof Janus

Abstract: The paper describes the history of the Bernardine Monastery complex and in particular its appearance and functions. The author made an attempt to reconstruct the layout of the buildings from the time when the Act of the Union of Lublin was signed. The article describes and presents in an interdisciplinary way the changes that took place in the structure of the complex and the phases of its transformation.

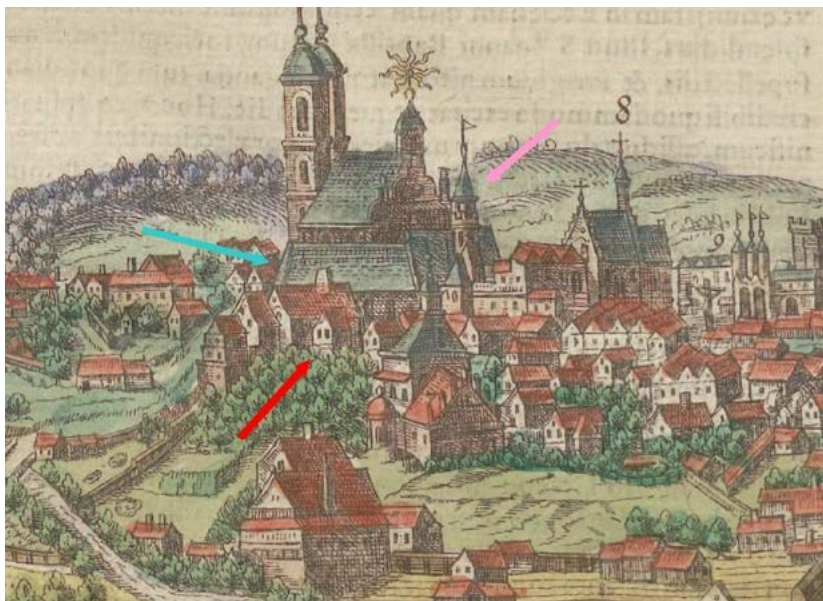
Fig. 1. A fragment of an engraving of Lublin made at the beginning of the 17th century, the Bernardine Church in the foreground (the blue arrow marks the southern wing of the monastery, the red – the building “Dom pod Orłem”) and the violet – an unidentified tower, <http://diglib.ub.uni-heidelberg.de/diglit/braun1618bd6/0001>

The first graphic representation of the church comes from the work of Hogenberg/Braun published in 1617. (Fig. 1). The church had two towers (now they don't exist anymore) at the façade, there is a bell tower topped with a dome marked on a rainbow wall, the south wing was topped with a gable roof with two gables, the building “Dom pod Orłem” with a prominent chimney is also visible. The gable between the nave of the church and the southern wing of the monastery seems to be above the part of the monastery with a façade in the vicinity of the middle of the sanctuary. An unidentified building on its right side of the church is a tower. It is not certain whether the tower can be linked to the Bernardines, but it was not possible to identify any other building that could have had such a tower at that time.

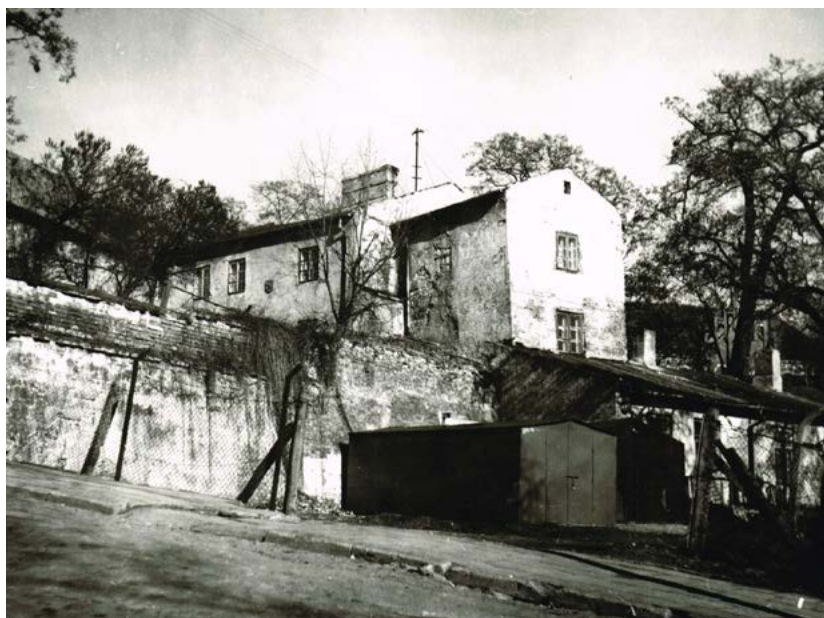
Fig. 2. The currently non-existing building "Dom pod Orłem", view from the side of the slope, A. Czerepiński 1972, LWKZ Archive

Before demolition, the building was two-storey (Fig. 2) and consisted of two parts of different heights, covered with different roofs. The only known basement stretched out of the building towards the monastery. In the hallway there was an inscription "IHS 1701" carved in stone. The image of the eagle on the western façade was added as early as the twentieth century²⁰. The dimensions of the main part formed a square with a side of about 10.5 m, combined with its location right next to the cliff may suggest the existence of a tower building, which was later gradually extended. The building does not in any way refer to the Bernardine buildings and the surrounding area, nor does it refer to the boundaries of the plot. Its original function is unknown, although it is possible that it was built on a plot of land that was not owned by the Bernardines, or existed there before the arrival of the monks²¹.

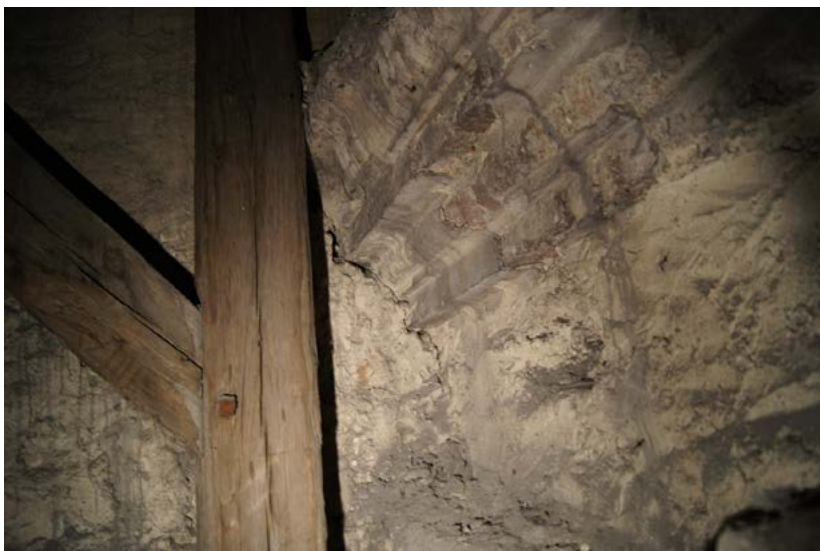
Fig. 3. The level of the attic above the southern nave of the Bernardine church, view of the cornice of the original façade, made between 1557 and 1569, photo: K. Janus, 2012.

The stage of reconstruction is quite readable both for the church and a part of the monastery. Thanks to the characteristic bricks, we know that the façade gained a new gable plastered with a cornice (Fig. 3), from which the larger fragments of the attic have survived. Most probably the whole church was plastered at that time, new vaults were made, and its dimensions, layout and probably height were not changed. The sanctuary was probably closed rectangularly and not polygonally²⁴. In the case of the monastery we know that just like the church, it suffered a lot in the fire. The reconstructed south wing was two-storey, with a steep gable roof (the gable on the side of Bernardyńska Street had a three-axis division – a blende on the axis vaulted segmentally and two small, rectangular holes on the sides (Fig. 10), below there was a cornice made of bricks laid “on the crease”. We know that the monastery, and certainly its gable, was plastered, the east wing had no existing annexes, on the ground floor there was a kitchen and a refectory and on the first floor there were cells (Fig. 5). Bernardines at that time were well equipped. There is no mention of the donations after the fire, but the renovation of the church must have been completed before 1569.

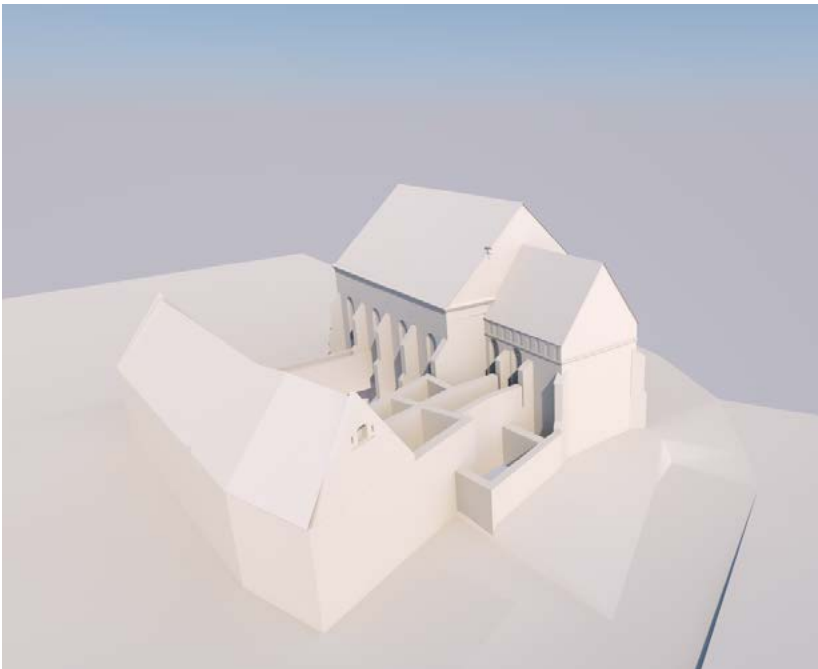
Fig. 8. An attempt to reconstruct the appearance of the complex from 1569, by K. Janus

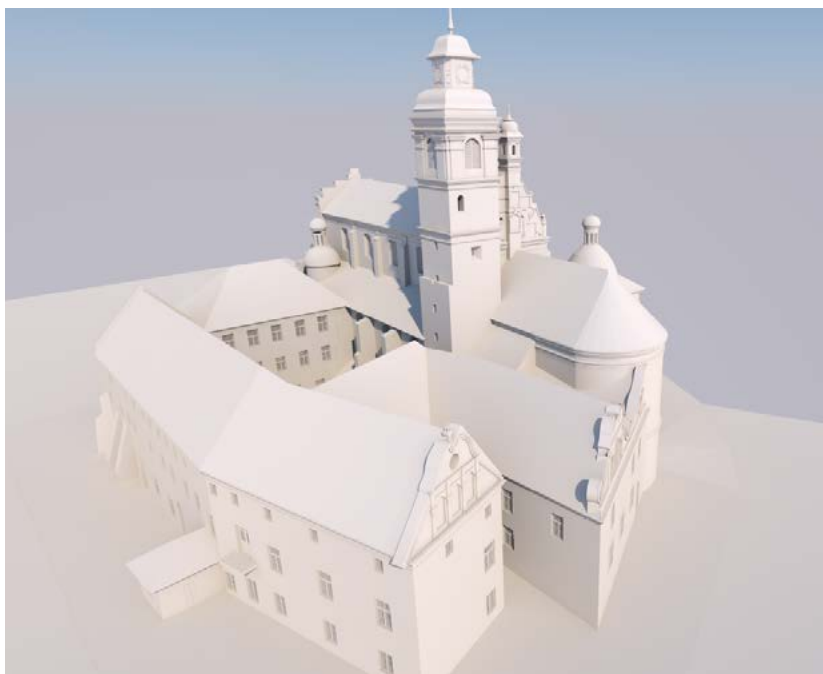
Fig. 9. Contemporary model of the building, by K. Janus

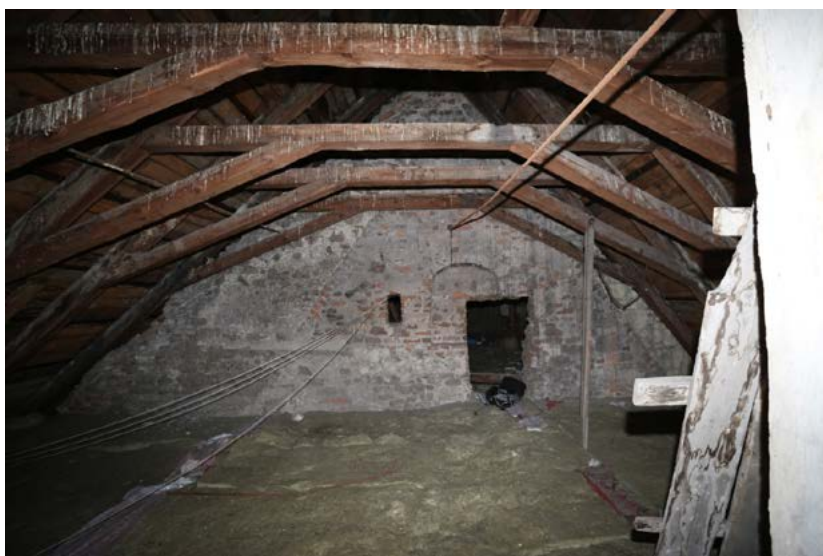
Fig. 10. The attic above the eastern annex of the monastery – a visible gable forming the gable wall of the monastery in 1569, photo by: K. Janus, 2012.
