Artistic painted decorations on the outside walls of the castles in western Ukraine

Mykola Bevz

Department of Build Conservation, Faculty of Civil Engineering and Architecture, Lublin University of Technology

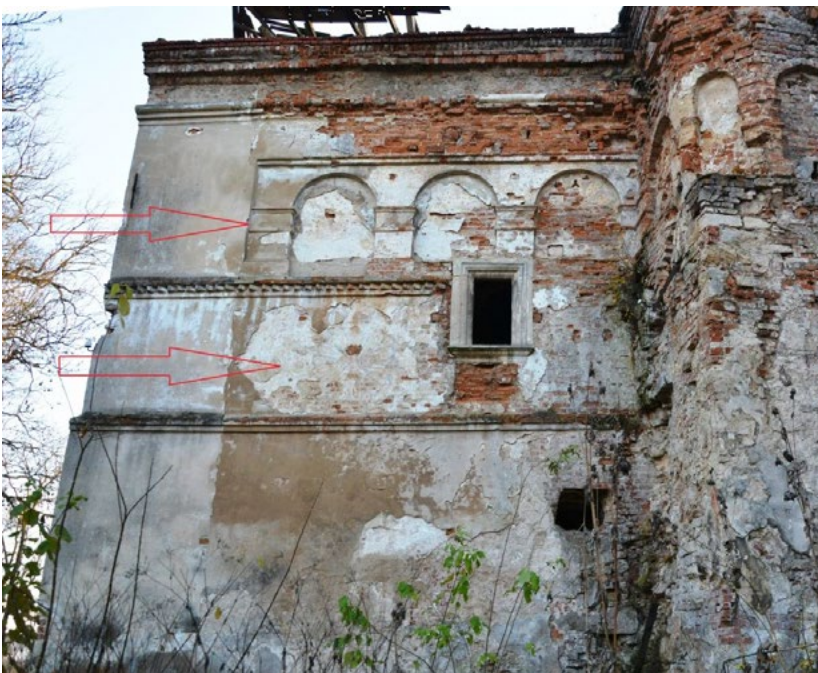
Fig. 3. The north wall of the corner tower of the Pomoriany castle. The places where the polychrome paintings preserved are indicated with arrows. Photo by M. Bevz, 2017.

The paintings were at the height of the second and third tiers on the outer wall of the southeast corner tower (Fig. 1, 3). This tower has been preserved in its reconstructed form. Its northern wall is best preserved and features Renaissance style with the remains of a “blind” arch belt over which, apparently, once had an attic end (sketch at Fig. 2). Nowadays, the upper part of the tower has a cornice end that is dated to the time of the rebuilding of the castle under Jan III Sobieski. The bricks and the eaves are similar to those parts of the castle

Red, grey, and blue colors dominate in the paintings. The murals are in the state of an emergency. Most of them are lost, although preserved fragments can be used to reconstruct an integral image. The second tier of the tower was painted with rosettes almost two meters in size (Fig. 3), among which were drawn some geometric figures (Fig. 4, 5, 6).

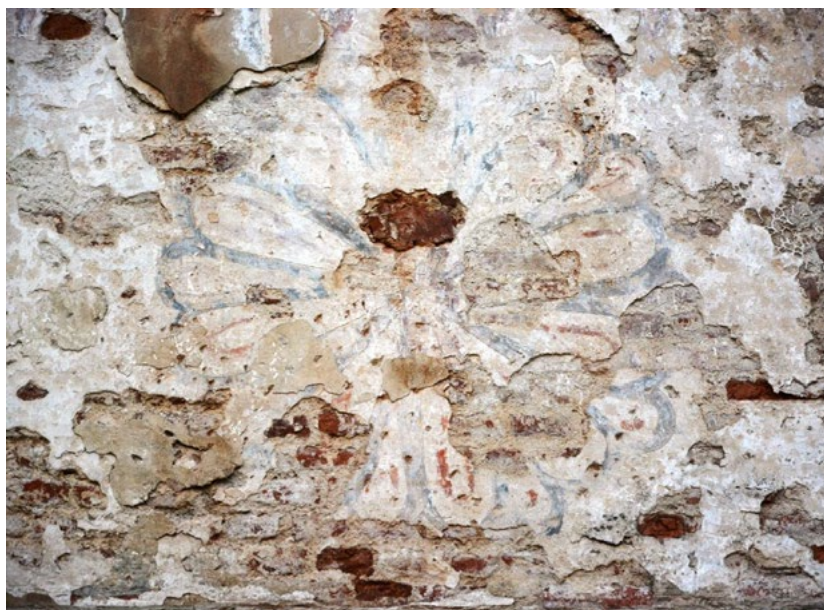
Fig. 4. A large rosette is drawn on the 2nd tier of the outer wall of the corner tower of the Pomoriany castle. Photo by M. Bevz, 2017.

- Application of polychrome composition with brushes, using water-soluble paints. Paints were applied on clean, non-textured surfaces. These features can be seen in the photo fig. 4, 5, 6. When drawing rosettes and buds, two colors were red and blue. However, in many places, these colors were mixed. As a third color, masters used whitewash. We selected samples of plaster and paint and submitted them for laboratory analysis. It should also be noted that pigment may have been added to the top layer of the plaster. The plaster has a light yellowish-golden hue (Fig. 6).

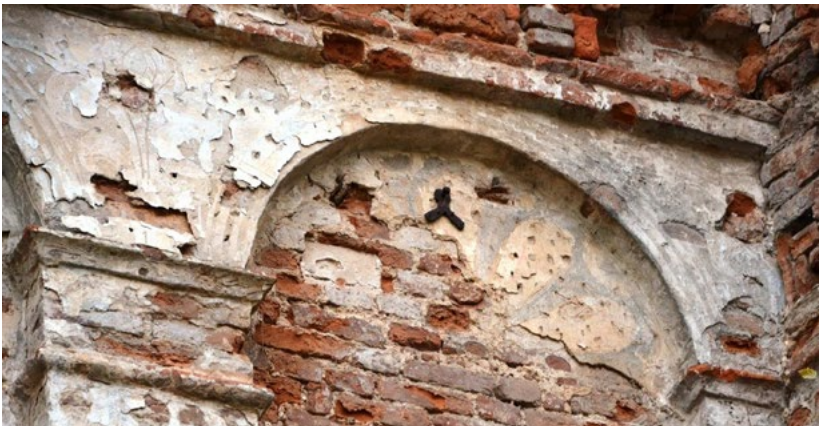
Fig. 6. Hand circle-drawn archivolts and half-rosettes in the arch belt on the 3rd tier of the outer wall of the tower. On the left side to the arch are fragments of a rose with branches. Photo by M. Bevz, 2017.

The third tier of the tower, which was built with a blind arcade, was also decorated with polychrome paintings. Their pattern corresponded to the arcade profiling of the wall. Under the arches were painted half-rosettes similar in style to those found on the 2nd tier (Fig. 6, 7). The pilasters had hand-drawn fluting. Their traces are still barely readable. Above the arches, striped archivolt (at seven belts) were drawn in detail. The triangular fields between arches above the pilasters are the most interesting: there is a large rose with symmetric branches (fig. 8).

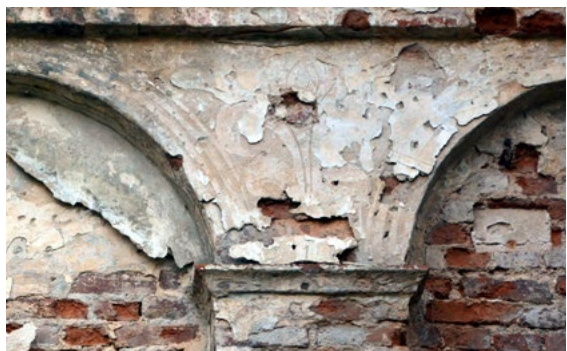
Fig. 8. Hand-drawn rose with branches on the 3rd tier of the outer wall of the tower in Pomoriary castle. Photo by M. Bevez, 2017.

- Scraping of those parts of the drawing that were to serve as the background, the top thin layer of plaster, giving it the character of the textured surface (Fig. 8);

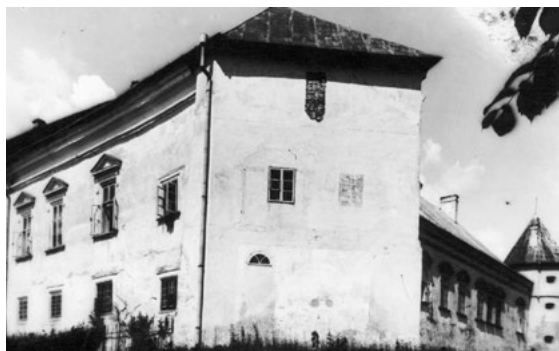
Fig. 9. The castle in Pomoriary. Photo from 1914 [polona. pl]. The place of the lost octagonal tower.

The tradition of exterior murals on the walls of the Pomoriany castle has proven to be very enduring. An interesting fact is finding photographs from the early twentieth century, which depicts a dummy painted window on the second tier of the same tower but on its north wall (Fig. 9). This is undoubtedly a later painting decoration. It comes from the time when the tower was already partially dismantled and plastered again. On the newly built part of the tower, a fake window was painted to give a symmetrical composition to the facade. It happened, probably at the end of the 18 – early 19 century. Similar drawings of dummy architectural decorations and elements are known from other objects. Large dummy framed windows were painted on the walls of the second tier. They decorated the lost gallery with a colonnade of Zhovkva Castle after its rebuilding in the 18th century. We were able to fix the polychromy of these windows in the late 1990s. Nowadays, these murals are already completely lost. Similar painted window decor is on the walls of Pidhirtsi Castle at the junction of the second tier with the terrace on the south side of the palace (Fig. 17, 18). In our opinion, these paintings should also be dated to the eighteenth century.

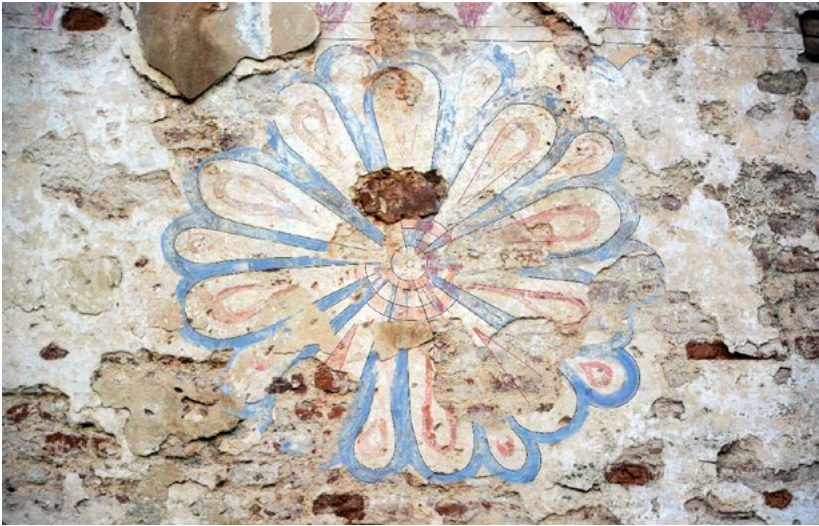
Fig. 10. Photo collage – reconstruction of polychrome painting rosettes on the facade of the castle tower in Pomoriany. Made by M. Bevz, 2019.

The composition and shape of the carved rosettes and triglyphs are very similar to the rosettes and vertical stripes painted on the facade of the southwestern tower (Fig. 7, 10). From this we can conclude that the detected painted decoration on the walls of the castle was made, looking at the carved scenery. That is, the painted and carved decoration of the castle walls were created in stylistic unity.

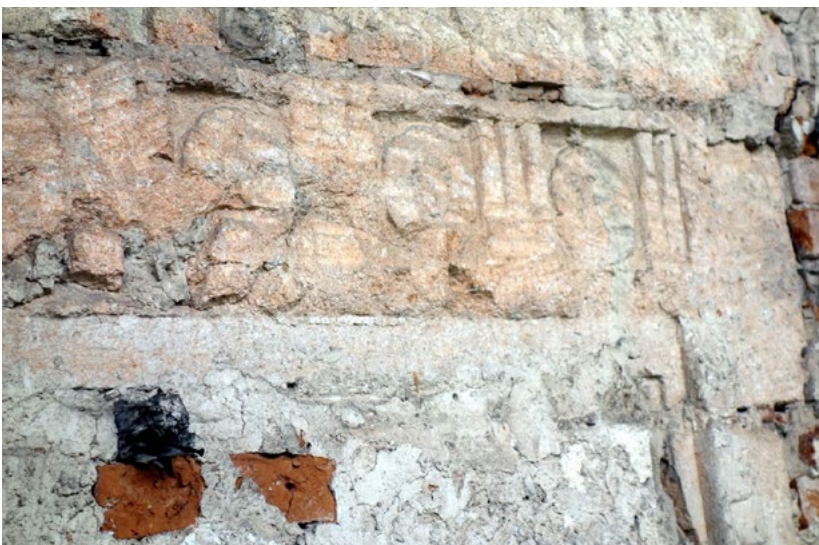
Fig. 12. Fragment of the south wall of the castle in Pomoriany. The carved window framing is made in limestone. The scenery is made up of carved rosettes and triglyphs arranged alternately. The carved forms were partially cut down during the rebuilding of the castle in the 17th century. Photo by M. Bevz, 2017.

As a result of studies of the walls of Pomoriary castle, we found another interesting detail. On the main facade of the castle palace, as a result of the plaster fall, old bricked opening of windows and doors have appeared (Fig. 12, 13). The edges of these old slits are carved out from a limestone. These slots refer to the earlier period of operation of the castle. They were bricked up during the rebuilding of the castle in the time of Jan III Sobieski. The stone decoration of these original frames of windows have a renaissance character in shape and plastic. In particular, the upper beams of these frames have a very interesting carved decoration in the form of rosettes and triglyphs.

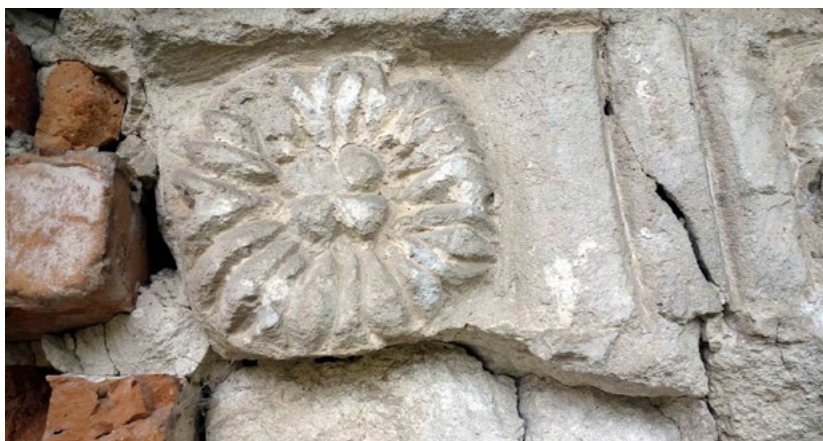
Fig. 13. A well-preserved carved rosette from the window framing of the 16th century. Castle in Pomoriary. Photo by M. Bevz, 2017.

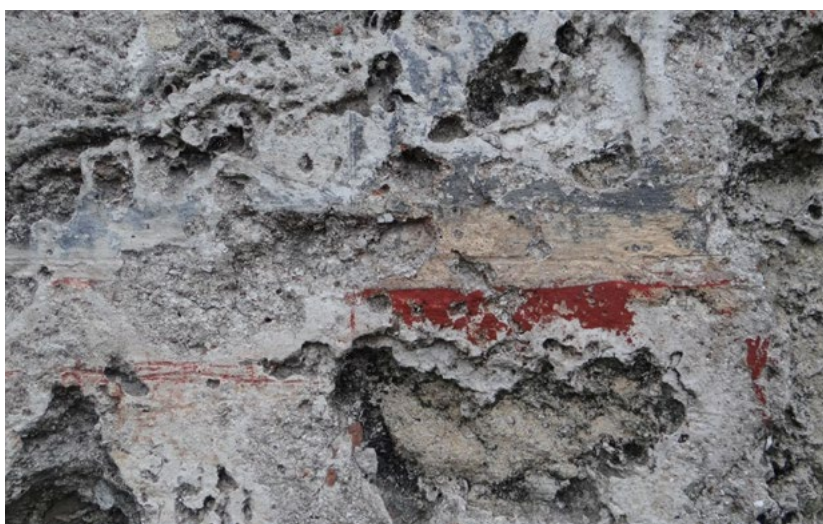
Fig. 14. Fragments of paintings at the outer wall of the castle in Yazlivets. Photo by M. Bevz, 2017.

Unlike the Pomoriany castle, fragments of paintings in Yazlivets are in the lower tier on the straight section of the northern defensive wall between the semicircular tower and the corner (Fig. 14).

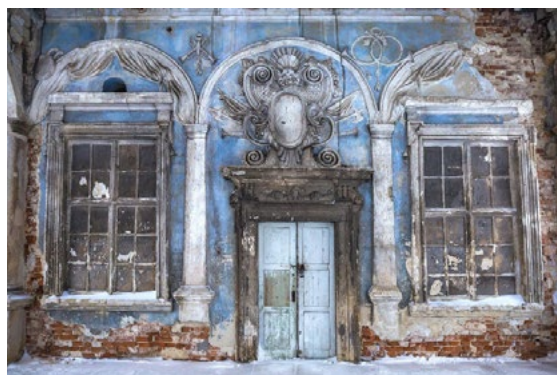
Fig. 18. Photo of stucco and painted fictitious windows on the eastern terrace of the castle in Pidhirtsi (present state). Photo by E. Shavlovskya [12].

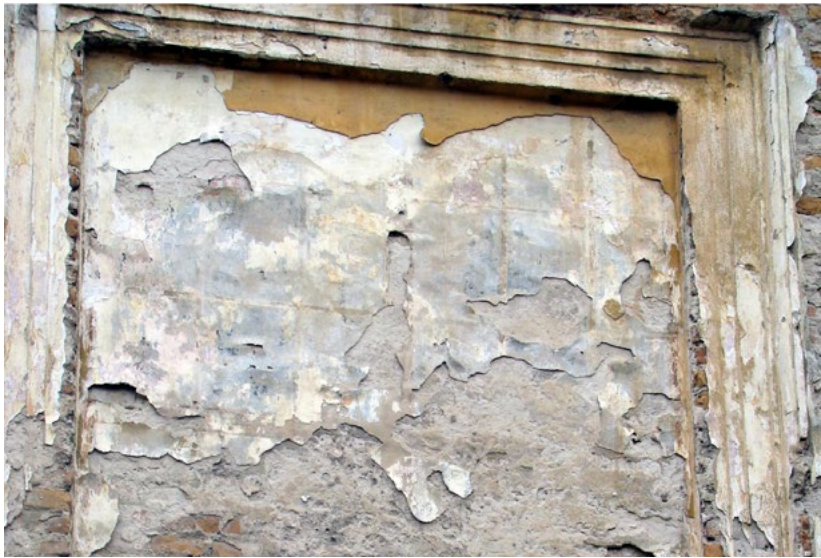
Fig. 20. Photo of the remains of artistic fictional paintings (the window) on a wall of the castle in Zhovkva. Photo by M. Bevz, 2012.

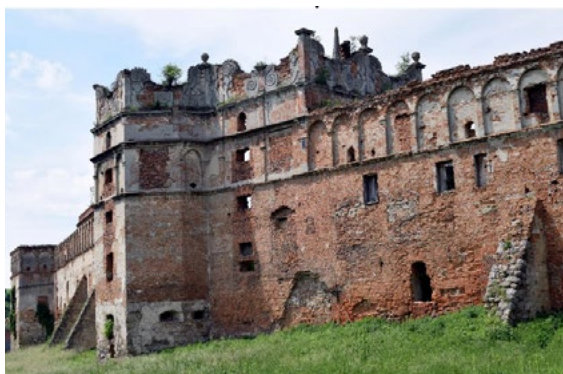
Fig. 21. Castle in the village of Stare Selo. Photo by M. Bevz, 2019.

We found another example of decorating the castle walls using paintings. This decoration found in 2019 in the Stare Selo castle. This is a castle that was built in the late 16th-early 17th century. Saved in ruins. Its architectural appearance has not been much changed in subsequent periods. Therefore, this castle is analogous to the castles in Pomoriany and Yazlivets. In particular, the architecture of the castle towers in Stare Selo is very similar to that of the Pomoriany Castle tower. The towers of these castles have the same granular plan and the same type of attic tops. On the outer walls of the southwestern tower and on the wall of the south gate, we find the remains of markings under polychrome scenery. This scenery had the character of a geometric ornament (Fig. 21–24).

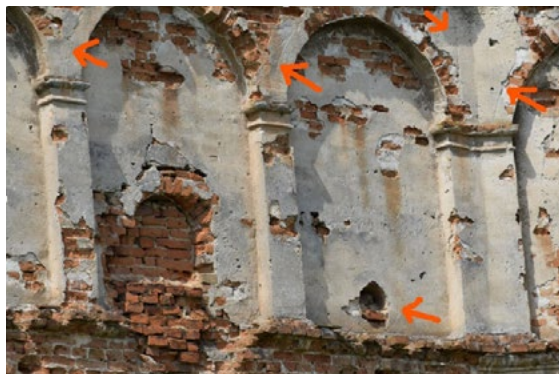
Fig. 22. The photo of the arcade belt of the upper part of the outer wall of the Stare Selo castle. Arrows indicate traces of marking for painting on plaster. Photo by M. Bevz, 2019.

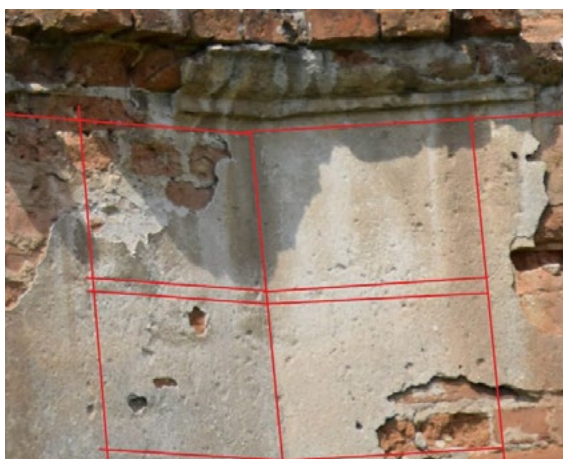
Fig. 23. The fragment of the outer wall of the west wall of the Stare Selo castle. The lines indicate the marking on the plaster for painting. Photo by M. Bevz, 2019.
