The use of 3D scanning for the inventory of historical buildings on the example of the palace in Snopków

Abstract: This paper discusses the use of modern technology of inventory measurements based on the inventory of the historical palace and park complex in Snopków. The inventory of the site was made using laser scanning measurements. The article draws attention to the specificity of the inventory of historical sites, their complexity and diversity of architectural details that are important for proper revitalisation and further preservation works.

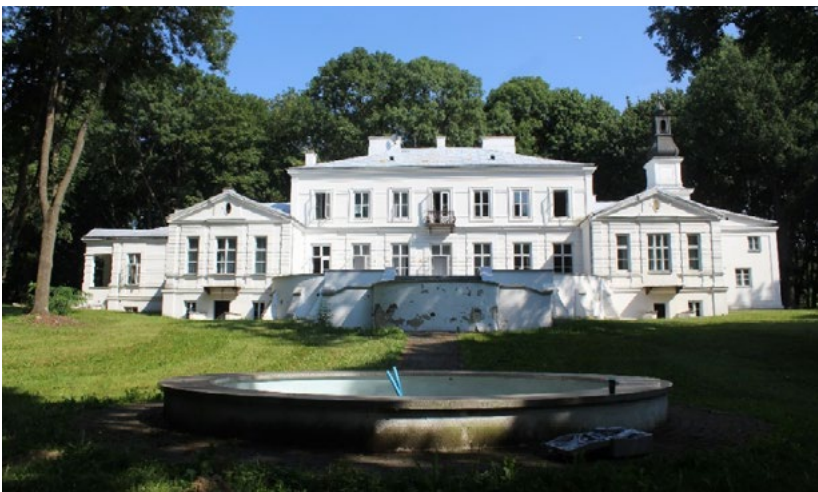
Fig. 2. South façade. (author's own photograph)

The palace building has a basement under a part of its surface built on the plan of the letter "U" with a multi-sloped roof. The plan of the building is composed of segmented rectangles, with the two-storey central part with an unusable attic and one-storey side wings with usable attics. Outermost east two-storey wing has lowered ground floor level. The second floor of the east wing is not connected with the palace floor. On the south side, there is a semi-circular terrace with three-run concurrent stairs. The main body of the palace on the east side is crowned with a clock tower with a tented roof. (Fig. 2.)

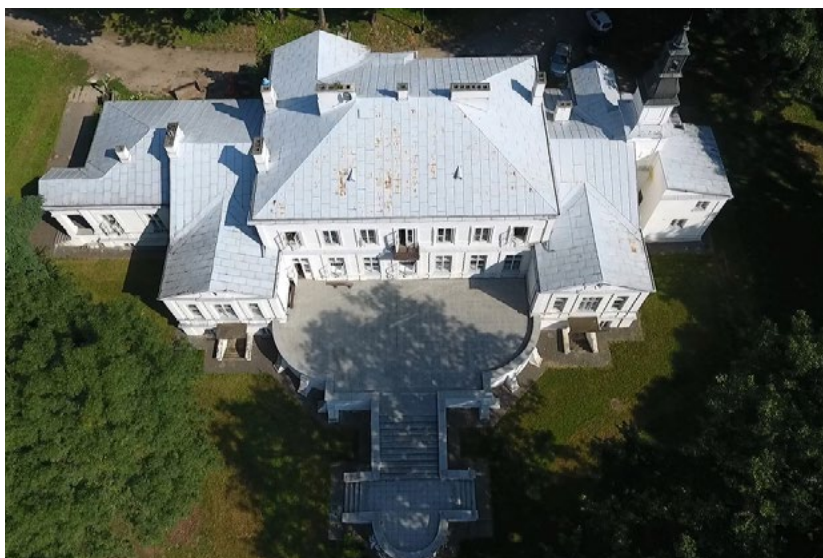
Fig. 3. Top view (author's own photograph)

The palace is situated on the main axis of the complex, about 80 m away from the border with a farmyard. It is established on the projection close to an elongated rectangle on the east-west axis. The front of the building faces north. On the south side, on the axis of the palace there is a large semi-circular terrace with three-way symmetrical stairs and a semi-circular landing in the main axis (Fig. 3.).

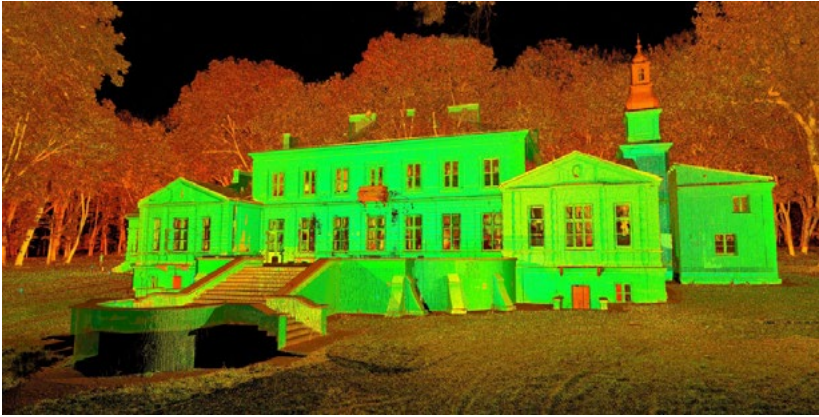
Fig. 4. Obtained point cloud with the Leica C10 (elaborated by the author)

Measurements performed with the use of modern laser scanning technology can reduce the risk of measurement error to a minimum. The data obtained with the device in the form of a point cloud (Fig. 4.) are used to create very precise inventory note. Thanks to this technology, it is possible to reproduce the existing building geometry taking into account the accurate architectural detail (Fig. 5.) in a three-dimensional space. Additionally,

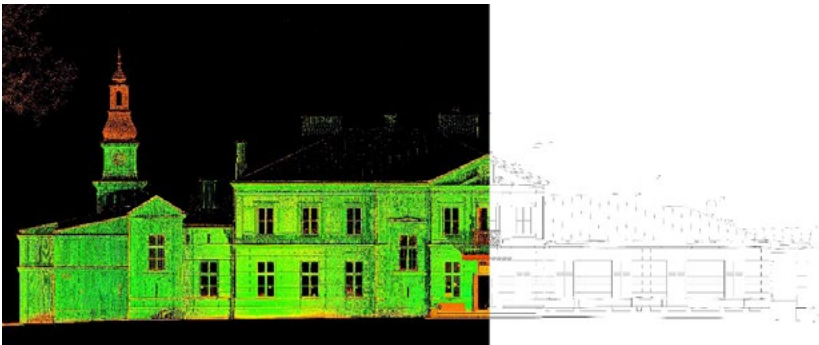
Fig. 5. Overview of the façade development with the completed drawing (elaborated by the author)

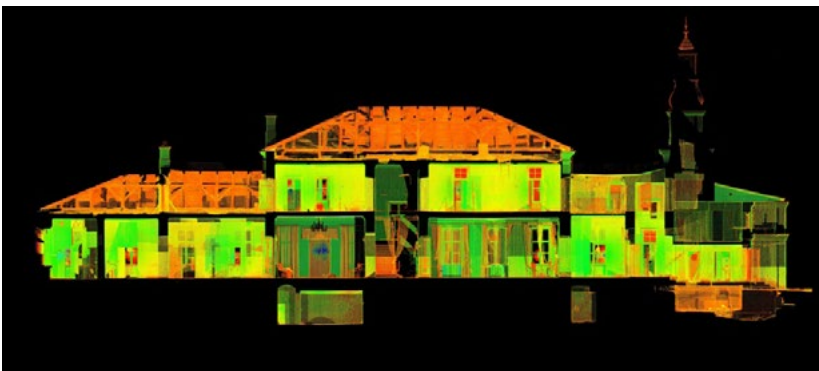
Fig. 6. Cross-section of an object generated from a cloud of points (elaborated by the author)

This method also gives the opportunity to conduct a comparative analysis based on archival materials and to develop a detailed assessment of the technical condition of the facility. After generating a point cloud obtained from scanning the palace building, some elements were noticed which could be omitted with the use of the traditional method, i.e. different thickness of walls on subsequent floors and reference of their location in relation to each other. This is illustrated by the cross-section of the object generated in *Leica Cyclone* program (Fig. 6.). All deformations in the building's geometry are clearly visible and clear. Then 2D documentation was prepared based on the generated image (Fig. 7.)

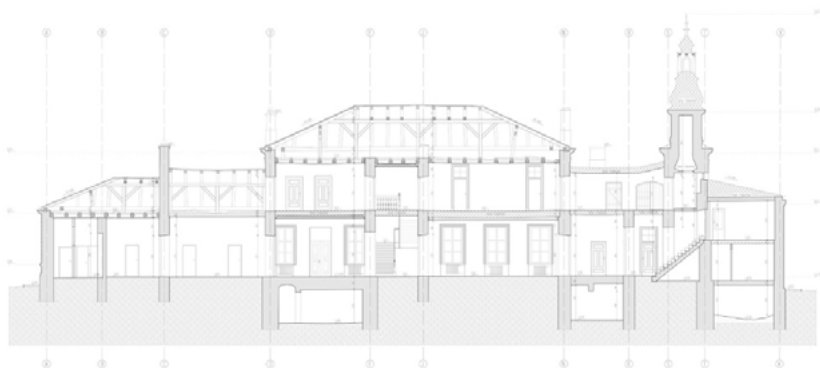
Fig. 7. Cross-section of the object based on a point cloud (elaborated by the author)

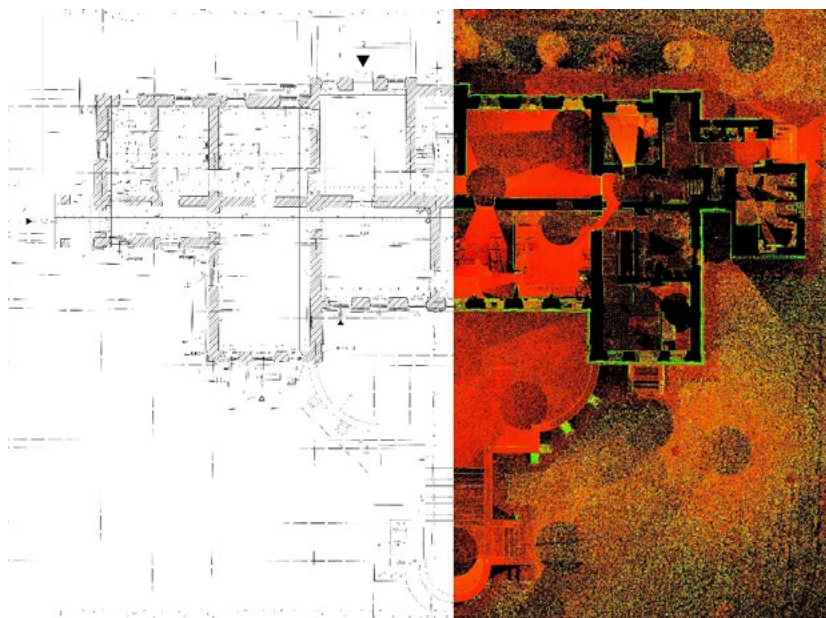
Fig. 8. Summary of the projection generated from the point cloud with the projection made on the basis of the cloud (elaborated by the author)

When working with the acquired point cloud, it was possible to transfer the actual state onto the paper version keeping the maximum accuracy of the building geometry. The following picture shows a comparison of a 3D scan generated in Leica Cyclone program with a drawing made on its basis representing the plan of the ground floor of the building (Fig. 8.).
