Assessment of the technical condition of a historic building using photogrammetry and terrestrial laser scanning: the case of the Juliusz Osterwa Theatre in Lublin

Abstract: This paper presents a methodology for assessing the technical condition of historic building façades, using the Juliusz Osterwa Theatre in Lublin as a case study. The approach is based on the integration of terrestrial laser scanning (TLS) data and close-range photogrammetry. The comprehensive dataset enabled the generation of a dense, metrically reliable 3D model of the building envelope as well as façade orthophotos. These products were used to prepare a detailed graphical inventory of damage, including surface cracking, cracks and fractures, corrosion, plaster losses, biological growth, and damp areas. The resulting damage maps allowed the identification of zones of advanced degradation, the prioritisation of conservation interventions, and the indication of methodological limitations and directions for further development, confirming the high utility of the proposed methodology in modern integrated diagnostics of historic buildings in urban environments.

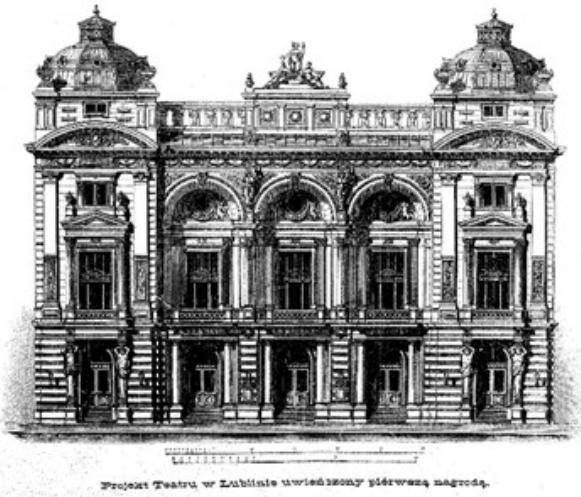
Figure 2. Winning competition design of the Theatre – front façade. Source: [5] (accessed 2025 Nov)

Constructed between 1884 and 1886 according to the winning competition design by architect Karol Kozłowski, the building represents an eclectic architectural style (Fig. 2). From the beginning of its existence, the structure has served a theatrical function, except for the period of the First World War, when it was temporarily converted into a military hospital.

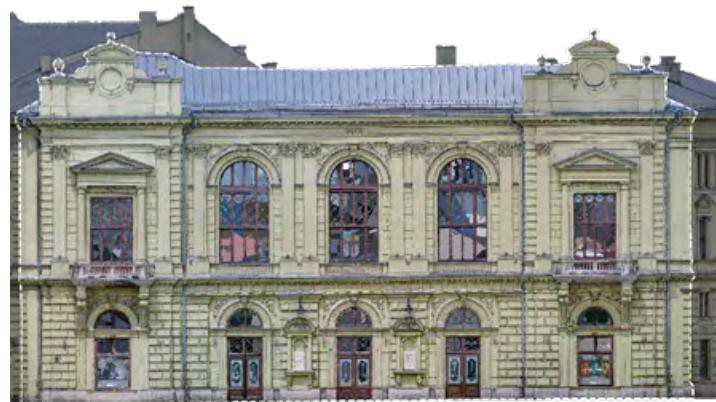
Figure 3. Current view of the front façade. Source: Authors

The building mass (Fig. 3) consists of three interconnected parts shaped in accordance with the course of the surrounding streets, with later extensions located on the northern side. The building is partially below ground and covered with gable roofs. The individual segments share the same overall height but differ in the number of storeys (2, 4, or 5), reflecting their varied functional uses.

The two-storey, five-axis front façade features lateral pseudo-risalits and rich classical detailing, with central arched portals and elaborately designed windows and *portefenêtres* on the upper floor. The façade is crowned by a cornice with modillions, a frieze bearing the date "1886," and attics adorned with aediculae and vases. The interior retains a representative entrance hall as well as a richly ornamented stucco decoration of the auditorium, balconies, and boxes.

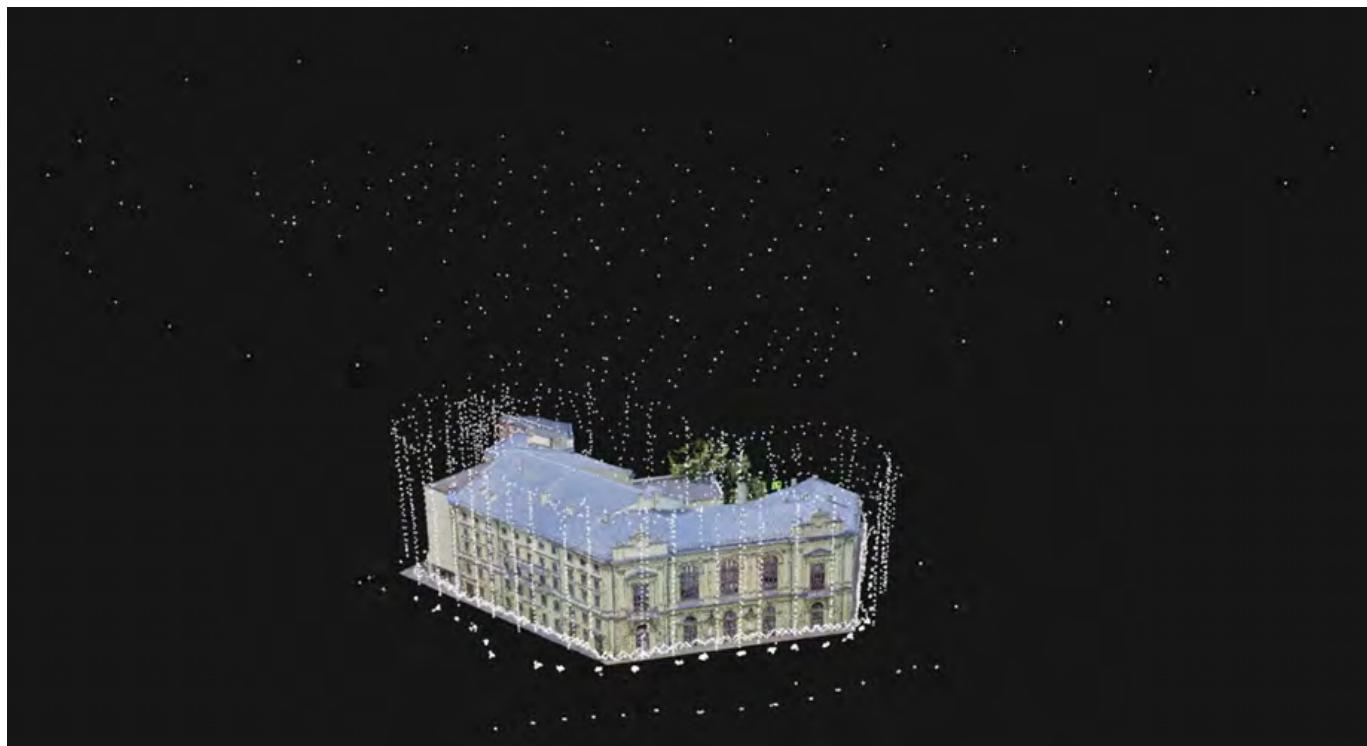
Subsequently, the software matched common features between pairs of images. This process is computationally intensive, as the number of comparisons increases with the size of the photographic dataset. To reduce processing time, the algorithms may utilise additional metadata, such as the image acquisition date or the GPS coordinates of the camera. This allows the set of potential image pairs to be narrowed, significantly accelerating the analysis.

Figure 4. Photogrammetric point cloud with camera positions. Source: Authors

After establishing the mutual relationships between the detected feature points, the software determined the external orientation of the images, corrected optical distortions, and reconstructed the initial geometric structure of the object. A prerequisite for computing the spatial position of a point is its registration on at least two images. The result of this stage is a sparse point cloud containing a set of 3D coordinates along with radiometric information.

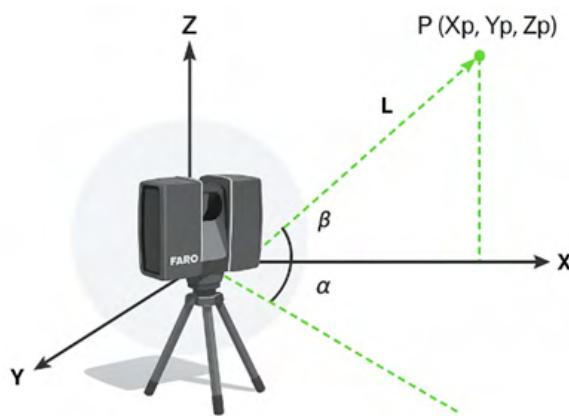
In TLS instruments, the distance L is measured using either the time-of-flight principle or the phase-shift measurement method. A movable mirror or scanning head directs the laser beam in a controlled manner, performing scanning in both vertical and horizontal planes. For each recorded reflected signal, the instrument determines a set of measurement parameters, including the distance L , the directional angles α and β , the return intensity, or other radiometric parameters. Based on the known geometric parameters of the beam and the measured distance, the scanner computes the spatial coordinates of point P in the instrument coordinate system (Fig. 5). In subsequent processing, the data are registered and georeferenced, allowing their transformation into a global or project-specific local coordinate system.

Figure 5. Principle of operation of the laser scanner.
Source: Authors

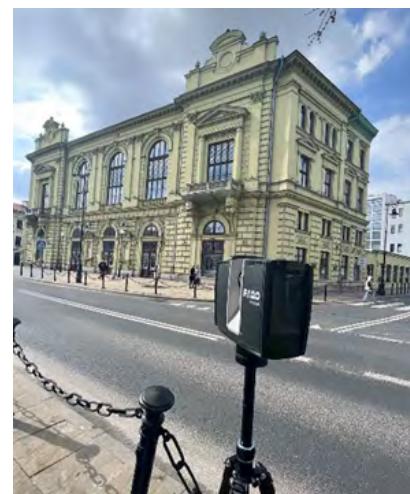
Figure 6. Photograph from the laser scanning process on the site. Source: Authors

Modern stationary laser scanners (Fig. 6) integrate additional sensors, including an inertial measurement unit (IMU), a magnetic compass, a GNSS receiver, and RGB cameras or panoramic camera systems, which enables automatic synchronisation and colourisation of the point cloud. Acquisition rates reaching several million points per second, combined with variable angular resolution, allow the collection of extremely high-density data, often exceeding several hundred points per square metre. Measurement accuracy on the order of 2–6 mm, and in high-precision instruments even below 2 mm, makes this technology particularly suitable for applications requiring a high level of geometric detail, such as structural diagnostics, architectural surveying, conservation documentation, and deformation monitoring.

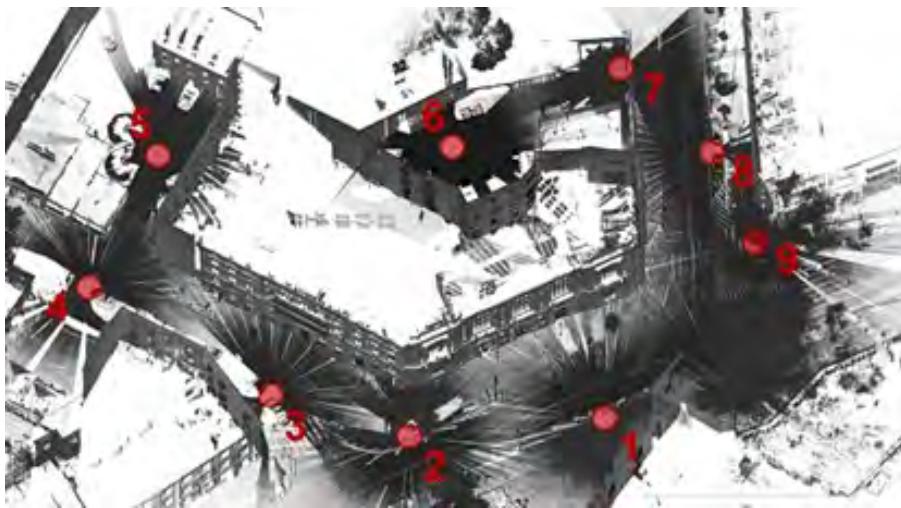
Figure 7. Layout of laser scanner stations. *Source: Authors*

The scanner stations (Fig. 7) were linked using a network of reference targets and adhesive markers placed on stable façade elements, such as corners, sections of window surrounds, and cornice segments (Fig. 8). These points were used both for multi-station registration and for subsequent integration with the photogrammetric model. The registration process was carried out in software dedicated to the operation of the instrument, resulting in a single, unified point cloud representing the entire building.

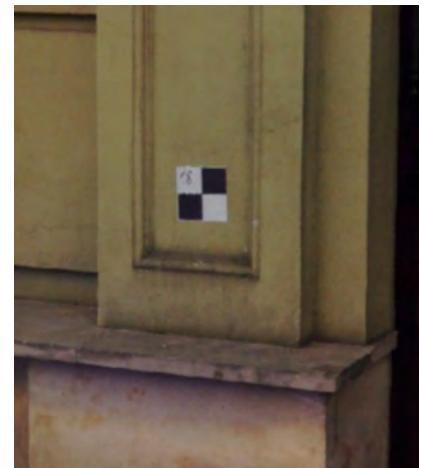
Figure 8. Photograph of a control point. *Source: Authors*

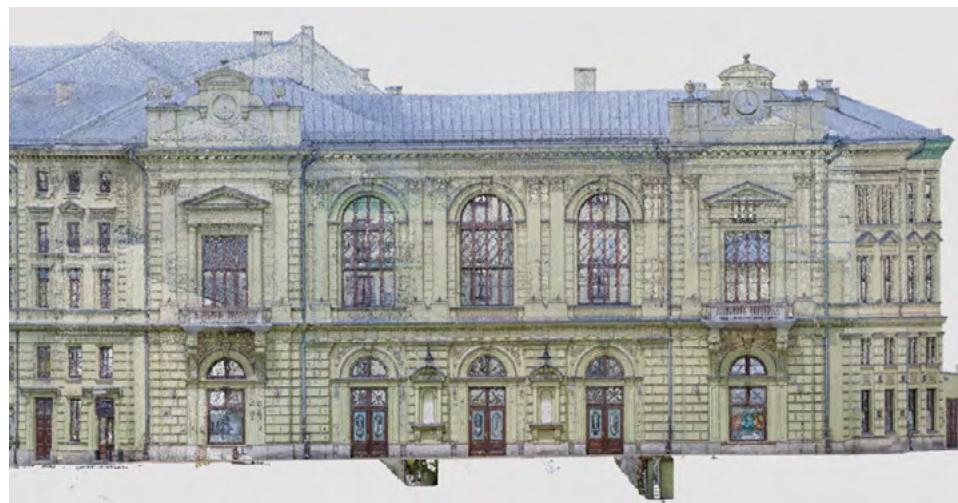
Model texturing was carried out using the complete set of photogrammetric images. This resulted in a realistic reproduction of surface colour and texture, enabling visual identification of discolouration, streaking, soiling, and other traces of material degradation. The quality of the textures proved sufficient for their further use as base materials in manual and semi-automatic damage mapping at the scale of architectural detail. Below, two example façade models are presented: the front façade (Fig. 9) and a side façade (Fig. 10).

Figure 9. Point cloud of the front (south-eastern) façade. *Source: Authors*

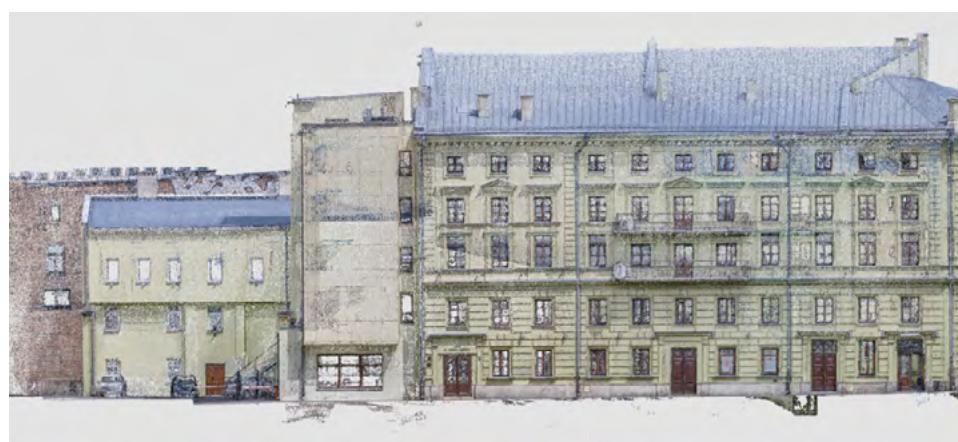
Figure 10. Point cloud of the southern façade. *Source: Authors*

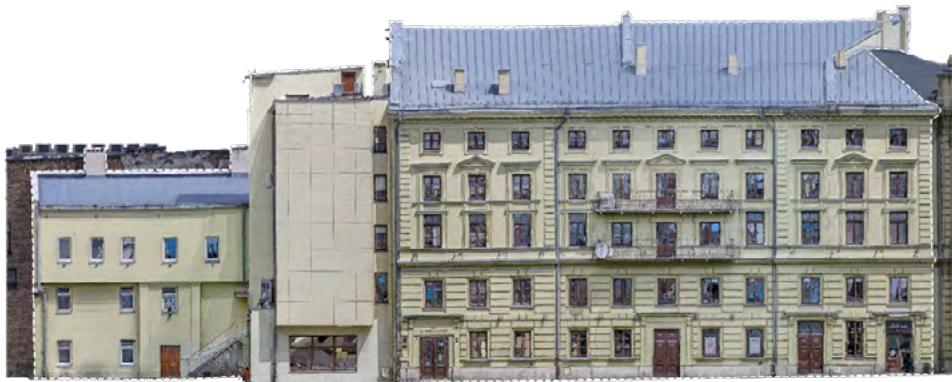
Based on the 3D model, orthophoto representations of the individual façades were generated (Figs. 11 and 12), forming a set of two-dimensional base materials in orthogonal projections. Each base covered the full height of the façade

Figure 11. Orthophoto of the southern façade. *Source: Authors*

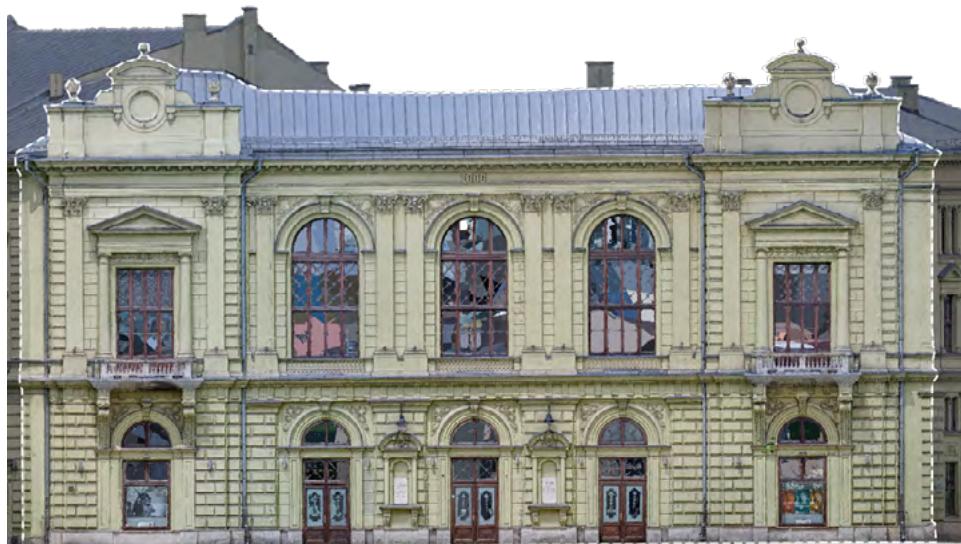
Figure 12. Orthophoto of the south-eastern façade. *Source: Authors*

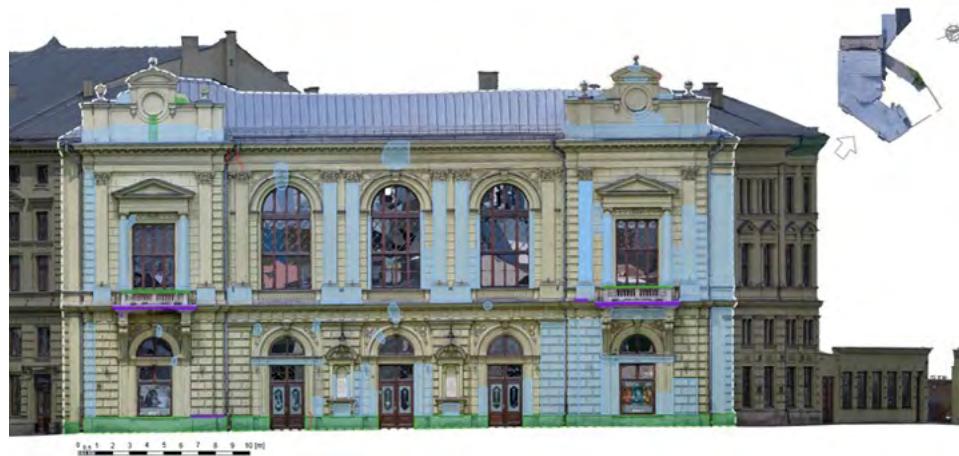
A detailed graphical inventory of damage was carried out on the orthophotos of the individual façades (Figs. 13 and 14). For the purposes of the study, a set of damage categories corresponding to the applied cartographic legend was defined, including:

Each category was marked on the inventory drawings using a distinct graphical symbol, which enabled both qualitative and quantitative analysis of the spatial distribution of damage. The mapping results revealed a clear differentiation in the state of preservation between the individual façades. The highest concentration of damage was recorded:

- in the plinth zone, where dampness and associated biological corrosion as well as plaster losses predominated;
- in areas of architectural detail (cornices, window surrounds, attics), which are particularly exposed to rainfall and temperature fluctuations and where numerous instances of surface cracking, cracks, and corrosion of metal elements were observed;

- in corner zones and around openings, where oblique and vertical cracks and fractures accumulated, potentially related to structural behaviour or previous repair interventions.

Figure 13. Graphical inventory of damage on the front (south-eastern) façade. *Source: Authors*

A comparison of the results obtained for the two façades analysed in detail showed that the façade more exposed to direct atmospheric influences and traffic-related pollution is characterised by more advanced degradation of the plaster layer, a higher proportion of plaster losses, and more intensive biological corrosion. In contrast, the less exposed façades exhibit a lower degree of damage while retaining a relatively better condition of the architectural detail.

Despite the identified limitations, the obtained results demonstrate that a hybrid photogrammetric–laser scanning model can serve as an effective tool supporting the planning and execution of interventions on historic façades. The developed damage maps enable the prioritisation of conservation needs by indicating zones with the highest degree of degradation and potentially the greatest risk to user safety.

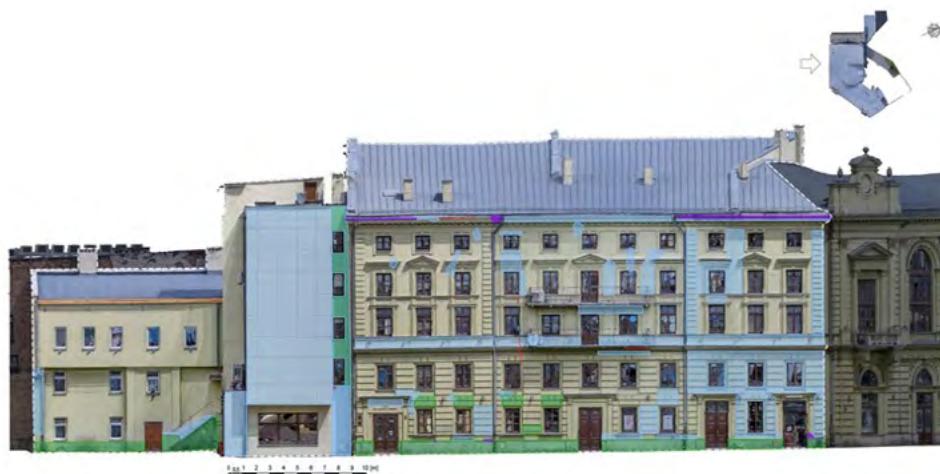
Figure 14. Graphical inventory of damage on the southern façade. *Source: Authors*
