Revisited the localization of fortifications of the 18th century on the surroundings of village of Braha in Khmelnytsky region

Abstract: the results of the survey of the territories of the village Braha in the Khmelnytsky region, which is in close proximity to Khotyn Fortress, are highlighted in this article. A general description of the sources that has thrown a great deal of light on the fortifications of the left bank of the Dnister River opposite the Khotyn Fortress according to the modern landscape, is presented.

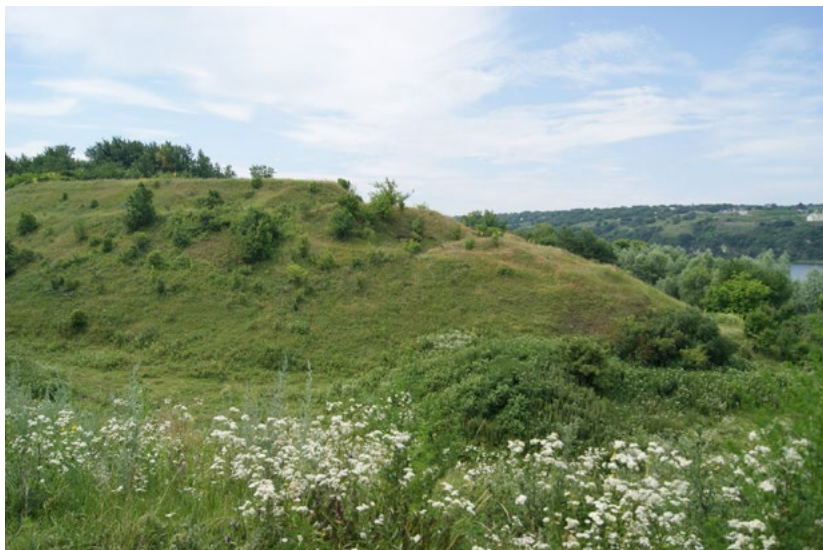
Fig. 4. Remnants of Redoubt in the Area of Braga On the North Side as of 2014. Photo by the author

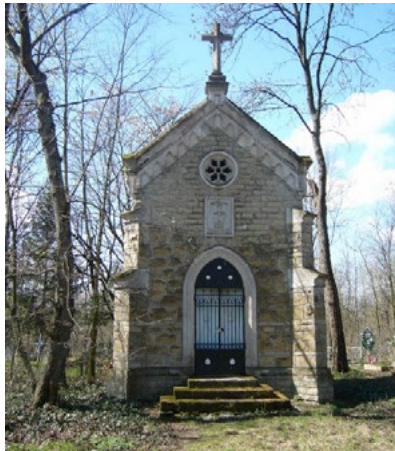
Fig. 6. Zebrowski's chapel and crypt in the Catholic cemetery. 2014 Google Photos

The development of archival sources, aerial photography based on of the mentioned above scheme will allow to investigate archaeologically the sites of localization of the former fortifications, to refine the tracing of numerous fortifications of different times, that will also allow to have a new look at the specifics of the ancient fortifications of the Khotyn complex and understand the basic principles of its arrangement and landscape. At this stage, it is necessary to collect and accumulate all revealed information about the historical and cultural heritage of the settlement, about its historical sites (Fig. 6, 7), which will help to reproduce a more complete picture of the historical development of Braga village.

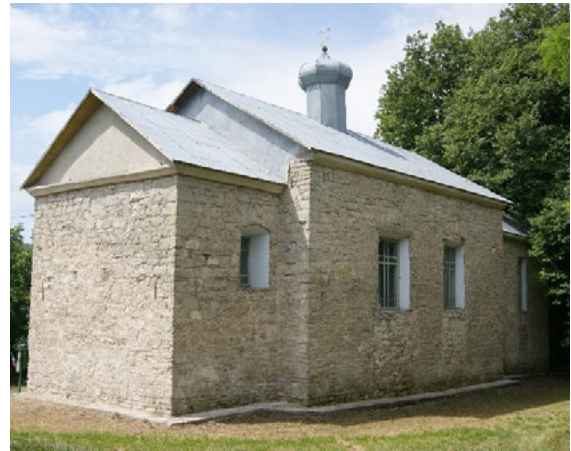
Fig. 7. Christian Temple of the 18th cent. on the territory of the village Grout. 2014. Photo by the author
