The wooden roof structures of Żuławy Region arcaded houses of type III - research, current state and analysis

Tomasz Zybala

*The Department of Structural Mechanics; Faculty of Civil and Environmental Engineering;
Gdańsk University of Technology;
tomasz.zybala@pg.edu.pl; ORCID: 0000-0001-9186-4960*

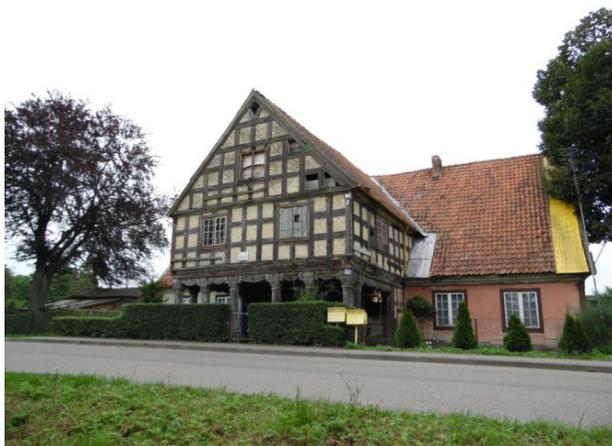
Fig. 2. The arcaded house in Bystrze (author's own photography)

The arcaded house in Bystrze no. 5/7 was built in 1819 by Jakub Jamuet [21]. The historic building is located in the village, near the Mątowy Wielkie – Lisewo Malborskie road. The building has a wooden structure. The log walls are plastered. The risalit of the half-timbered structure is based on 10 columns. The foundation of the building is made of brick. The roof construction is two-collar beams¹¹ and the roof is covered with red pantile.

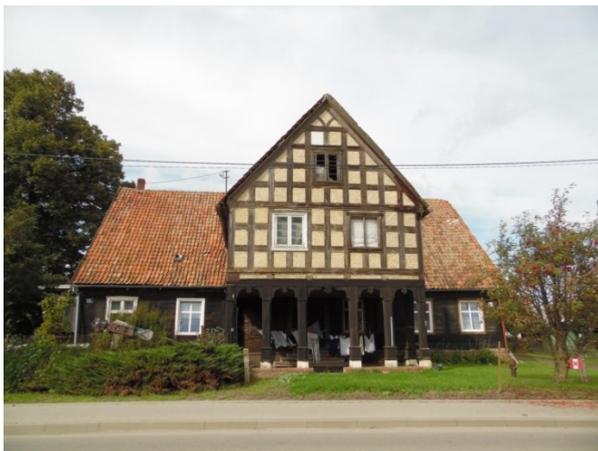
Fig. 3. The arcaded house in Marynowy (author's own photography)

The arcaded house in Marynowy no. 42 was built in 1804 by Hermann Hekker [22]. The building is located in the village near the Malbork – Nowy Dwór Gdański road. It has a wooden frame and the log walls are not plastered. The risalit of the half-timbered structure, with a filling of the yellow small brick in herringbone, is based on 10 columns. The foundation of the building is made of brick. Two-collar rafter construction; lower collar beam is supported by posts (Figs 10-11); the roof is covered with the red pantile. The individual cross-sections of the rafter framing elements are: 14x24cm purlin, 8x18.5cm post, 18x26cm rafters, collar beams: lower 15x25cm and upper 13x26cm (Tab. 2). Connection of the collar beam with the rafter with the simple lap joint; connection of the rafters with the ridge with the lap joint. The slope inclination angle is 43° (Fig. 12). The number of trusses is 18, their spacing is 1.10m, the roof span is 12.50m. Planks of 5cm thickness are placed on the lower collar beam. The condition of the structure is acceptable¹⁴. As a result of leakage of the roof covering, numerous moisture and damages are visible in the rafter framing. Gravitational ventilation of the attic is not disturbed; there is constant air circulation.

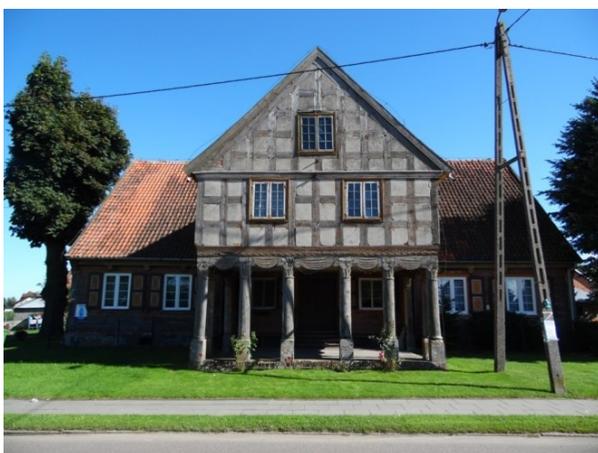
Fig. 4. The arcaded house in Nowa Kościelnica (author's own photography)

beam there are 5cm thick plates. The structure is in good condition. The roofing is sealed. The components of the rafter framing are well preserved and despite their age, they do not show any major damage. Some elements of the rafter framing show carpentry markings, one may see the symbol IIII on a collar beam (Fig. 14). Gravitational ventilation of the attic is not disturbed, there is constant air circulation.

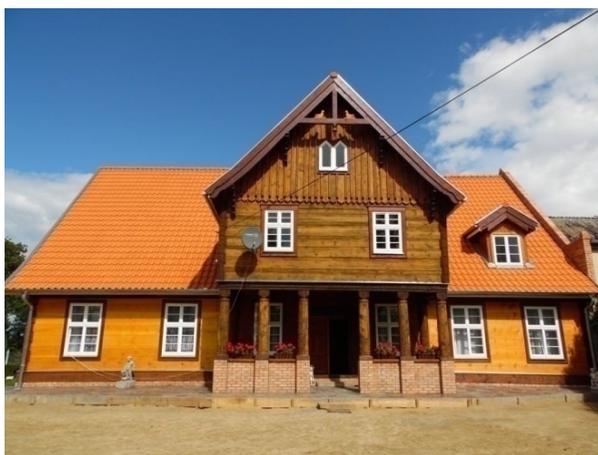
Fig. 5. The arcaded house in Rybina (author's own photography)

The arcaded house in Rybina no. 12 was built in the first quarter of 19th century [24]. The historic building is located in a hamlet about two kilometers from the centre of the village. It has a wooden frame and the log walls are not plastered. A risalit of a wooden log construction; at the top a boarded timber beam construction, based on 8 columns. The foundation is made of the brick. The rafter roof structure is two-collar-beam, the roof is covered with red pantile. Individual sections of the rafter framing elements are: rafters 16x23cm, collar beams: lower 16x18cm and upper 14x16cm (Tab. 4). Connection of the collar beam with the rafter with the simple lap joint (Fig. 16), connection of the rafters in the ridge with the lap joints. The slope inclination angle is 46° (Fig. 18). The number of trusses is 15, their spacing is 1.25m, the roof span is 11.50m. On the lower beam there are 4.5 cm thick boards. The structure is in good condition. The roofing is sealed. In 2017 the house was completely renovated. One roof truss was repaired by replacing a collar beam (Fig. 17). Gravitational ventilation of the attic is not disturbed, there is constant air circulation.

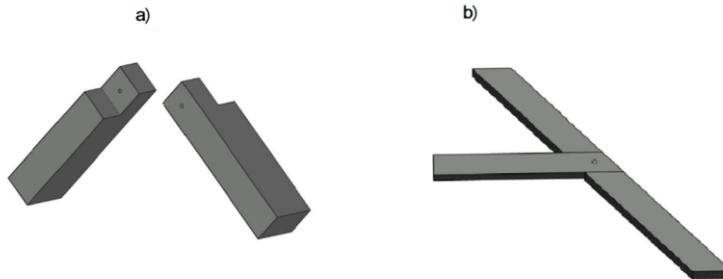
The cross-sections of the individual elements of the rafter framing are as follows: rafters 15x28cm, collar beams 15x19cm (Tab. 1). The rafter framing construction of the arcaded house in Bystrze has been made with the use of traditional carpentry joints: lap and simple lap joints (Fig. 6).

Fig. 6. Carpentry joints: a) lap joint , b) connection of collar beam with rafter with simple lap joint. (author's study)

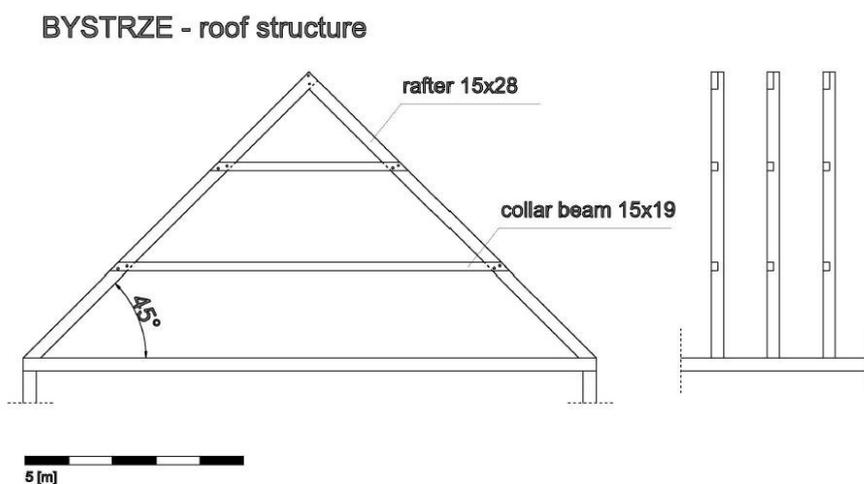
The connection of rafters in the ridge is made with lap joints (Fig.7), the connection of the collar beam with the rafter with simple lap joints, for which two dowels are used (Fig. 8). The roof slope inclination angle is 45° (Fig. 9)¹². The number of trusses above the main body of the house is 15, the span of the roof is 12.40m and the spacing of trusses is 1.25m. The condition of the structure is acceptable¹³. As a result of leakage of the roof covering, numerous dampness and damages are visible in the roof structure. Gravitational ventilation of the attic is not disturbed; there is constant air circulation.

Fig. 9. The simplified scheme of the roof structure of the arcaded house in Bystrze. (author's study)

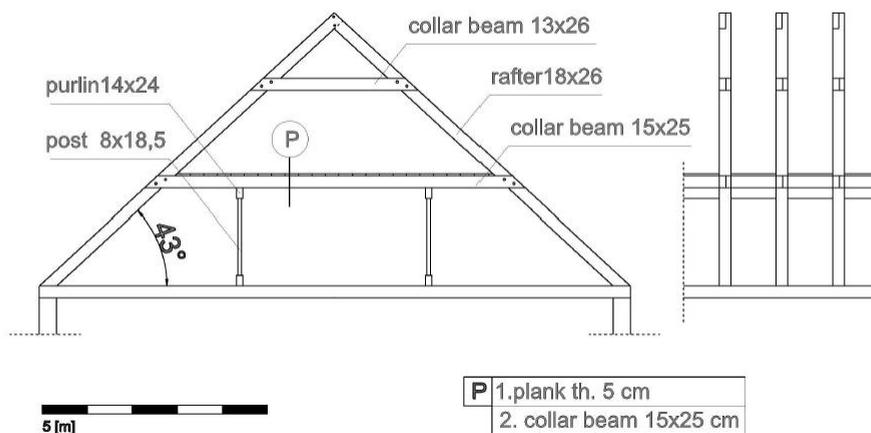
MARYNOWY -roof structure

Fig. 12. The simplified scheme of the roof structure of the arcaded house in Marynowy. (author's study)

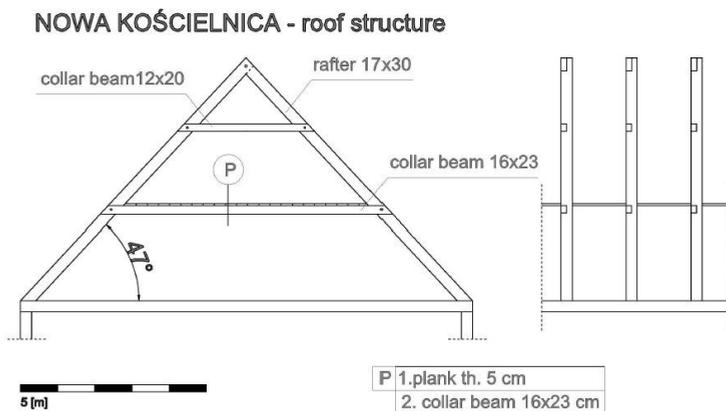
The arcaded house in Nowa Kościelnica no. 50/51 was built in 1840 [23]. The building is located in the village, near the Ostaszewo - Niedźwiedzica road. It has a wooden construction and the log walls are not plastered. The risalit of the half-timbered structure is based on 10 posts. The foundation is made of stone. The rafter roof structure is two-collar beams, the roof is covered with red pantile. Individual sections of the rafter framing elements are: rafters 17x30cm, collar beams: lower 16x23cm and upper 12x20cm (Tab. 3). Connection of the collar beam with the rafter with the simple lap joint, connection of the rafters in the ridge with the lap joints (Fig.13). The slope inclination angle is 47° (Fig. 15). The number of trusses is 15, their spacing is 1.40m, the roof span is 11.80m. On the lower

Fig. 15. The simplified scheme of the roof structure of the arcaded house in Nowa Kościelnica. (author's study)

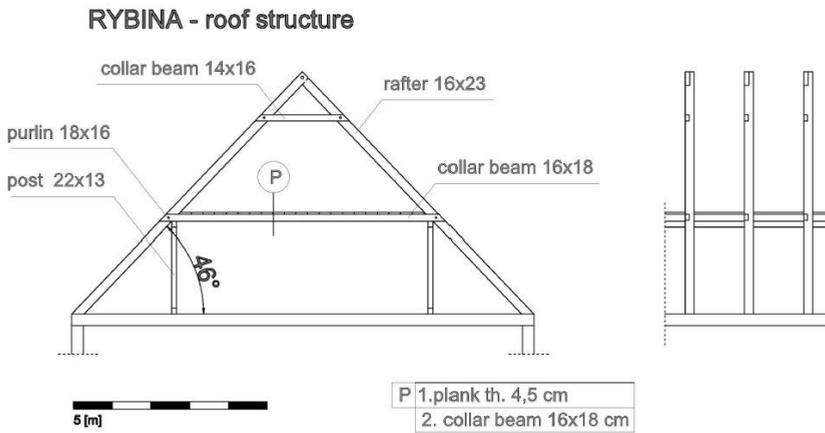
Fig. 18. The simplified scheme of the roof structure of the arcaded house in Rybina. (author's study)
