Restoration of load-bearing structures in a multi-storey residential building after a fire caused by military operations

Abstract: This article presents the visual and instrumental investigations, along with the necessary engineering and technical decisions, for restoring load-bearing structures of multi-storey residential buildings damaged by fire due to war. It is economically advisable to replace and strengthen 20% of the emergency floor slabs and 16% of the load-bearing walls to allow residents to return to their homes as soon as possible. The temperature during the fire was determined using specific samples of damaged materials, building structures, and equipment, which allowed for a more accurate assessment of the damage to brick walls and prefabricated reinforced concrete floor slabs. The possibility of further use of the building was also determined based on a survey and necessary measurements of its structures, including the determination of physical and mechanical characteristics (crack width, flexures, concrete strength, brick grade, and mortar grade). The prefabricated reinforced concrete round hollow floor slabs had delaminated along the ribs between the hollows, show

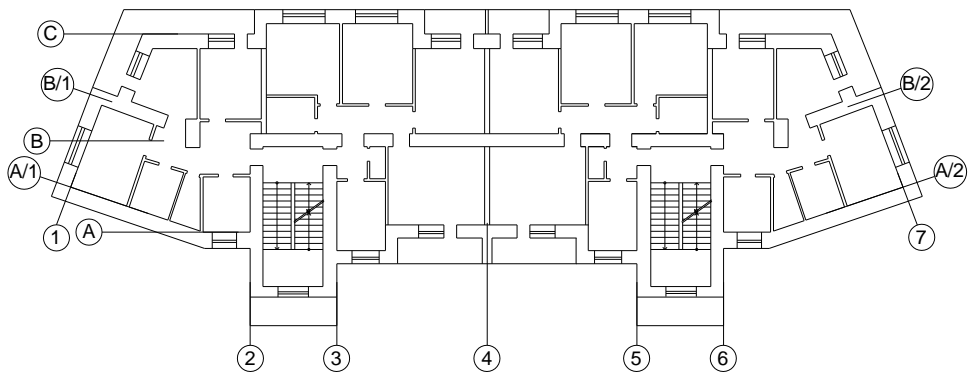
The first section is a five-storey building with three entrances. The second section is an eight-storey building with two entrances. The third section is a five-storey building with two entrances. The third section suffered direct damage from an aerial bomb, resulting in almost complete destruction, making restoration impossible. Additionally, the fire spread to the fifth entrance of the second eight-storey section (Figs 1, 2).

Fig. 1. The layout of an eight-storey section of a multi-storey residential building

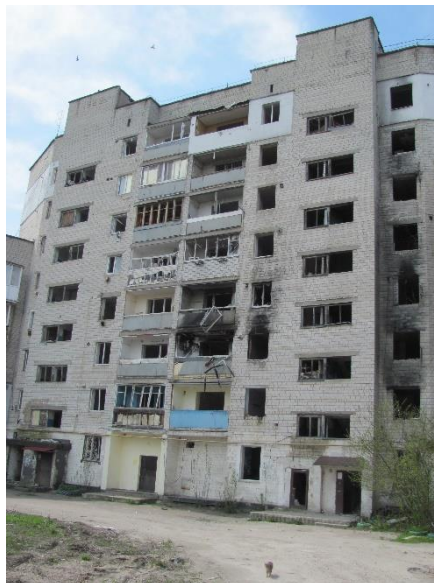
Fig. 2. Facade facing the yard along axis 'A'
