Budownictwo i Architektura 23(3) 2024, 159-170

Accessibility of service premises for people with disabilities in the historic areas of Lublin, Poland

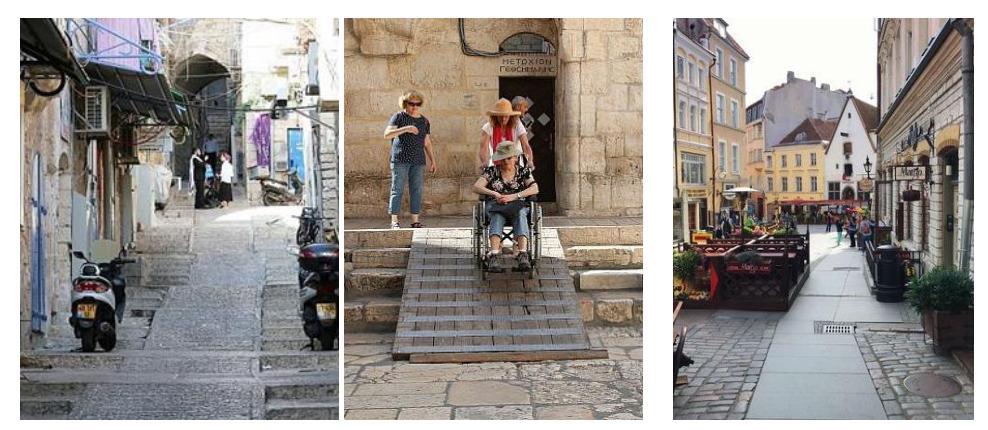
Fig. 1. A wooden ramp added to existing stairs in Jerusalem, providing wheelchair access to the Church of the Holy Sepulchre. *Source*: [19].

Fig. 2. Change in pavement type in Tallinn. Source: [20]

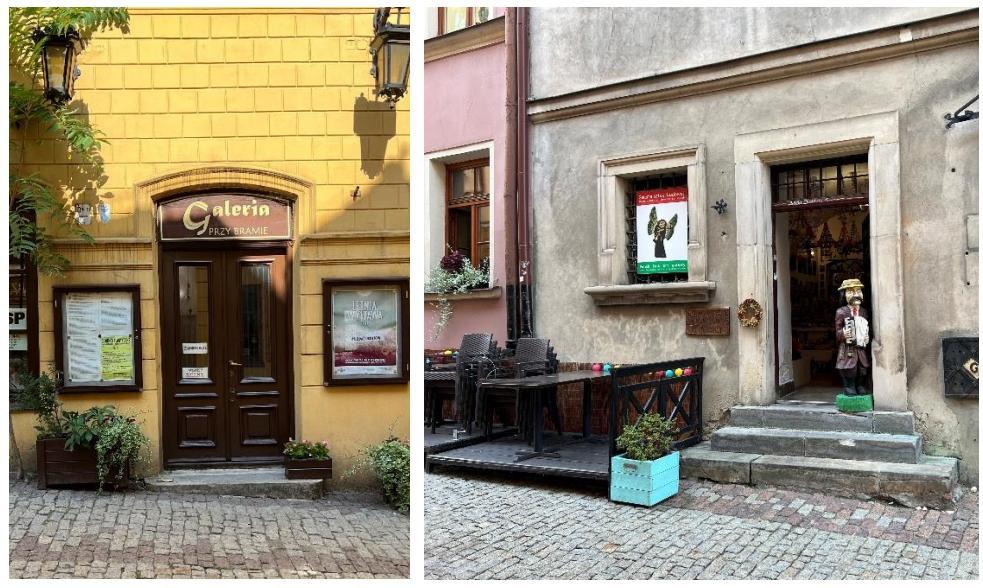
As a result of the research conducted along the main tourist route of Lublin's Old Town, spanning from the Krakowska Gate to the Grodzka Gate (Bramowa Street, Rynek Street, Grodzka Street, and Plac po Farze), the following data were obtained. 87% (39 out of 45) of the establishments along the main tourist route of the Old Town in Lublin have stairs directly at the entrance. 21% (8 out of 39) of the establishments with stairs at the entrance are equipped with handrails or grab bars to assist individuals with mobility issues. 41% (16 out of 39) of the establishments with stairs at the entrance have a landing that allows for the safe and easy opening of doors (Fig. 5).

Fig. 4. Narrow entrance door leaf, step, and significant slope of the terrain in front of the entrance; *Source:* Author

Fig. 5. Lack of handrails, damaged stairs, obstruction in the doorway, elevated outdoor seating area; *Source:* Author

29% (13 out of 45) of the establishments do not have at least one entrance door with a minimum width of 90 cm (Fig. 4). These cases typically involve double doors, where only one leaf is commonly used for entry. In 53% (24 out of 45) of the establishments, other obstacles for persons with disabilities were observed. These include damage to the entrance steps, planters and interior fixtures obstructing the door and stairway, rubber mats protruding above the floor, a cross slope in the terrain directly in front of the stairs/entrance, and steps made of irregular cobblestones. The results are presented in diagrams (Fig. 6).

In the context of tourism, a crucial sector of the economy in cities like Lublin, the lack of appropriate accessibility solutions can lead to the social exclusion of persons with disabilities, limiting their ability to enjoy services and tourist attractions. Although access to buildings may theoretically be possible, actual use often becomes challenging right at the entrance. Nevertheless, partial improvements in accessing services and navigating the main tourist route could be achieved. With relatively modest financial investments, business owners can significantly enhance the accessibility of their services for persons with disabilities. Immediate actions could include adding ramps to outdoor dining areas, installing handrails and grab bars on entrance stairs, replacing double doors with narrow leaves by doors that have a minimum width of 90 cm and feature assisted opening, repairing damage to floors and steps, levelling floor mats with the surrounding surface, and removing obstacles from stairs and doorways.

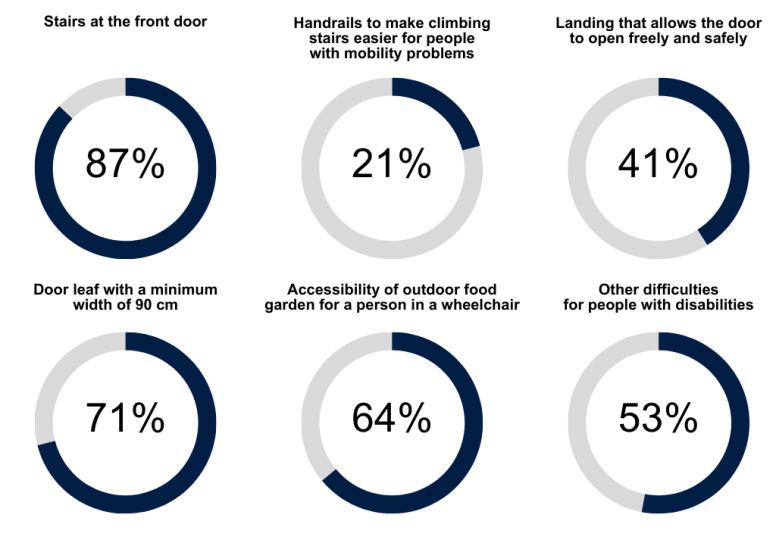
Fig. 6. Results on diagrams, Source: Author

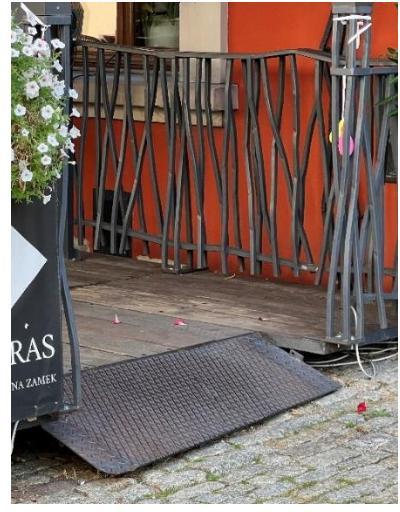
Outdoor dining areas are present in 56% (25 out of 45) of the establishments, of which 40% are elevated above ground level (constructed from wood or steel) and operate during the tourist season. Only 10% of these elevated outdoor seating areas have ramps that allow wheelchair access (1 establishment) (Fig. 7). Overall, 36% of outdoor dining areas are inaccessible to individuals using wheelchairs.

Fig. 7. A ramp instead of a step in the outdoor dining area; *Source:* Author

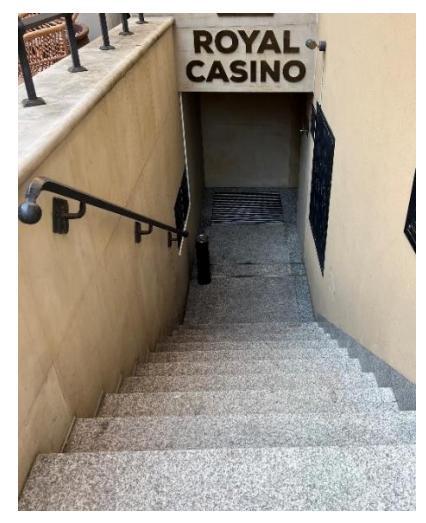
Fig. 8. Smooth stair surface with handrail; *Source:* Author

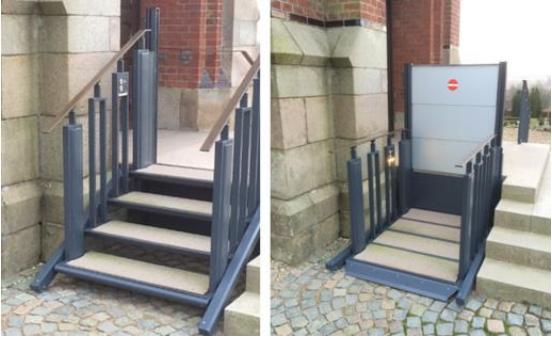
Fig. 9. Stair lift as an alternative to entrance stairs; Source: [25]

In Lublin's Old Town, more advanced solutions requiring greater financial resources are also feasible. One significant improvement would be the installation of strips of flat, even pavement in place of the irregular cobblestones. These strips should be wide enough to allow tourists to pass each other in both directions and should include designated resting areas without sloped terrain (Fig. 7, Fig. 8). Another beneficial measure would be the installation of lifts for wheelchair users as an alternative to entrance steps. These lifts could be designed to blend with traditional wooden and steel staircases (Fig. 9). A mobile ramp would be possible, with a lightweight design that could be easily dismantled as required (Fig. 10).

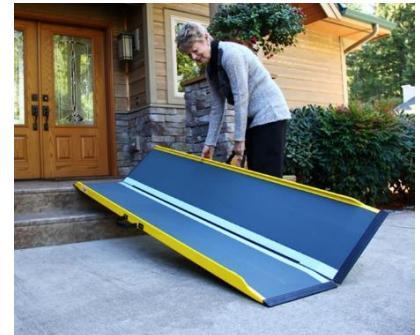
Fig. 10. The unfolding ramp. *Source:*[26]
