Analysis of the state of preservation the historic arcaded houses in Vistula Delta listed in the National Inventory of Historical Monuments

Tomasz Zybala

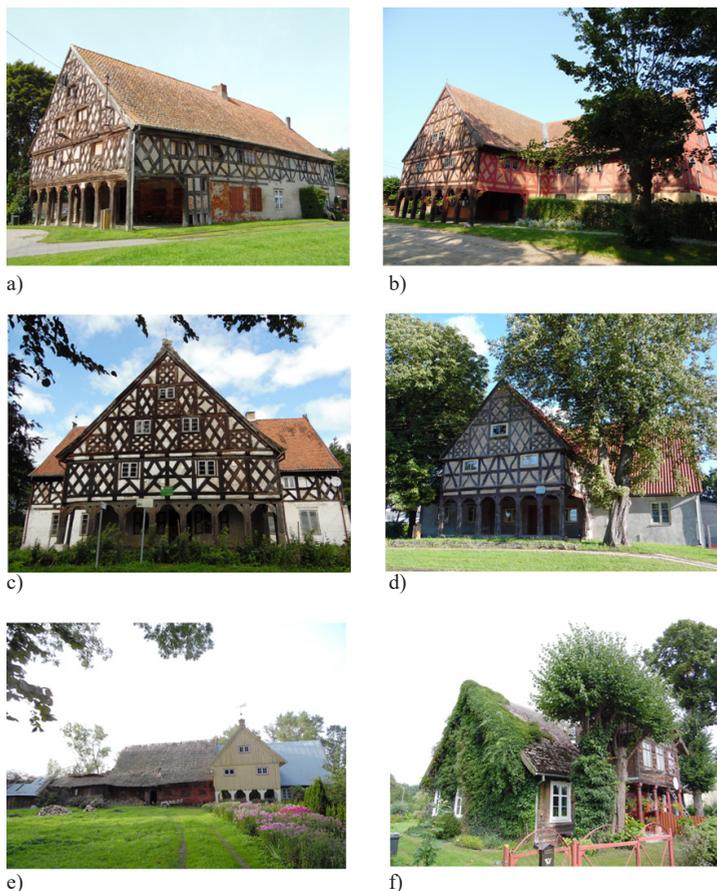
Fig. 1. Types of arcaded houses: a) type I house in Klecie, b) type II house in Trutnowy, c) type II-III house in Stalewo no.14, d) type III house in Koszwały, e) type III house in Markusy, f) type III house in Mikoszewo no. 68 (photo by the author)

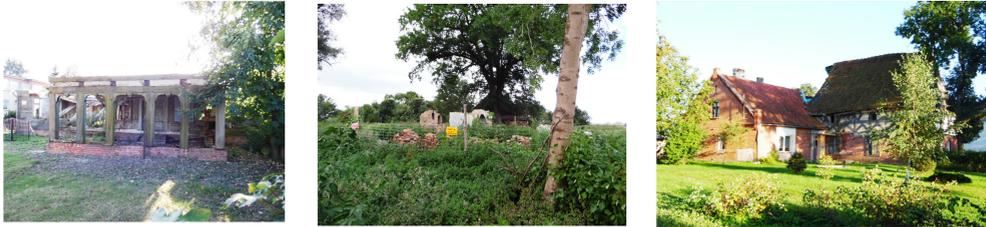
houses in Lasowice Małe (Fig. 2a)²¹, Kławki (Fig. 2b)²² and Świerki (Fig. 2c)²³. The list of historical monuments (as of 2015) also includes an arcaded house in Złotów, which burned down in 2014²⁴.

Fig. 2. Destruction of arcaded houses: a) Lasowice Małe, b) Kławki, c) Świerki (*photo by the author*)

²¹ The house is in ruins. Only part of the ground floor of the building has survived (as of 2016).

²² The house was demolished, in 2016 there was only a chimney.

²³ The house is partially destroyed (1/3 of the roof collapsed).

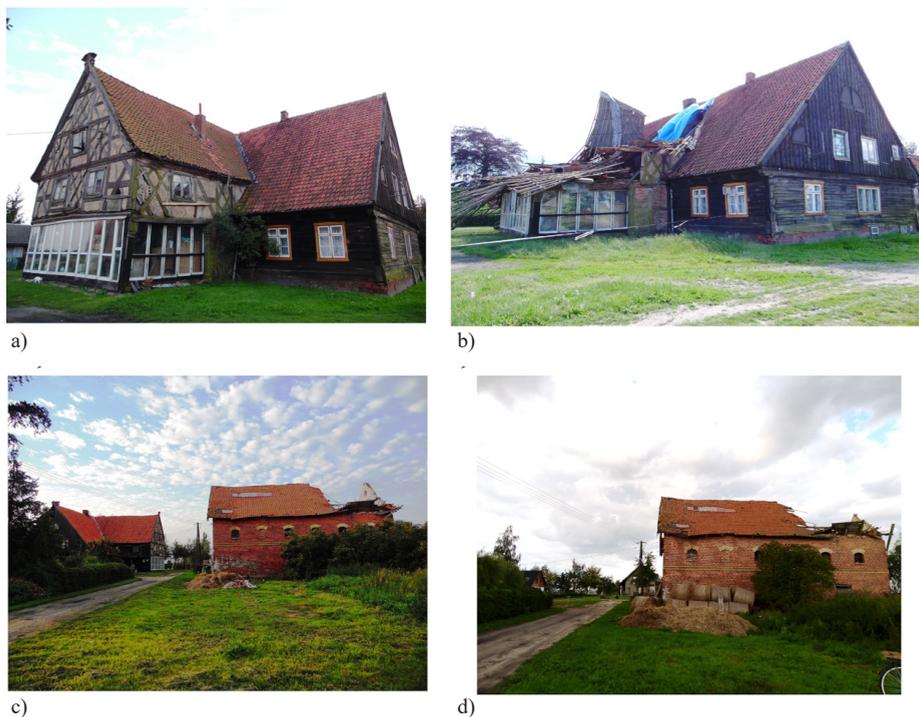
During five years of research, the state of preservation decreased by one monument (Fig. 3a). In 2017, the house in Izbiska from 1778 was completely destroyed²⁵. In May 2017, as a result of a strong wind, the arcade collapsed (Fig. 3b), in November 2017 the house burned down. No attempt was made to rebuild it (Fig. 3c, d)²⁶.

²⁵ In 2016, the author measured the geometry of the break as well as the height and cross-sections of the columns.

²⁶ In 2020, only the foundations of the house and construction rubble from its demolition are left.

Fig. 3. Destruction of the arcaded house in Izbiska: a) August 2016, b) June 2017, c) view of the farm – August 2016, d) view of the farm – September 2020 (*photo by the author*)

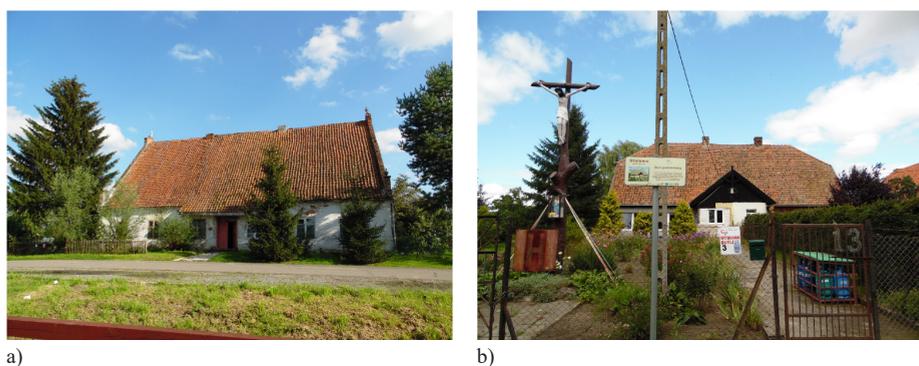
Some houses have lost their avant-corps as a result of breakdowns or reconstructions and are no longer arcaded houses. Examples of such activities are houses in Marynowe no. 23/25 (Fig. 4a) and Stalewo no. 18 (Fig. 4b)²⁷.

Fig. 4. Houses in: a) Maynowy no. 23/25 b) Stalewo no. 18 (*photo by the author*)

²⁷ The house was heavily rebuilt, completely lost its features of an arcaded house, decorations were removed.

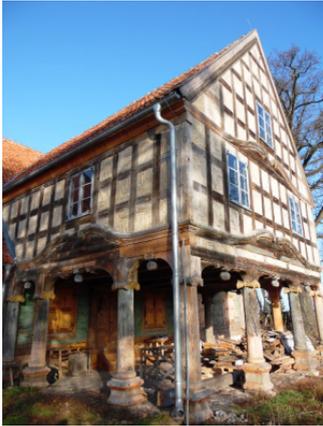
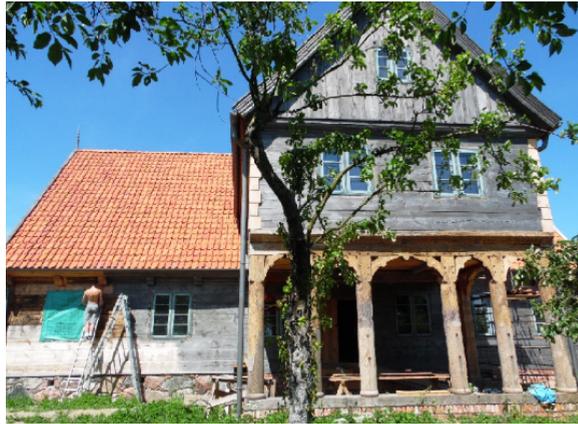
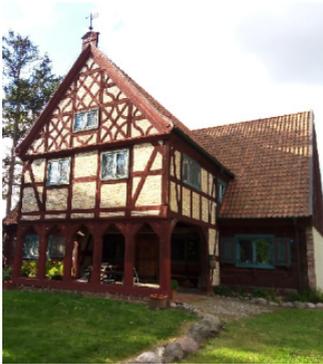
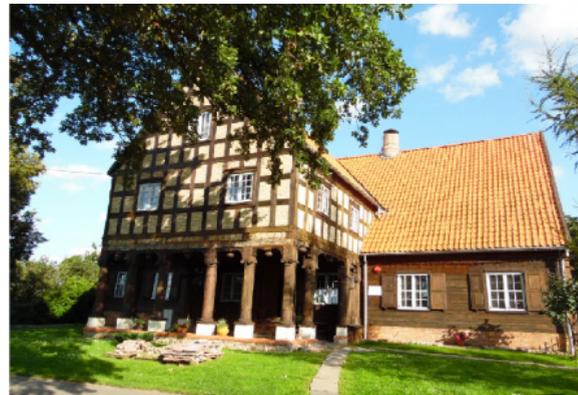
Fig. 5. Arcaded houses in: a) Orłowo no. 66, during construction and conservation works in 2015, b) Miko-szewo no. 55, during construction and conservation works in 2017, c) Przemysław no. 4, d) Marynowy no. 19 / 19a (photo by the author)

No	localization	voivodeship	House type according to Kloepfel statistics	date of construction	remarks
21	Nowy Dwór Gdański, 74 Morska Street	Pomeranian	III	1800	technical condition: good, residential house
22	Mikoszewo 55 (Fig. 5b)	Pomeranian	III	1800	technical condition: very good, reconditioned in 2017, residential house
23	Krzywe Koło 36	Pomeranian	III	early XIX	technical condition: very good, the building houses the Caritas Center of the Gdańsk Archdiocese
24	Lubieszewo 29	Pomeranian	III	early XIX	technical condition: good, residential house, part of the building is used as a guesthouse
25	Orłowo, 1 Wspólna Street	Pomeranian	III	1802	technical condition: good, currently uninhabited
26	Orłowo, 66 Żuławska Street (Fig. 5a)	Pomeranian	III	1802	technical condition: very good, after complete renovation 2013-2018, residential house
27	Marynowy, 19/19a Podcieniowa Street (Fig. 5d)	Pomeranian	III	1803	technical condition: very good, house after general renovation in 2012, residential house, part of the house intended as a guest house for tourists

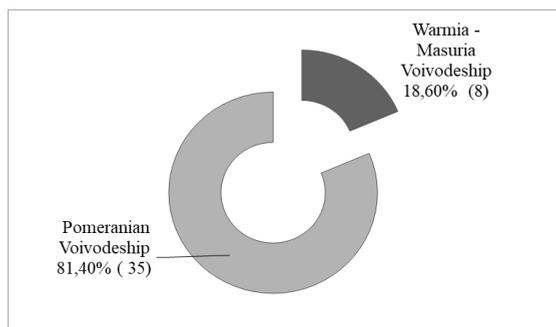
Until 2020, 43 arcaded houses from the Żuławy Wiślane area, entered in the register of monuments, have survived. Most of them are located in the Pomeranian Voivodeship – 35 houses (81.40%), the remaining 8 (18.60%) are located in the Warmia – Masuria Voivodeship (graph 1).

Graph 1. The number of arcaded houses in the Voivodeships: Pomeranian and Warmia – Masuria (*author's work*)

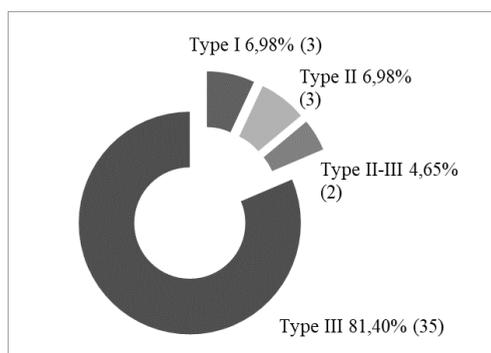
The least numerous group of preserved monuments are houses: type I - 3 houses 6.98% (Gdańsk Lipce, Klecie No. 4, Rozgart No. 13a), type II – 3 houses 6.98% (Miłocin No. 8, Trutnowy No. 7, Nowa Kościelnica No. 64) and type II-III 2 houses 4.65% (Stalewo No. 14, Steblewo No. 22/24). Type III houses are the most numerous group – 35 buildings 81.40% (graph 2).

Graph 2. The number of preserved arcaded houses – types division (*author's study*)

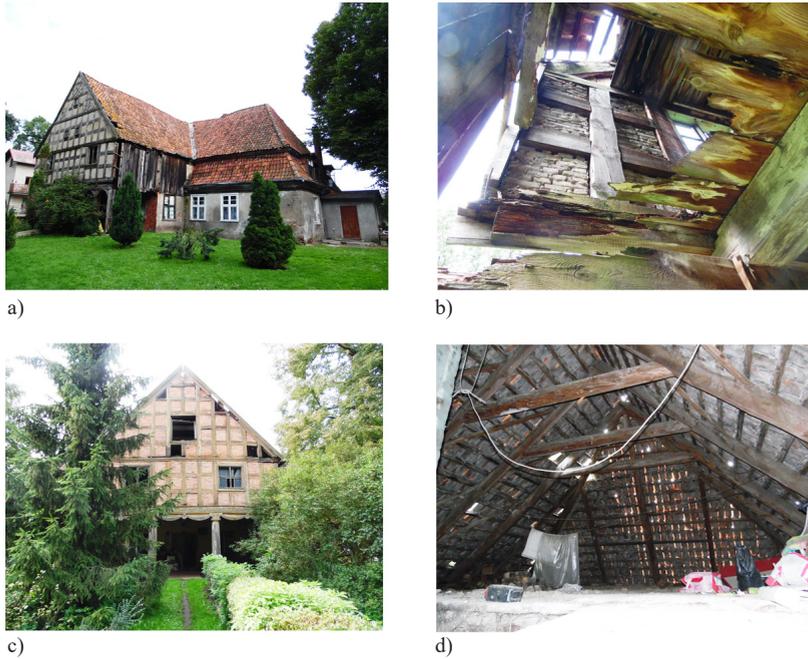
12 houses (27.91%) are in a very good technical condition, 19 houses are in a good condition (44.19%), 10 houses are in sufficient condition (23.26%), 2 houses are in insufficient condition (4.65%) – monuments in Steblewo (Fig. 6) (Graph 3).

Fig. 6. Houses in: a) Steblewo 22/24, b) Steblewo 22/24 the catastrophic condition of the gable wall of the portico, c) Steblewo 15/17, d) Steblewo 15/17 leaking roofing (*photo by the author*)

This number is likely to decrease within a few years. Two houses in Steblewo require immediate construction and conservation works. Their technical condition is insufficient. Lack of adequate funds for repairs and little involvement of the owners in saving them will result in the loss of more monuments from the 18th century.

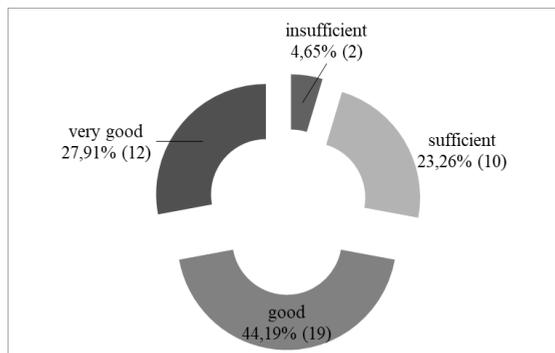
Graph 3. Technical condition of arcaded houses, as of 2020 (*author's study*)

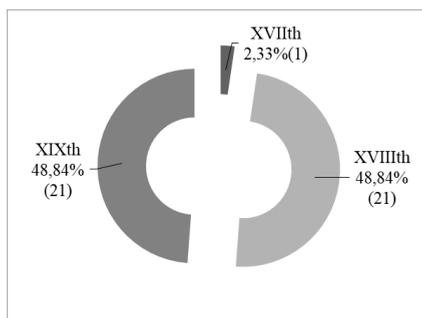
Only one house from the 17th century (2.33%), 21 houses from the 18th century (48.84%) and 21 from the 19th century (48.84%) (graph 4) have survived to the present day.

Graph 4. Age of arcaded houses (*author's work*)

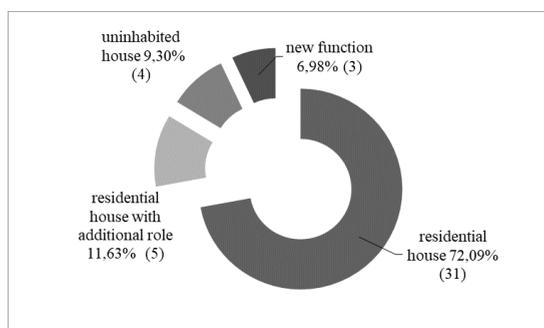
31 houses (72.09%) have a residential function, 5 preserved buildings (11.63%) have an additional role (Trutnowy 7, Miłocin 8, Klecie 4, Lubieszewo 29, Marynowy 19 / 19a). Four houses (9.30%) are uninhabited (Nowa Kościelnica 64, Stalewo 14, Orłowo 1, Lasowice Wielkie 12). Three houses (6.98%) have a new function: Gdańsk Lipce – hostel, Przemysław 4 – guesthouse, Krzywe Koło 36 – Caritas Center (graph 5).

Graph 5. The function of the preserved arcaded houses (*author's work*)
