## AWARENESS OF MATERIALITY IN TIME AND CONDITION. THOUGHTS ON THE RELATION BETWEEN ART HISTORY AND CONSERVATION

**ABSTRACT:** Art historical research needs to consider the materiality of artefacts, but the character of the material and the state of preservation of any object change over time. Today's restoration and conservation sciences provide the basis for present research in the field of history of art and architecture. Following this premises and with some examples from current research projects our contribution tries to show how much the contemporary academic Art History can benefit from the material and technical knowledge of conservators.

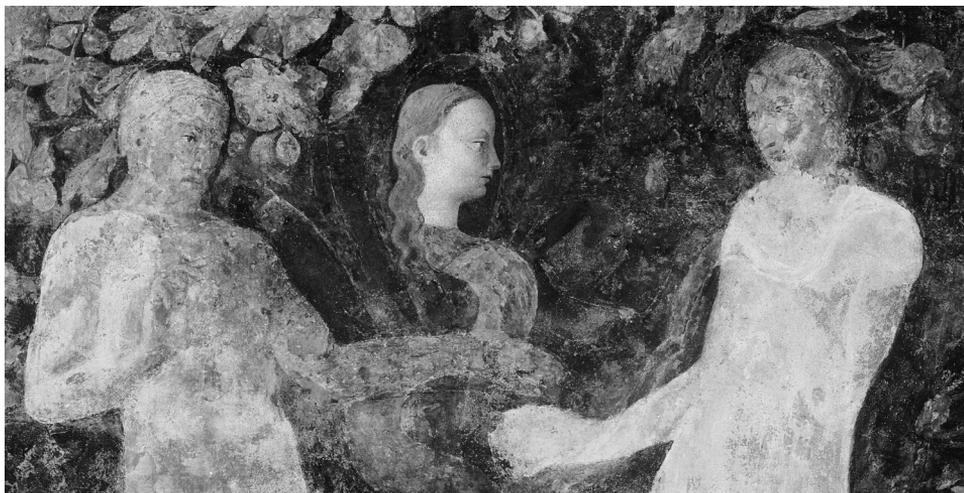
Fig. 1 Santa Maria Novella, Chiostro Verde, Paolo Uccello, Original Sin (detail), Photo: Alinari N. 4027 B, 1930.

condition of the cloister.<sup>17</sup> Restoration of the murals began again only in 1929 with Amedeo Benini.<sup>18</sup> Differently than in the previous campaign, the intention was to leave the paintings in their original location, thus avoiding the complicated and expensive process of detachment. The first murals Benini worked on were Paolo Uccello's *Creation scenes*.<sup>19</sup> The sources are full of descriptions of the disastrous state of the pictorial surface, which makes the legibility of the painting today quite surprising. Benini focused his intervention on the consolidation of the surface.<sup>20</sup> The reviving substances applied by Benini to the murals most likely caused the major damage we see today, accelerating the destructive effects of the humidity and salt migration. In fact, only three years after his operations on the Creation, in 1934, the documents cite "*da pochi mesi a questa parte, tutto ciò che di vivo e apparentemente brillante era tornato in luce, è oggi smorzato e in parte addirittura svanito*".<sup>21</sup> What makes the case study on the Chiostro Verde particularly interesting and relevant to the topic of this publication is the possibility of juxtaposing written sources with historical photographs of the murals. Two photographs by Alinari from 1930 and 1933 (Fig. 1 and 2), for instance, are evidence for the massive abrasion the pictorial surface has suffered as a consequence of the substances used in the consolidation by Benini. The later photograph of 1933 precedes the detachment of this scene, carried out a decade later, in 1941, by Mauro Pellicoli (1887-1974) of the Istituto Centrale di Restauro, under the direction of Cesare Brandi.<sup>22</sup>

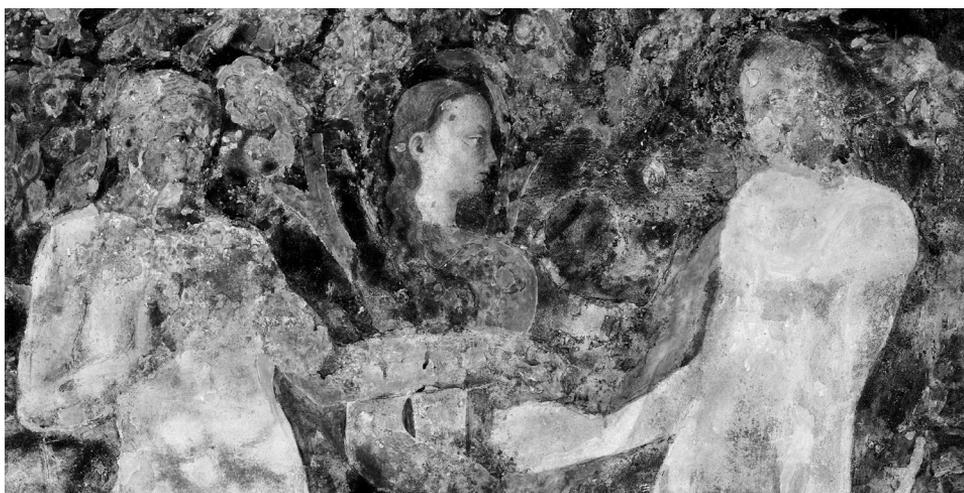
Fig. 2 Santa Maria Novella, Chiostro Verde, Paolo Uccello, Original Sin (detail), Photo: Alinari N. 4027 D, 1933.

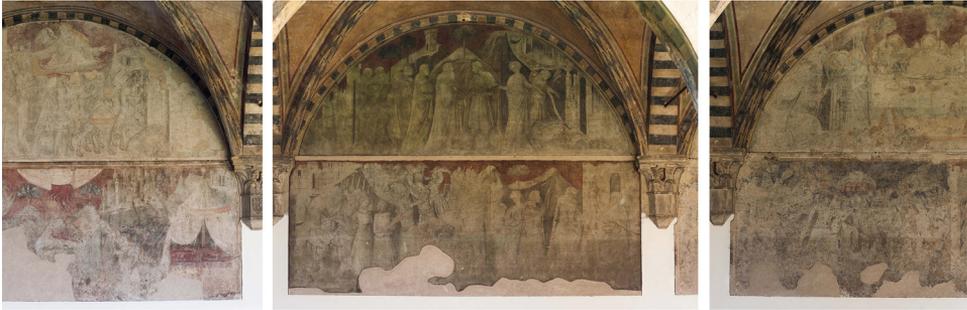
Fig. 3 Scheme of the first three bays of the southern wall in the Chiostro Verde, Santa Maria Novella.

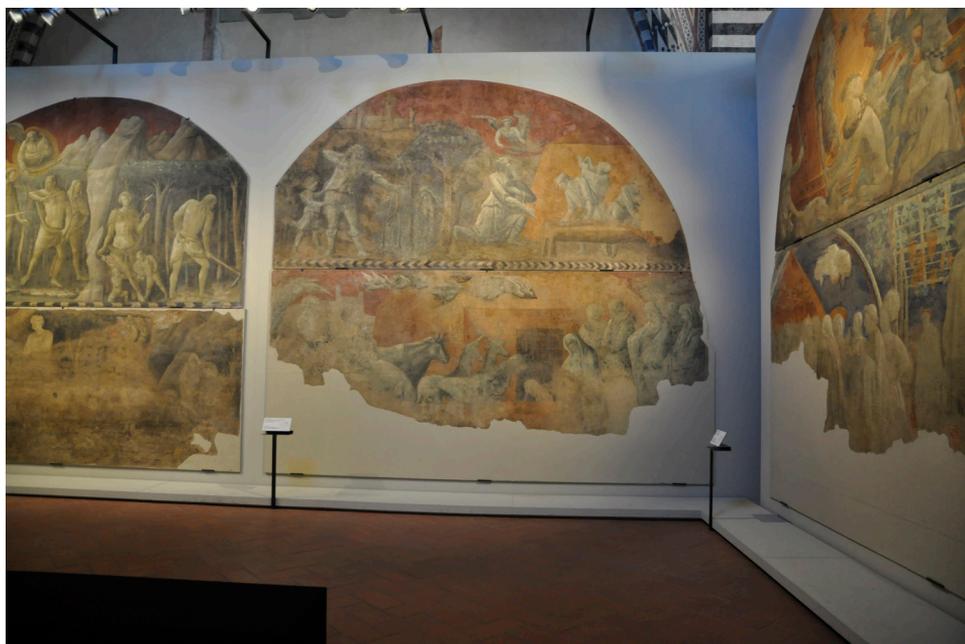
Fig. 4 Display of the restored murals of the Chiostro Verde in the adjacent refectory, Santa Maria Novella.

Today, the scientific community, like in the early 80s, is again confronted with the question of relocation and therefore accessibility, usability, philology and conservation. Following the recent restoration campaign on the murals of the first four bays of the eastern wall (including the scenes attributed to Paolo Uccello) (Frosinini, 2019), the detached paintings have been located on huge panels in the ancient refectory of Santa Maria Novella, which is adjacent to the Chiostro Verde (Fig. 4). The hanging or musealization of these scenes surely enhances the durability and maintenance of the works, which would be hardly compromised in their original location due to continuous infiltration and air pollution. However, the installation of these eight murals evokes a chapel or oratory rather than the wall of a cloister. Moreover, it ignores the original height of the paintings from the ground (both curatorial decisions forced by the architectural space of the refectory), which misleads the beholder and disregards a historically acceptable 'reconstruction'. The current state of the Genesis-cycle, though, touches crucial ethical aspects of conservation practices: should we guarantee the conservation for future generations, at least of the masterpieces of the cycle? Is it then tolerable to not allow the visitor to experience them in their original location by breaking up the continuity of the cycle? And if so, can we accept that those parts, which are not by the hand of a major artists, deteriorate due to the general increase of air pollution? – These are difficult questions which require serious, carefully studied answers by an interdisciplinary pool of scholars who believe that it is absolutely necessary to discuss these problems in interdisciplinary settings the absolute necessity to discuss. Only by debating the advantages and disadvantages might knowledge be generated and contribute to the field of ethics in conservation.

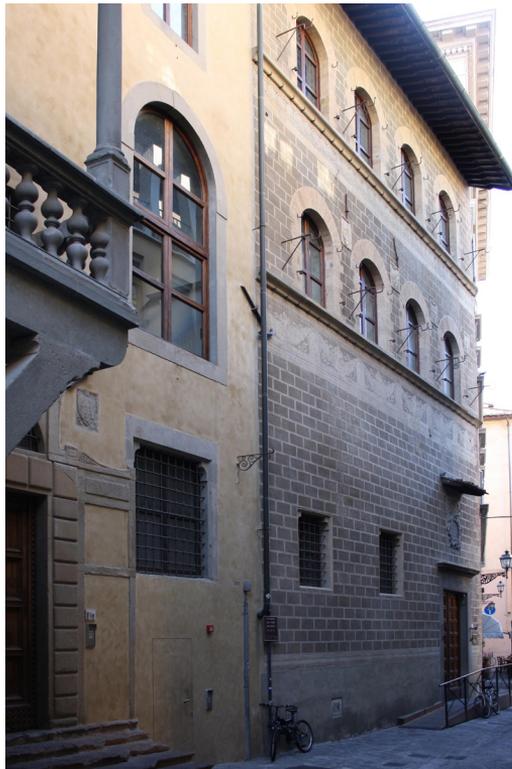
Fig. 5 Residenza dell'Arte della seta, Florence, situation 2016.

Around 1460 the building was adorned with a *sgraffito* facade showing a depiction of ashlar work, a frieze with putti, garlands, and the guild's symbol (Huth, 2016, vol. 1, cat. no. 24; Thiem/Thiem, 1964, cat. no. 25, 70-1). However, in 1921 the building was reconstructed and the facade was redesigned – with significant changes, as evinced by comparison. Not only the remains of the Quattrocento decoration have been lost, but so have the original motifs and structure of the facade's design as well as all information regarding its material and technical execution. Today, the facade shows a strange brownish coloring, and the lighter ornaments have a drab or yellowish tone. A similar situation is evident on the Palazzo Corsi in Borgo Santa Croce,<sup>29</sup> which was recently renovated.<sup>30</sup> The *sgraffito* facade largely dates back to 1938.<sup>31</sup> Only small portions of the original decoration were preserved as references. Before the most recent renovation, it was possible to distinguish between original and renovated elements, but now the entire surface has a uniform appearance, as the result of a highly questionable conservation approach (Fig. 6). Whenever the existing standards of conservation ethics are ignored, this needlessly complicates any examination. The treatment of this facade is truly regrettable, especially given that there are two exemplary restored *sgraffito* facades in Florence, namely those of the Palazzo Dietisalvi Neroni and the Casa Lapi.<sup>32</sup> In the case of Palazzo Corsi, one hopes that a meticulous preliminary examination and a complete documentation of all interventions exist. Precise and publicly available documentations of restoration measures form the basis of later research. Therefore, such documentation is an important joint source for restoration practice and art historical study.

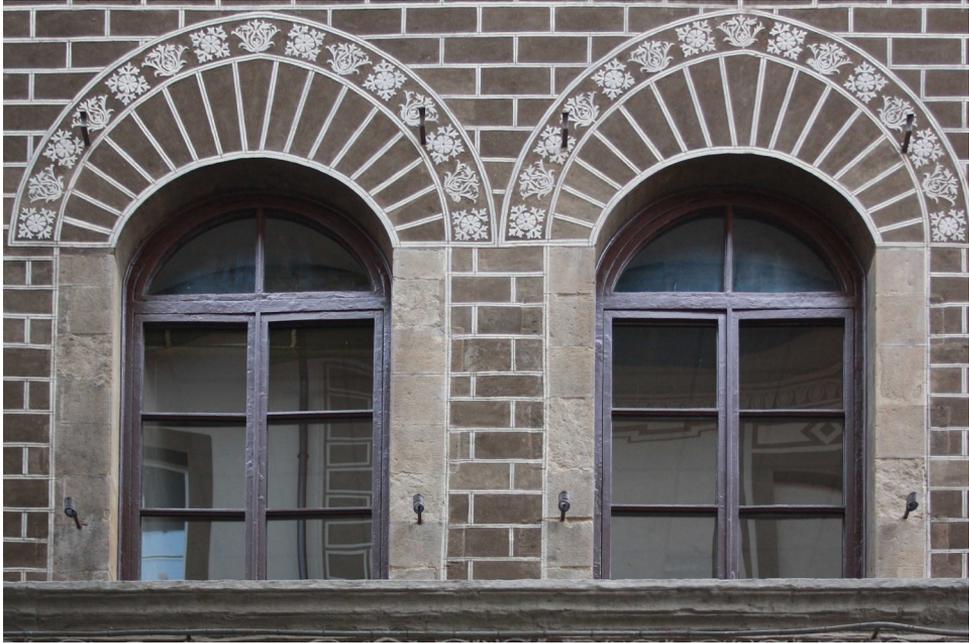
Fig. 6 Palazzo Corsi, Florence, facade after the 2017 restoration.

As with the Arte della Seta residence, the facade of the Palazzo Corsi shows an obtrusive brownish coloring. One can exclude the possibility that this corresponds to the original Quattrocento coloring, because no plaster or whitewash of the fourteenth or fifteenth century contains such pigments. Furthermore, the current surface has a scratched decoration, but painted. Color and technique are essential in producing the aesthetic effects of a building front – or any other pictorial object. Therefore, in terms of art historical research, questions of color and technique are not secondary matters; they are of equal importance as any other topic of discussion, such as problems of dating, the transfer of motifs and ornaments, the attribution to a specific artist or artisan, or the overarching cultural context.

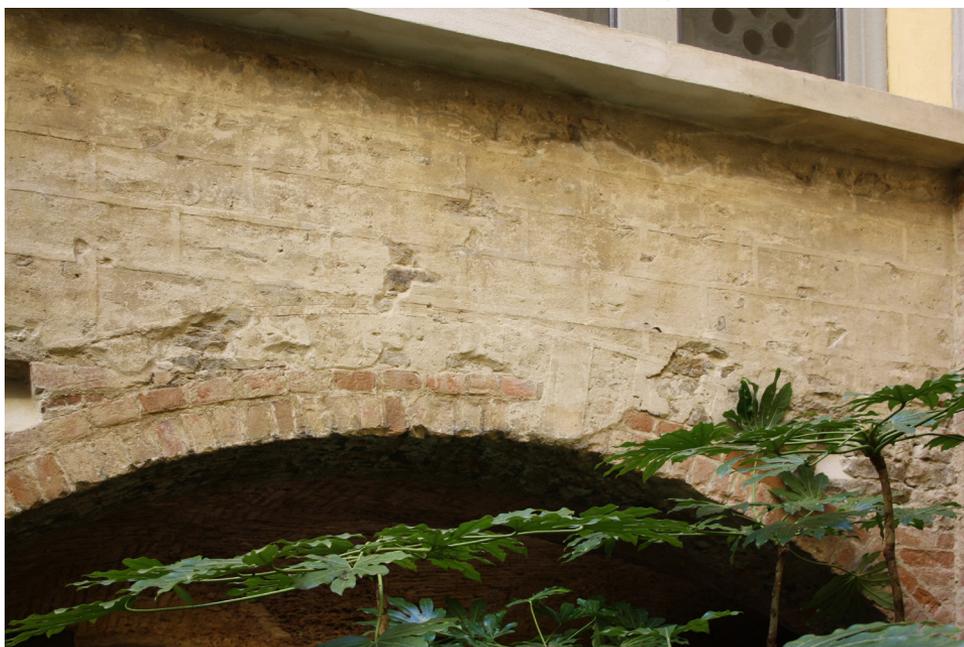
Fig. 7 Chiostro antico, S. Croce, Florence, sgraffito decoration, ca. 1325.

Other *sgraffito* facades that have not undergone later interventions also lack intense contrast, which has commonly been considered as key feature of this kind of wall decoration. This is amazing, given that the art historical perception of *sgraffito* is based on a bold bichrome contrast and also that the purpose of restoration is often defined as the renewal or reconstruction of this contrast, as demonstrated in examples mentioned above. However, an analysis of the material and execution of these unrenovated examples argues for a new perspective. The technique was not developed as cheap substitute for bichromatic marble incrustations, but as a simple regulation of joints. The earliest known *sgraffito* decoration in Florence can be found in the so-called Chiostro antico in the complex of the Florentine monastery of S. Croce. Dating circa 1325 and located in the little-known narrow cloister behind the Cappella Pazzi in S. Croce, it covers the brickwork of the ground floor arcades below the Corridoio del Noviziato (Fig. 7).<sup>34</sup>

As demonstrated by this example, from the invention of the *sgraffito* in early Trecento until mid fifteenth century the plaster was always uncolored. The use of black pigments was probably introduced for the decoration in the courtyard of the Palazzo Medici (Huth, 2016, vol. 1, 64). The new, elegant grey – or “silver” as Vasari later writes<sup>35</sup> – was intended to harmonize with the walls and the architectonic elements made of grey macigno. The current coloring of the restored courtyard is not reliable proof.<sup>36</sup> However, many *sgraffito* decorations in Florence were executed shortly after those of the Palazzo Medici, and they adapted the motifs and coloring of the decorations in the Medici courtyard.<sup>37</sup> One example is the decoration in Villa La Pietra.
