PROTECTION AND RENOVATION OF PUBLIC AREAS IN A MODERNIST CITY: THE CASE OF THREE STREETS IN THE HISTORIC CITY CENTRE OF GDYNIA

ABSTRAKT: This article concerns issues related to the preservation and restoration of public space in Gdynia's city centre, which was designed and built mainly in the 1920s and 1930s. In 2007, a major part of the city centre was entered into the register of monuments as a historic complex of urban architecture. Moreover, in 2015, the area was declared a Monument of History. Protection of a complex of urban architecture covers not only the renovation of historic buildings but also the protection of public spaces that comprise an integral part of the historic complex. Therefore, preservation of the historic shape and design of public space in the centre of Gdynia is one of the city's key conservation tasks. Since protection of urban space in relatively young historic centres (less than a hundred years old) is a novel issue from the perspective of conservation, it is therefore worth analysing. Issues connected with the protection and restoration of public space in the centre of Gdynia are exemplified by three historic streets, built in the late 1920s and loca

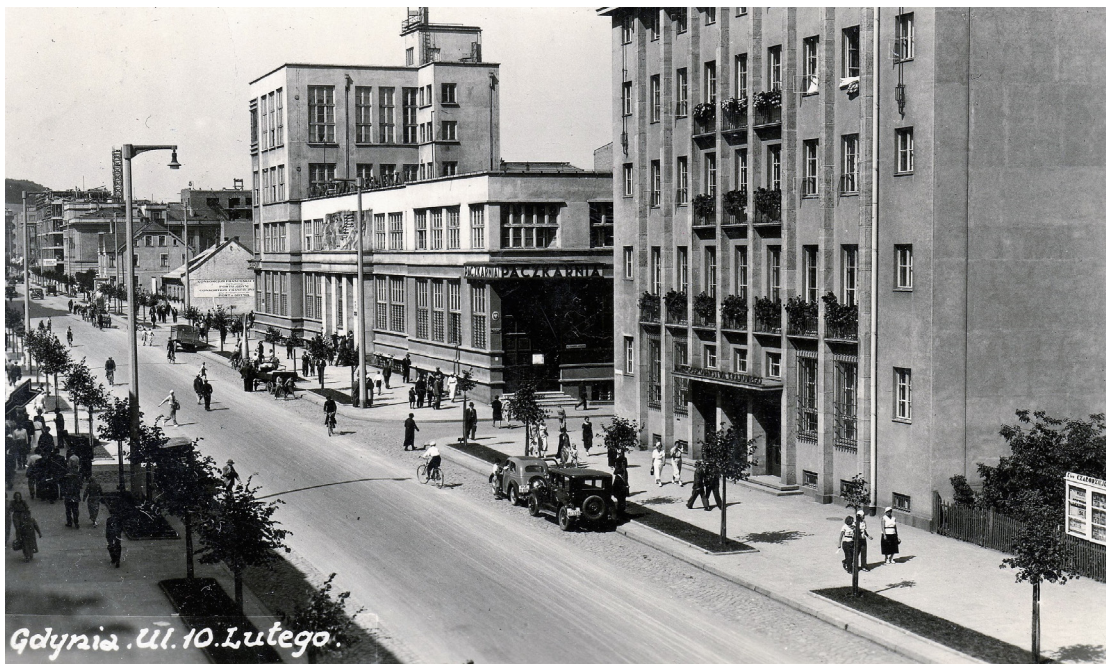
Fig. 1. Gdynia, 10 Lutego Street, the arrangement of the street in the second half of the 1930s; photo from private archives.

10 Lutego Street was arranged in place of Aleja Kuracyjna, which was planned at the beginning of the twentieth century to link the railway station and the beach. In the 1930s, 10 Lutego Street became one of the main compositional axes of the early modernist city centre (fig. 1). The width of the former avenue was then increased to 28 m. The street was laid out using a combination of modern bituminous surface and side lanes of cobblestones with curbs made of longitudinal basalt bricks. Cobblestone lanes were intended for the traffic of vehicles without tires, and as parking lanes (fig. 2). Rows of linden trees were introduced on both sides of the street. Encased in concrete enclosures, the trees were planted in twos, in regular square lawns.

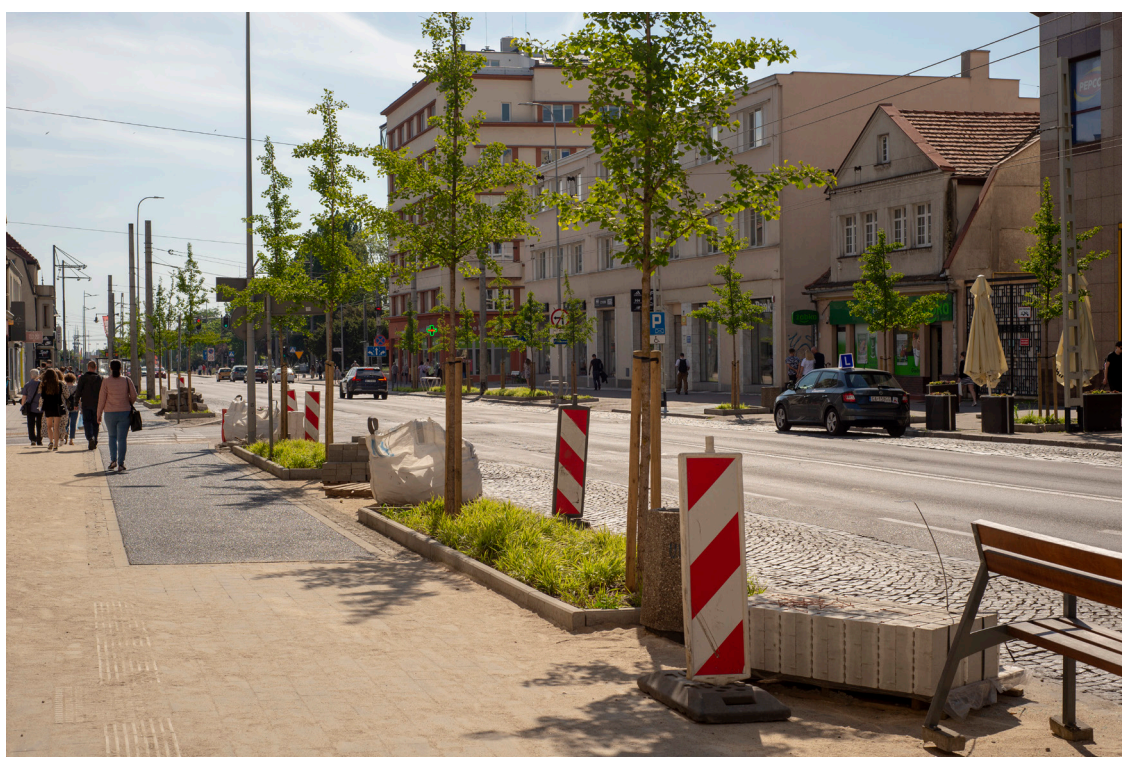
Fig. 3. Gdynia, 10 Lutego Street, after renovation works, which included the conversion of parking bays as well as the reintroduction of the historic width of pavements and the replanting of trees; photo by B. Ponikiewski.

out, including the elimination of a significant number of parking bays, and the restoration of the original width of pavements. Owing to the above, comprehensive reconstruction of the old arrangement of trees was made possible. Since the conditions for the growth of trees were unfavourable due to dense traffic and chemical measures against icing, it was decided in consultation with the conservator of monuments to introduce a foreign species of greater resilience (gingko tree) yet with features similar to the historical one (linden tree). Pavements were given a new surface made of concrete blocks of smaller format than in the original design, supplemented with textured slabs and directional markings for people with disabilities. A bicycle path was marked out in the northern part along the pedestrian lane (fig. 3).

The renovation of 10 Lutego Street aimed to restore the most characteristic elements of the historic composition from the interwar period. The former layout of the street, with wide pavements and rows of trees, was reconstructed and the side lanes of cobblestones on the roadway were repaired. Due to modern needs (concerning public transport stops, cyclists or people with disabilities) and the climate conditions that affect the city's greenery, comprehensive reconstruction of the original arrangement and of all its elements could not be pursued. Slight modifications to improve functionality and usability were accepted. In terms of conservation, they were assessed

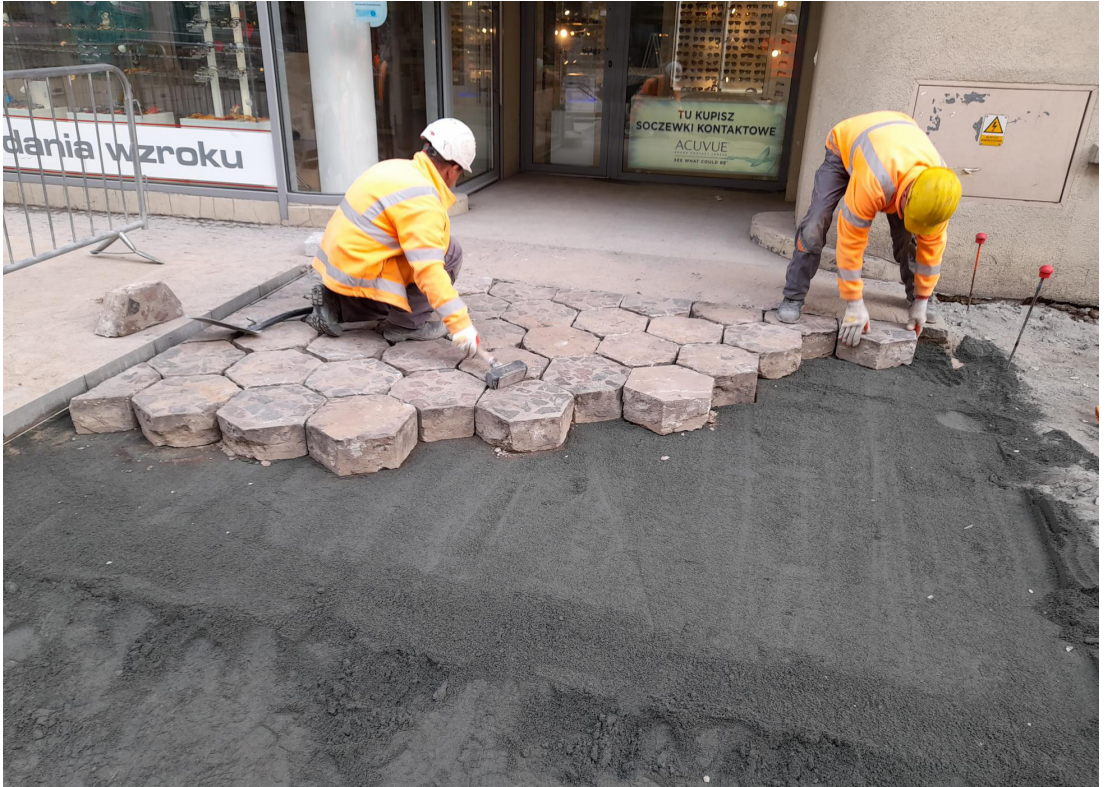
Fig. 4. Gdynia, Starowiejska Street during renovation works in 2022, which involved relocating the historic surface made of hexagonal blocks; photo by R. Hirsch.

of the existing width of the roadway with separate pavements, preservation of the historic road surface and stone curbs with local repairs, preservation of the historic surfaces of access roads to inner yards or former gates (fig. 4), and preservation of original materials, dimensions of stone elements, colours, types of joints as well as the brickwork of reused items. As for the degraded surface of pavements, it was decided to replace them on the provision that references be made to historical solutions, specifically concerning the square concrete slabs. Due to the varied style and time of construction of buildings along the street, some liberty was allowed for the newly designed street furniture, including street lamps, designed in a non-historical maroon colour to add diversity. Efforts to increase the area for pedestrians resulted in the creation of pedestrian zones with parklets, i.e. places to rest with seats and greenery, installed in a non-invasive and reversible way. At the degraded intersections, where asphalt had been reapplied, polished stone-block speed bumps were introduced to slow down the traffic. Finally, decisions were made to preserve existing trees and add seventy new ones owing to their value for both the entire city and the region, including rows of hawthorns that have lent Starowiejska Street a unique character.

All original elements of the street's development have been preserved, while missing ones were supplemented with historical stone material obtained from demolitions in other parts of the city, where the choice of material was secondary or it was extracted in minimal amounts, or with elements stylized as historical, as in the case of missing sections of stone curbs and concrete slabs of pavement surfaces. Detailed conservation issues were discussed on an ongoing basis directly at the construction site. Conservation modernization and its conditions also had to be closely related to multi-stage participatory activities and the needs of residents, specifically regarding the increase of space for pedestrians at the expense of cars. Therefore, it was necessary to introduce modern elements such as parklets, which made it possible to retain the original layout and width of the roadway, and to separate pavements. At present, the street maintains its historic decor and original elements, which have been enriched with modern utility details that are clearly highlighted in a different colour (burgundy).

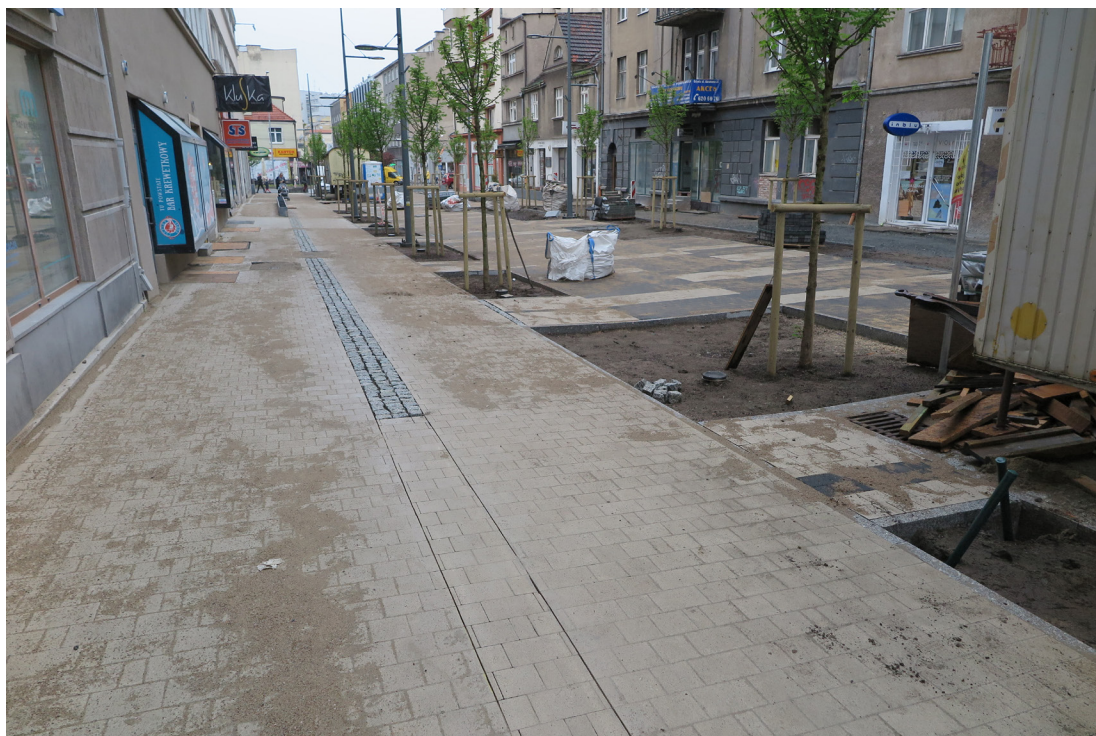
Fig. 5. Gdynia, Abraham Street, the section between Batorego Street and 10 Lutego Street, during the redevelopment into a so-called woonerf; photo from the archives of the Municipal Conservator's Office.

The described section of the street has been transformed to a high degree. No historical surfaces of roadways and pavements were preserved, and those that had been re-introduced were in poor technical condition. The road system was significantly changed due to the introduction of parking spaces. Moreover, since cars would park on the pavements, technical bollards of low aesthetic value were installed to prevent this. Lone trees in poor condition were the only remnants of the street's historic arrangement.

city authorities to cover, among others, the reconstruction of underground installations.¹³ The project intended to create a so-called *woonerf*, i.e. the first shared space in Gdynia where priority would be given to pedestrians and cyclists. A new surface with geometric patterns, made of two-coloured concrete slabs of various size (fig. 6), replaced the separation of the roadway and pavements (fig. 5). Car traffic was limited to a narrow lane in the middle of the street, and the speed limit was reduced to 20 km/h. Such reorganization of space facilitated the introduction of much greenery and many outdoor catering facilities. Additional street furniture was installed, including benches, bicycle racks and modern lamps. The project had to meet the accessibility standards of the city of Gdynia (Wysocki, 2013). Accordingly, directional guiding and warning systems were added to the pavements, and either they were adjusted to the level of house thresholds or ramps were built allowing unrestricted use of commercial premises located on the ground floor.¹⁴ The investment was commissioned in June 2019.

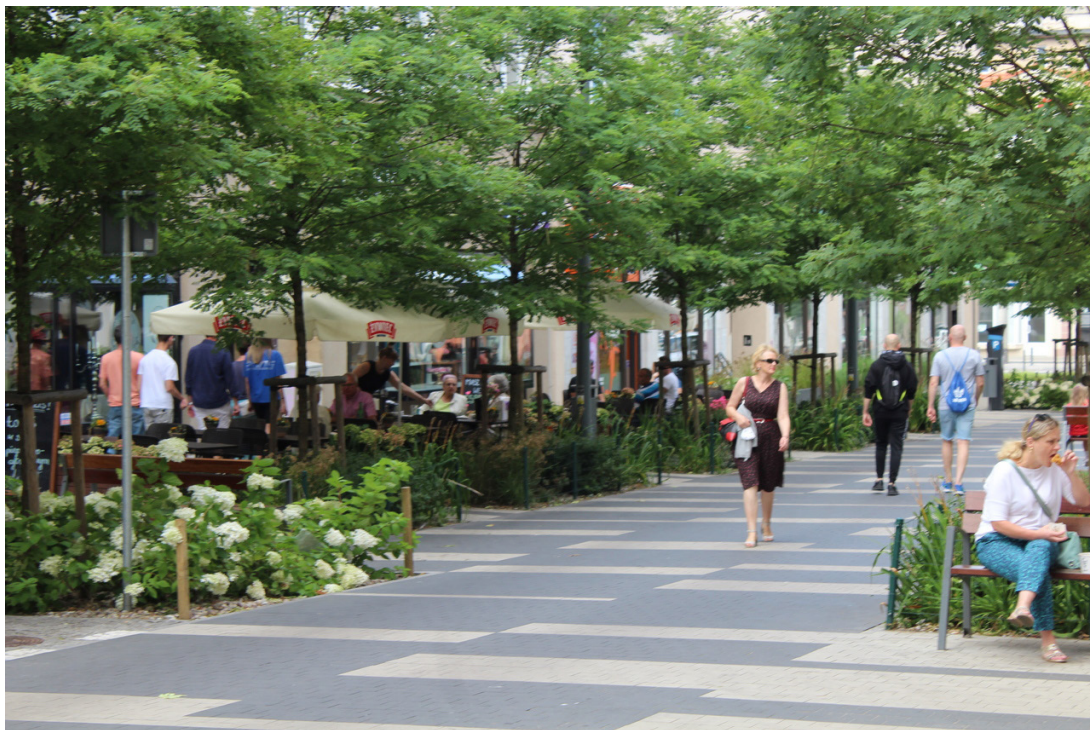
Fig.6. Gdynia, Abrahama Street, the section between Batorego Street and 10 Lutego Street after conversion into a so-called woonerf; photo by B. Ponikiewski.

The reconstruction of the section of Abrahama Street into the contemporary form of a *woonerf* is an example of current trends concerning utility and social expectations in modern European cities, where the idea of the so-called “shared space” has been implemented since the 1980s (Karlikowska & Kimic, 2017). However, not all such concepts may be compatible
