About historic stonework in Kraków

Anna Kulig

Politechnika Krakowska

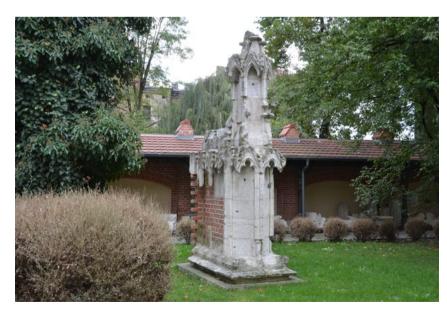
Fig. 1. Kraków, Pałacyk Czapskich, lapidarium w ogrodzie, pinakiel z XIV w.

The Hutten-Czapski Museum, the oldest branch of the National Museum in Kraków, boasts the most effective stonework collection integrated into the palace garden, with valuable pieces of Krakow's Gothic buildings (Fig. 1). In the garden the exhibits harmonise well with the greenery, with the dominant element being a medieval pinnacle (i.e. an original 14th-century pinnacle from Saint Mary's Church). Near the fence there is a collection of diverse details: massive and very small exhibits. The trees and flowers found in the garden provide the perfect background for the collection. Visitors can combine study of the collection with a walk, recreation in the garden or sketching decorative motifs. There are several characteristic exhibits that deserve a mention. Those include pieces of dimension stones made of Jurassic limestone in the late 14th century, e.g.: a) piece of a gable finial with crockets – which are a common element in Gothic architecture – on the edges; b) piece of aedicula that topped the buttress of presbytery in Saint Mary's Church in Kraków. The dimension stone was dressed to serve as the bottom part of a double sloped roof which adheres to the ends of wimpergs; c) part of aedicula of a buttress of altar wall. It includes a piece of a row of wimpergs. The wimpergs are separated by fleurons. The preserved fragment includes tracery on half of the wimperg and its diamond vault; d) pieces of pinnacles with parts of decorative wimpergs and crockets on the edges; they formed a part of aedicula of buttresses; e) piece of a portal jamb or window frame of unknown origin, second half of the 14th century; e) corner piece of a straight portal lintel with intertwining muntins and fragments of arches. This is an element of a characteristic, still Gothic, portal from the early 16th century. Similar portals can be found in large numbers in the Wawel Castle, monastery buildings in Kraków and Kazimierz and Kraków's tenement buildings and palaces; f) piece of a column with relief sculpture in the form of slanting check pattern filled with rhombi. This is a part of a pier placed between windows in an official room of a tenement building located in Kraków which dates back to the second half of the 15th century or the turn of 15th and 16th century. The collections include unidentified pieces that still have not been analysed by researchers. In the recent years the stonework collection from the Czapski Museum was divided and some of the exhibits were moved to a new location by the Granary. It is a small collection that includes exhibits from a few periods. The details are displayed outdoors under a roof, on shelving units, and labelled with an accession number. Due to the large number of exhibits within a limited space, exhibits other than those on bottom shelves placed in the first row are not easily visible. In some instances, it is difficult to see the origin and resemblance to the preserved and complete historic sites (Fig. 2).

The monumental presbytery of Saint Mary's Church enclosed on five sides is surrounded by buttresses. The presbytery buttresses (with stone drip cornices on chamfers) are four storeys in height and stand on a low stone plinth. The precise stonework of the beautiful architectural finial is made of dressed Jurassic limestone. The architectural finials of the presbytery are constructed in line with the contemporary model known as aedicula. The core of the composition is a horizontal form, a small structure (chapel) surrounded with muntins, whereas the front features a turret made of a pinnacle or its creative variation. Above the pinnacle on the south buttress of the altar wall there is an emblem of the Republic of Poland. For now, after conservation work and replacement of damaged elements¹⁴ (reconstructed by architects Tadeusz Stryjeński and Zygmunt Hendel – 19th-20th century) on the presbytery buttresses there are ten aediculae with pinnaces – turrets.¹⁵ The Gothic pinnacle found in the Czapski garden was moved there after replacement work on the building.

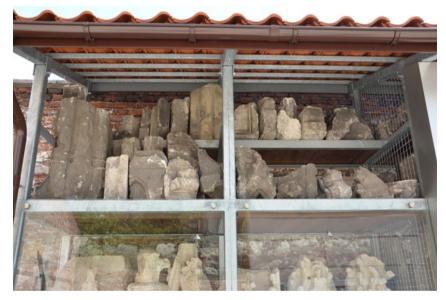
Fig. 2. Kraków, Spichlerz, Plac Sikorskiego 6, lapidarium
