Stone wood and metal in the memorial sculpture of Ukrainian historical cemeteries of the Polish-Ukrainian borderlands

Abstract: The memorial sculpture of Ukrainian historical cemeteries of the Polish-Ukrainian borderlands was analyzed. The existing state of objects is characterized. Use and preservation of materials – stone wood and metal – from which the typical models of the memorial imagery are executed was investigated. Special attention is paid to the discovery and research of unique samples of the memorial plastics made of different materials which were discovered during field works.

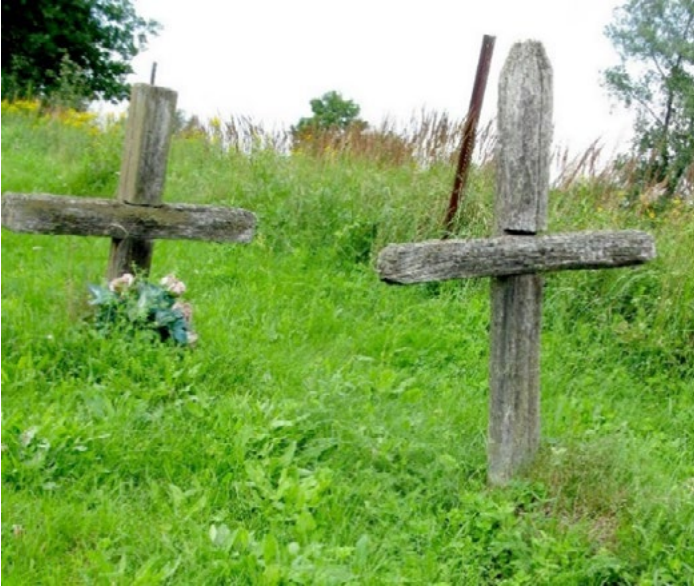
Fig. 1. Wooden crosses at the cemetery in the village. Citation

On the other hand, some wooden crosses can be found in the territory of some cemeteries, for example in villages or in former villages of Tsityl (Fig. 1), Dobra (Fig. 2), Dubrovitsa, Chervona Volya. Such crosses are usually very simple. These, so-called Latin crosses are made of plains, square in the section of boards. Sometimes a cross-section of the cross contained a small wooden or metal plate for the inscription. Still, more often than not, this is simply a cross without any decor, ornaments and the inability to identify who is buried there.

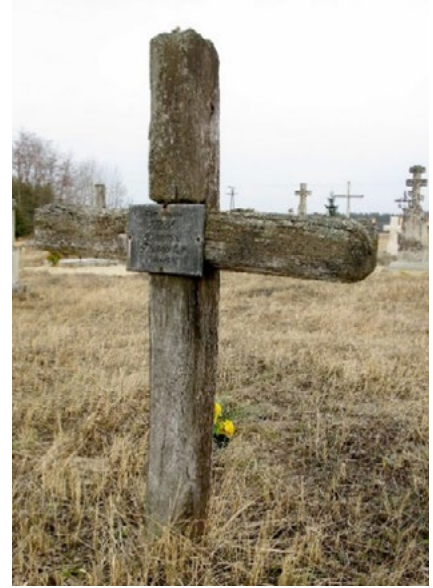
Fig. 2. Wooden crosses at the cemetery in the village. Good

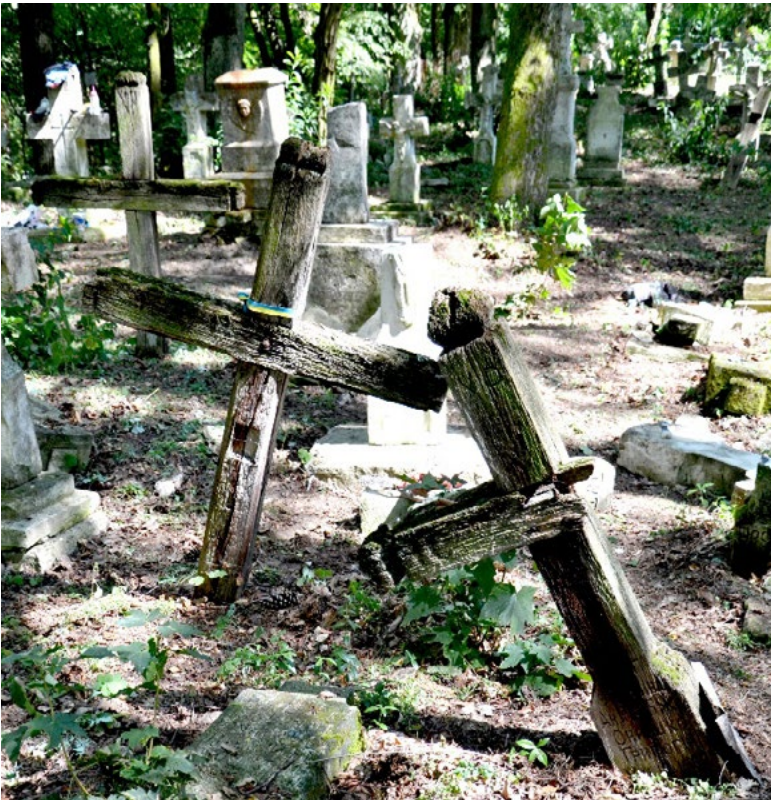
Fig. 3. Wooden crosses at the cemetery in the former village Sukha Volya

The cemetery in the former village of Sukha Wola, which we researched during one of the expeditions, turned my view of wooden crosses. There are not so many in the cemetery. Some still firmly stand, some have already bent (Fig. 3). During the cleaning of the cemetery, we occasionally stumbled upon the remains of wooden crosses, which clearly indicated that such crosses were much larger, but they simply did not physically survive until our time. So the crosses that were located at the beginning of the cemetery were Latin, traditionally quite simple in shape, made of plains, square in the section of boards.

The raams of the crosses ended with decorative bullets, and the bodies were covered with inscriptions. These inscriptions are engraved on a tree and are arranged in different ways – along, across, diagonally. The font of the inscriptions is correct and professional, and the work is executed skillfully. Some crosses have niches made of rectangular, circular or oval shapes, possibly for insertion of a photo, or maybe icons.

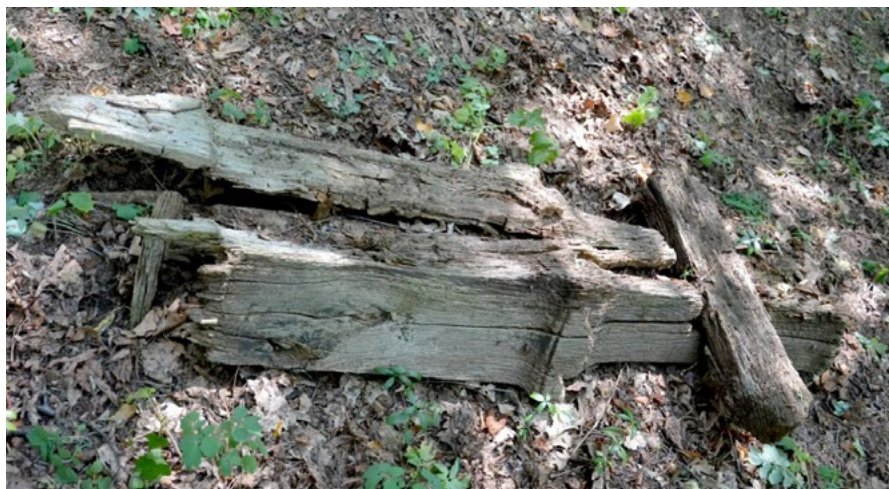
Fig. 4. Cross at the cemetery in the former village Sukha Volya

But the greatest impression was made by the great but very destroyed wooden cross that lay on the ground and was hidden between the grass, the leaves and branches were falling off. In form, this cross is an exact copy of a traditional stone cross on a complex built-up basis with a high base and a pillar of a stone. Not enough just crucifixion. The construction of the pillar carries a classic architectural character – it is completed with a traditionally profiled cornice crowned crown with teeth. In this case, these teeth are semi-circular. The teeth may be sharper or smoother, they may be different amounts depending on the size of the object. On the front side of the pillar practically for all its width niche with arch completion is carved. Such niches, at least in stone monuments, were intended for inscriptions. But in this case the tree is very destroyed. The lower part of this cross is very destroyed and partially lost so it is impossible to understand how and where it was installed and how it was attached to the base. (4)

And the technological aspect of building these monuments deserves attention. Stone monuments were always executed from several parts and these parts were mounted one to another without glue. A vertical cross made from one piece of wood. Even if a piece of wood is not one, then the integrity is mounted firmly and is perceived as one continuous fragment. The transverse plate is mounted, that is, the arms of the cross. They are executed from another piece of wood. In this part the master does not try to create the impression of integrity, but all the details are still mounted tightly. While parts of the stone monument are easily disassembled and collected together.

The first is when wooden monument repeat stylistically, and actually copy the stone model. I do not think that such a monument was truly unique, but at the moment it is the only surviving example that we have been able to find. Moreover, the wood collapses just before the eyes – it breaks down, drain down, rubbing, and requires conservation and preservation. The second is when stone monuments repeat stylistically, and actually copying the cast iron model. I do not know if such a monument was truly unique, but at the moment it is the only surviving example that we have been able to find. The stone is in good condition, it does not threaten the rapid destruction.

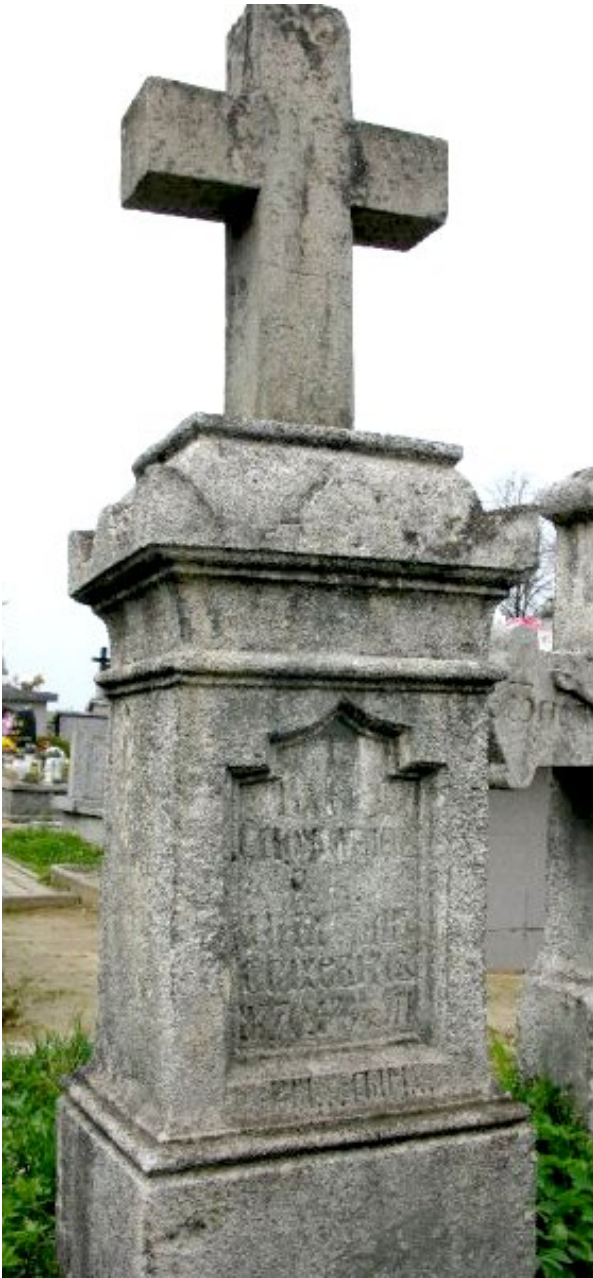
Fig. 5. Cross at the cemetery in the village Oleshucia

For comparison, here are two stone tombstones with the same compositional structure and construction, as in a wooden cross from former village Sukha Volya (рис. 5,6). There are much more of such examples, and several can be found on the each cemetery. The given examples are different in proportions, there is a richer and more modest profile of cornices, a different form of completion of a niche on the front side of the pillar. The cross that crouches the composition once is a crucifix, and once without. That is, there is always a place for creativity for the author of the art work, but composite models are preserved.

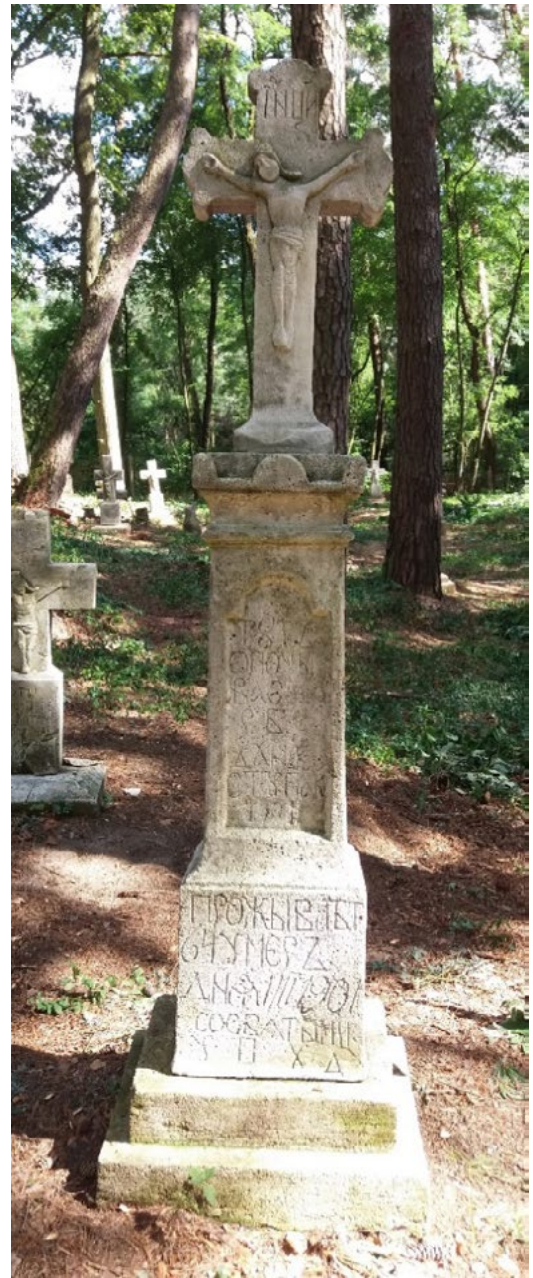
Fig. 6. Cross at the cemetery in the former village Sukhya Volya

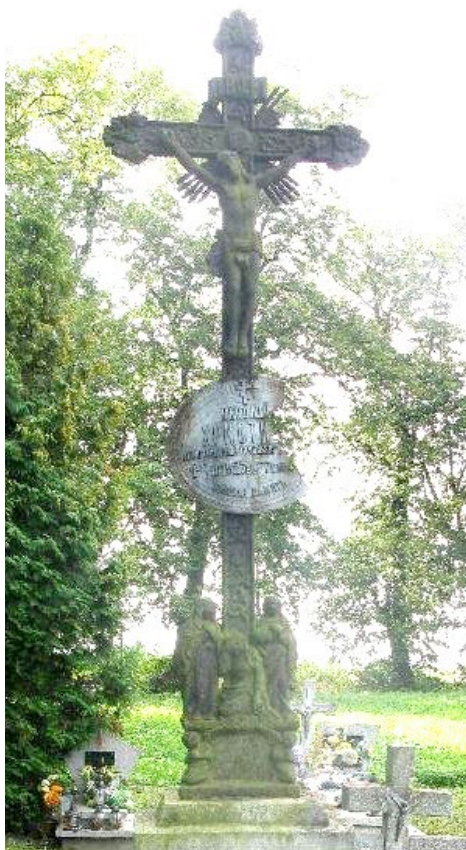
Fig. 7. Cross at the cemetery in the village Drohojiv

As has already been said about serial production – tombstones are ordered by catalog. The same crosses can be seen at the cemetery in Prague, Krakow, Lviv, Przemysl or Lubachiv, as well as in the cemetery of the non-existent already village in Lemkiv mountains. This is the motive of the cross with the crucifixion and the coming with Baroque motifs. In this Lemkiv village in the mountains, they made something unique and special. An exact copy of a cast-iron cast cross with baroque motifs – with figures of upcoming, angels – was cut from a stone. The composition, the posture and movement of the figures, the folds of clothing – is identical. Make such a thing is not very easy. The author of this monument is unknown, but it was to be a skilful and professional sculptor. The monument is located in Volosate, a former Lemko village, and now the official settlement of the Beskydy National Park in Poland.

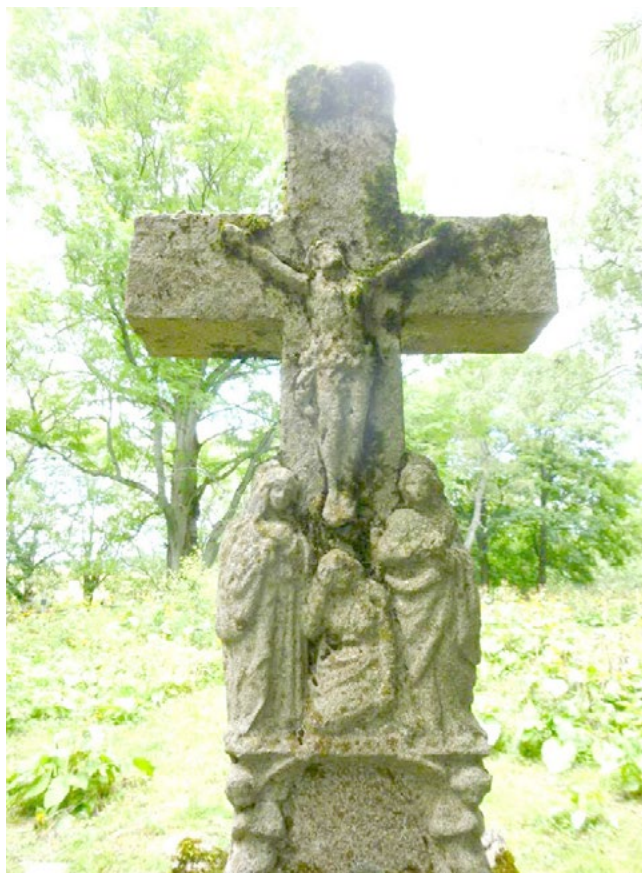
Fig. 8. Cross at the cemetery in the village Volosate
