The Influence of the Material-structural Characteristics of Travertine, Limestone and Alabaster on the Features of Their Use in the Construction of the Assumption Cathedral in Princely Halych

Abstract: The authors established the relationship between substance-structural characteristics of natural stone – alabaster, limestone and travertine, and the features of its use in the construction of the Assumption Cathedral in Princely Halych. The authors draw on data from archaeology, geology, the latest technological research, and the method of comparative analysis. The article shows the features and continuity of the materials application in the region construction.

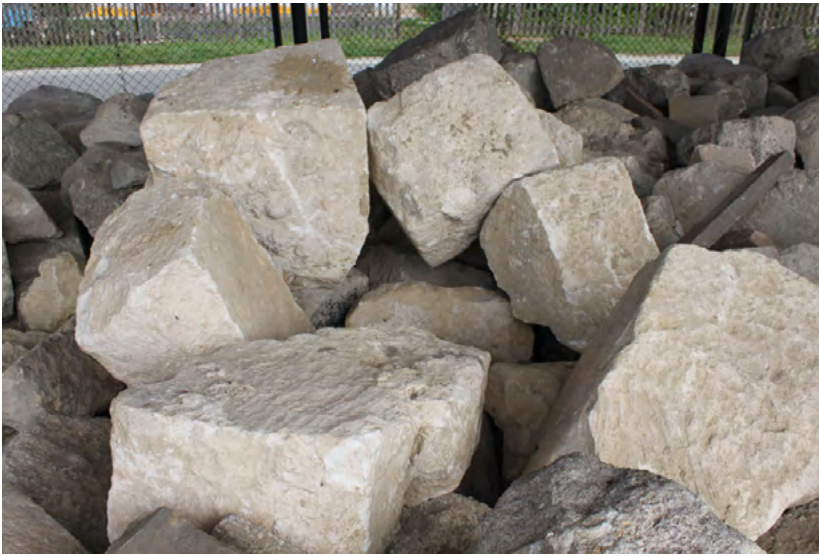
Fig. 9. Limestone blocks with traces of processing (village of Krylos)

In the vicinity of Princely Halych, as well as throughout the territory of the Halych-Volhynian Principality, numerous limestone deposits are known, some of which are still being quarried. Notably, during the princely period, limestone extraction and processing were carried out by breaking stone from horizontally layered strata. The stone was then cut into blocks of the required size and manually dressed. This method minimized structural disturbances to the stone and preserved its durability after processing.

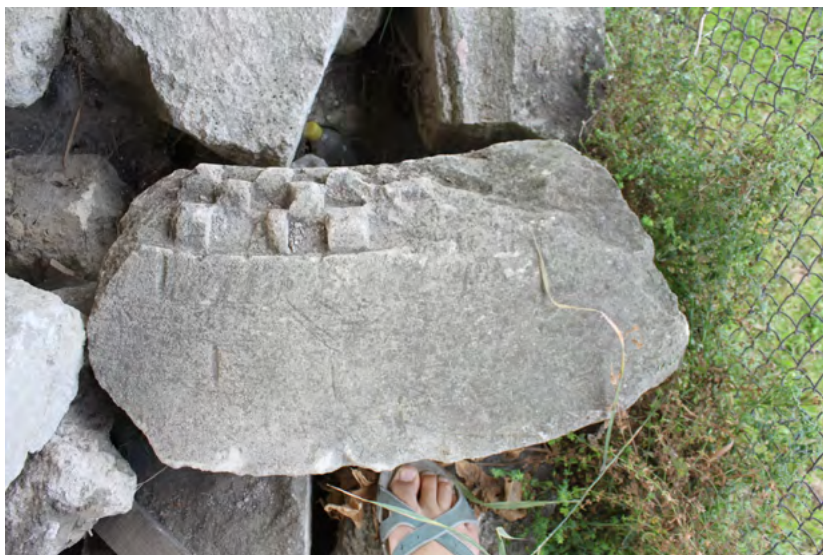
Fig. 10. Alabaster detail (village of Krylos)

The gypsum stone blocks identified among the building material of the Assumption Cathedral of Princely Halych are also characterized by diversity. Gypsum is represented by a cryptocrystalline or fine-crystalline variety of the rock – alabaster. Its deposits are chemogenic formations from the initial stages of halogenesis, accumulated in saline lagoon conditions in regions with a dry and hot climate. Alabaster is characterized by high density and massiveness due to the dense packing of isomorphic small (up to 10 μm) grains, which also affects its hardness, making it considerably harder than coarser crystalline gypsum [24]. The alabaster blocks found among the remnants of the structure show the presence of layers with a different composition. The carved decoration has a variety of colors, primarily white and gray, often with a bluish tint, and sometimes striped or mottled. They are usually massive, sometimes with interlayers of alabaster, gypsum, and carbonate-clay strata, and in some blocks, there are veins of translucent, parallel-fibrous gypsum – selenite, about a centimeter thick [8, pp. 45–46]. The visual heterogeneity of the coloration indicates the presence of impurities, while the structural diversity reflects the varying grain sizes and the presence of layers with different material compositions, which affects the durability of the alabaster, reducing its resistance. This material is sourced from villages near Halych, such as Bowsiv, Viktoriv, Zhuravno, and Sokil [9, p. 213].

Alabaster, like gypsum in general, is vulnerable to the action of water, as evidenced by numerous manifestations of karst formation in areas where gypsum rocks are prevalent. Moreover, under increased moisture conditions, the stone material becomes sensitive to subzero temperatures, and the combined effects of both factors lead to the destruction of the surface areas of the stone and its complete breakdown with repeated exposure to these destructive agents. The use of alabaster in global construction practices has been quite broad and diverse, including the construction of buildings, elements for water supply and drainage systems, cladding, and decorative interior and exterior elements. In our climatic conditions, with high humidity levels and significant daily temperature variations, the durability of the stone is much lower than in warmer and drier regions.

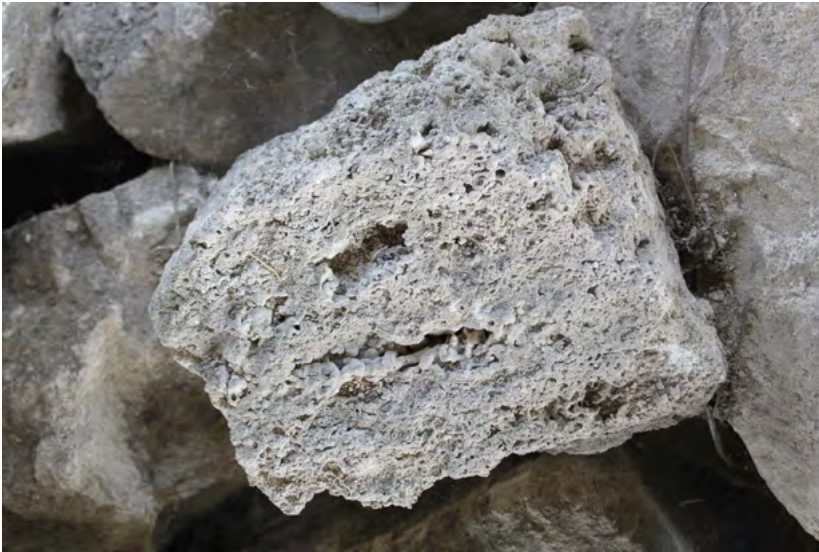
Fig. 11. Travertine block with a complex heterogeneous porous structure (village Krylos)

In Princely Halych, blocks of gray limestone tuff with a light beige tint were used. These are strong, though somewhat fragile, carbonate rocks with a porous and complex texture, exhibiting varying porosity, which ensures low thermal conductivity, good sound insulation, and ease of cutting. Microscopic studies revealed fine-grained, both homogeneous and complex structures, with the most characteristic structural features of plant forms. The main mineral-forming substance is calcite, which makes up 96–98% of the rock, with clay material and quartz grains present as impurities [11, p. 47]. Due to its high porosity and carbonate composition, this building material is also not resistant to moisture. Prolonged soaking is destructive to it. This likely explains
